**Santa Monica-Malibu  
Unified School District**  
John Muir - SMASH Elementary School

**Findings Report**  
**Building Envelope Investigation**

Report Date: June 30, 2022

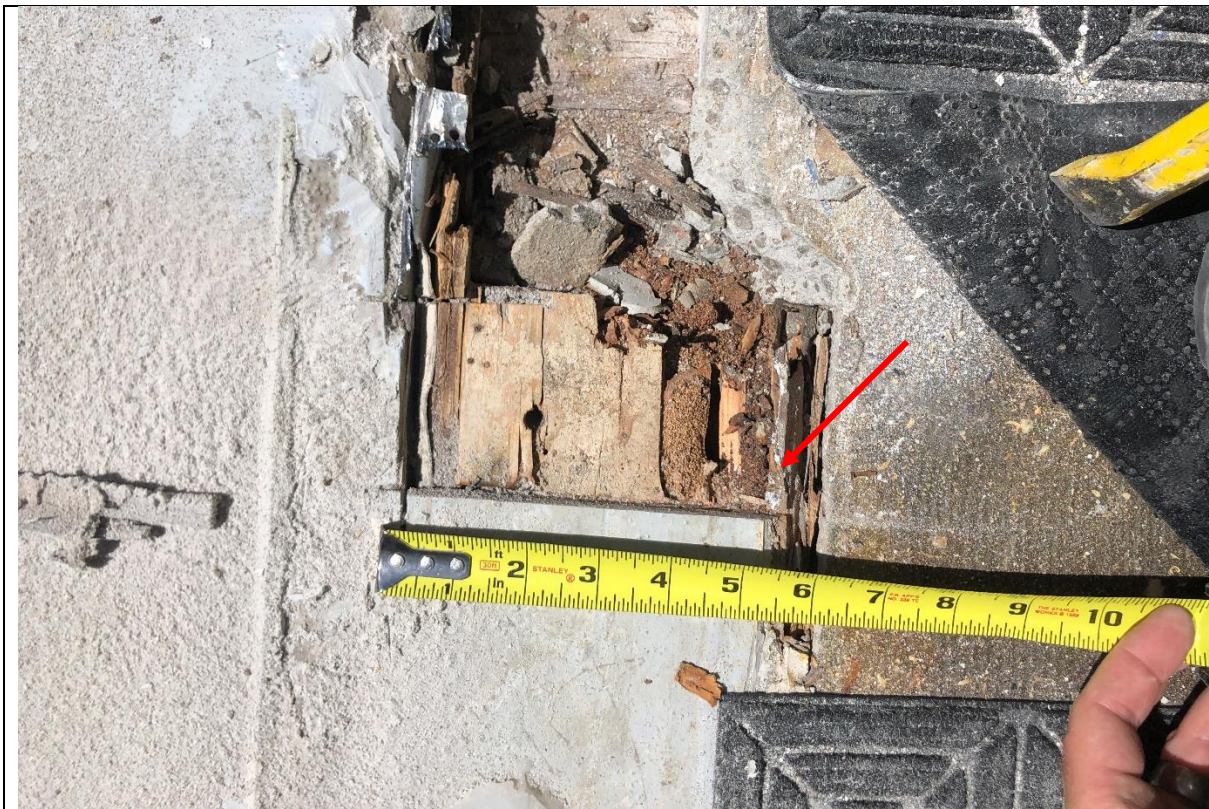
**Photo 87:**  
Water damage at the jamb to sill juncture at the threshold. DTR requested that this area be cut and opened for further visual observation.

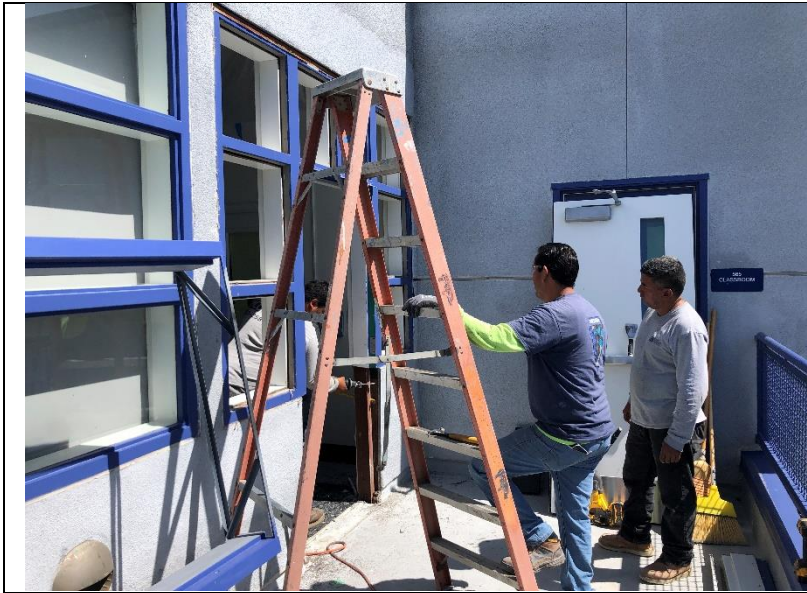
**Photo 89:**

A hollow metal frame being removed at building D.

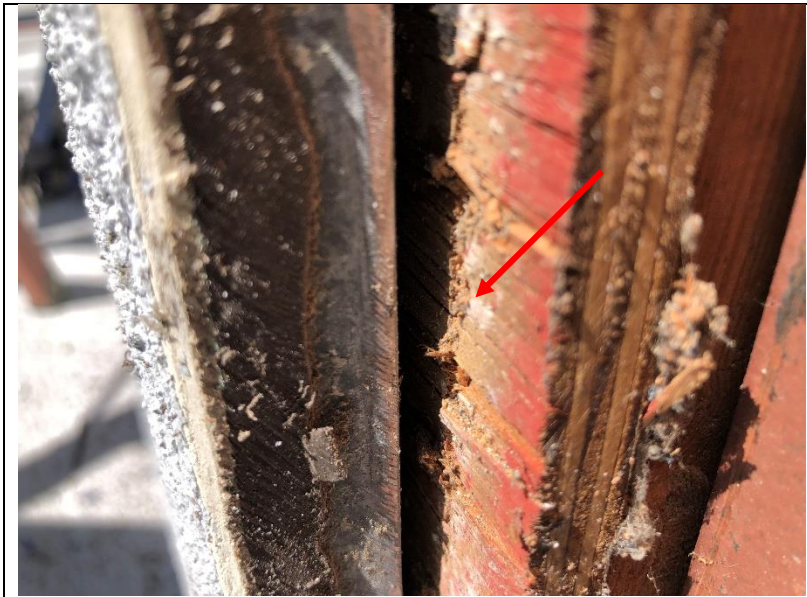
**Photo 90:**

The vertical building enclosure system is failing at the cladding, weather control layer, flashings, and sealants. Some of this is due to age and exposure and some is due to design and construction that does not conform to industry best practices (e.g., photo 90).

Delamination of the exterior plywood sheathing was observed after the hollow metal frames were removed.

No flashing, waterproofing, or weather resistive barrier were observed at this location.

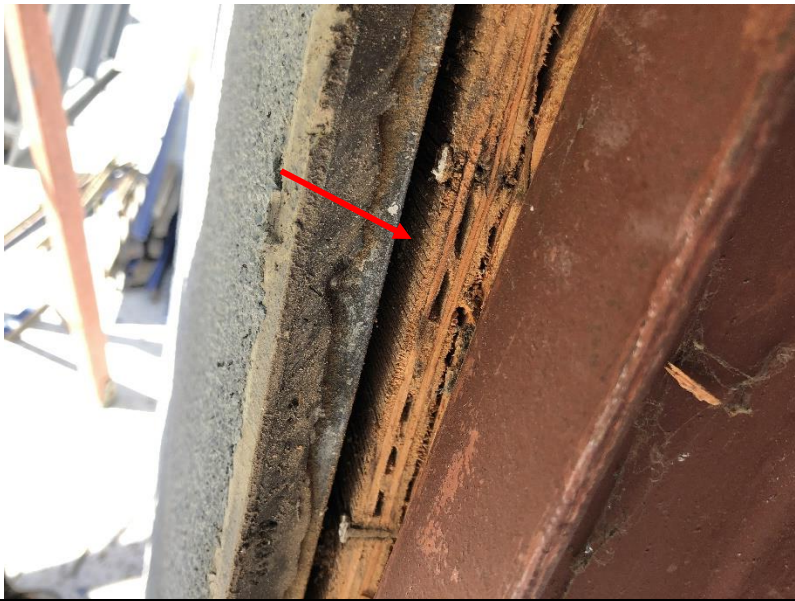
| | <p><b>Photo 91:</b></p> <p>Delamination of the exterior plywood sheathing was observed after the hollow metal frames were removed.</p> <p>No flashing, waterproofing, or weather resistive barrier were observed at this location.</p> |

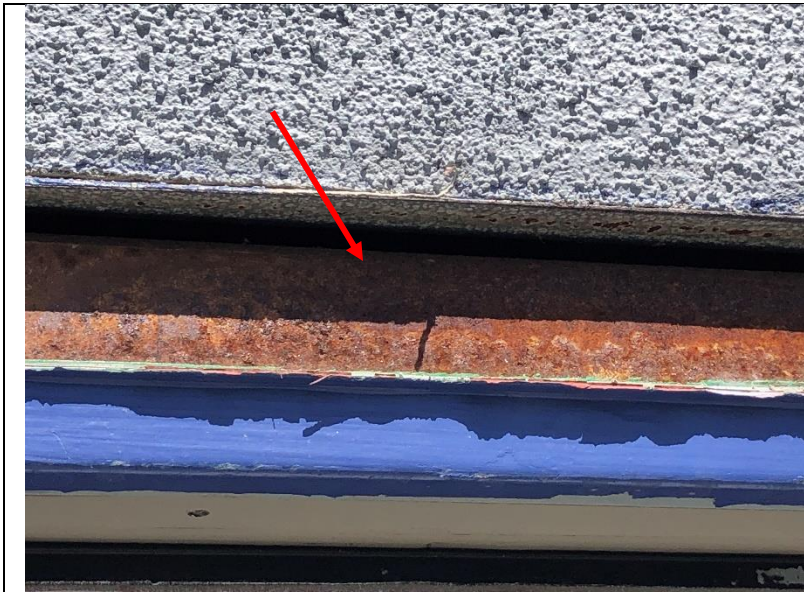
DTR observed that some of the hollow metal-framed doors had head flashing such as Technical Room 570, while others did not such as Classroom 480. When the head flashing above the door was removed at Technical Room 570, corrosion was observed along the head of the hollow metal frame. No weep screed was observed in the plaster stop at that location (**Photos 95 – 96**).

**Photo 96:**  
Corrosion was observed behind a head flashing at one of the hollow metal framed doors.

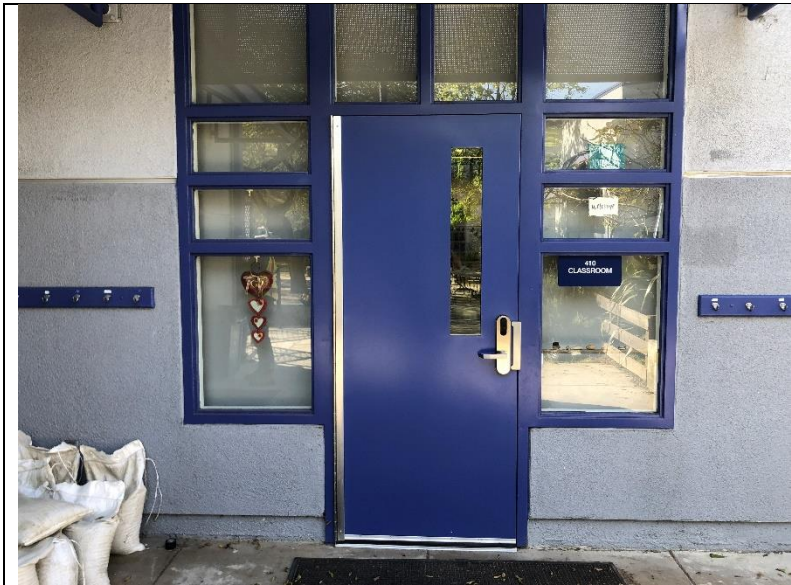
**Photo 97:**  
A hollow metal frame door/window assembly.

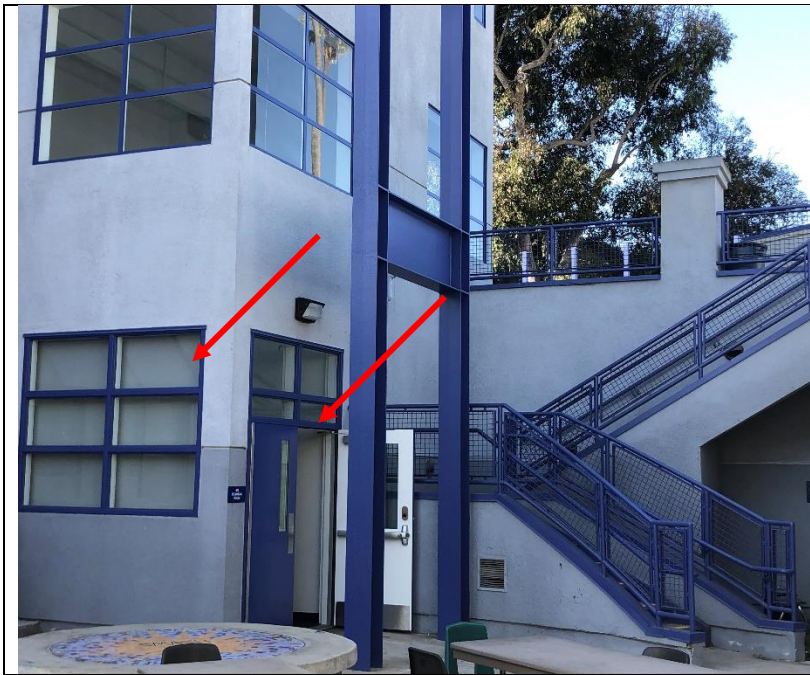
**Photo 98:**  
Hollow metal frame assemblies.

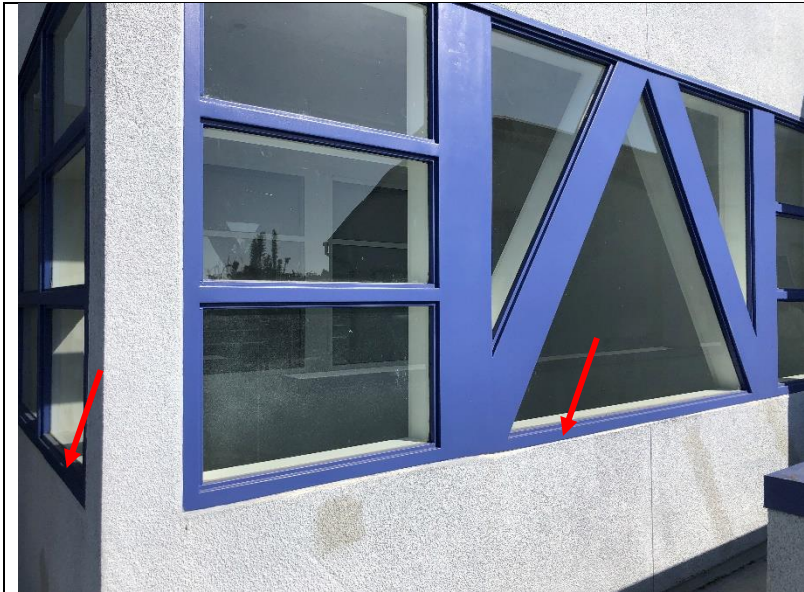
**Photo 99:**  
Hollow metal frame assemblies.

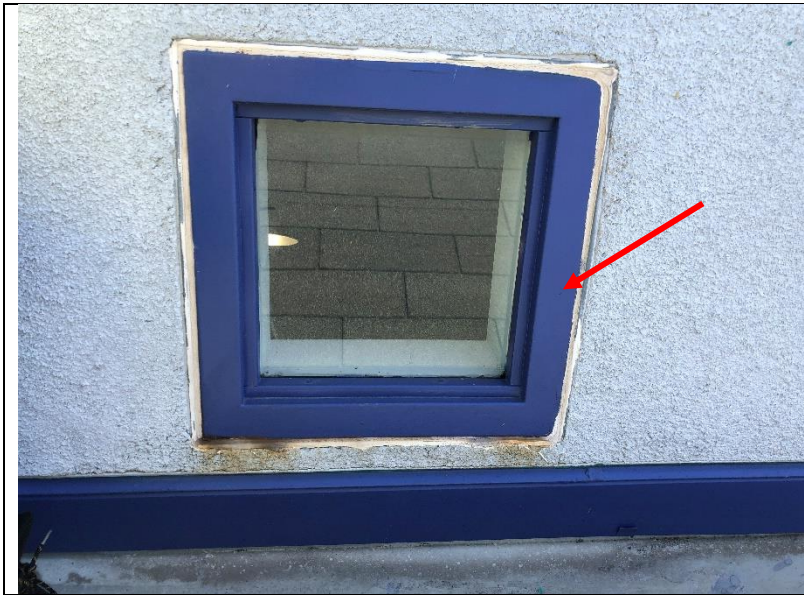
**Photo 100:**  
A hollow metal frame window at the saw-tooth roof.

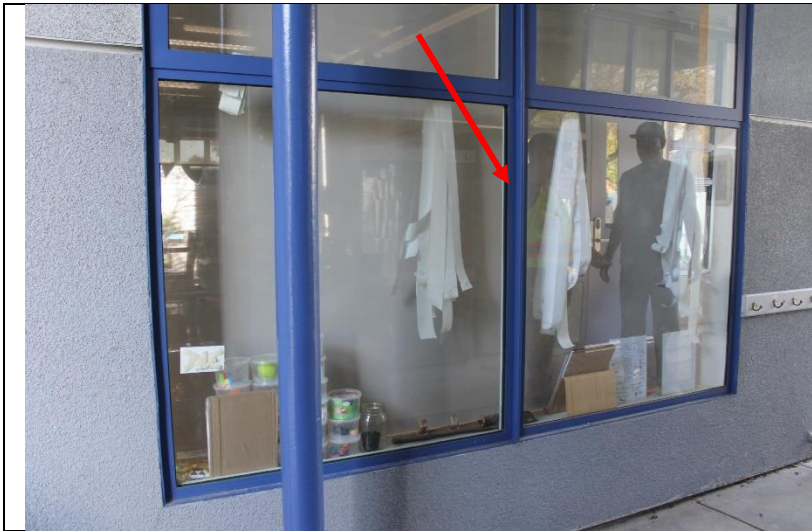
**Photo 101:**

Aluminum framed windows under one of the covered walkways.

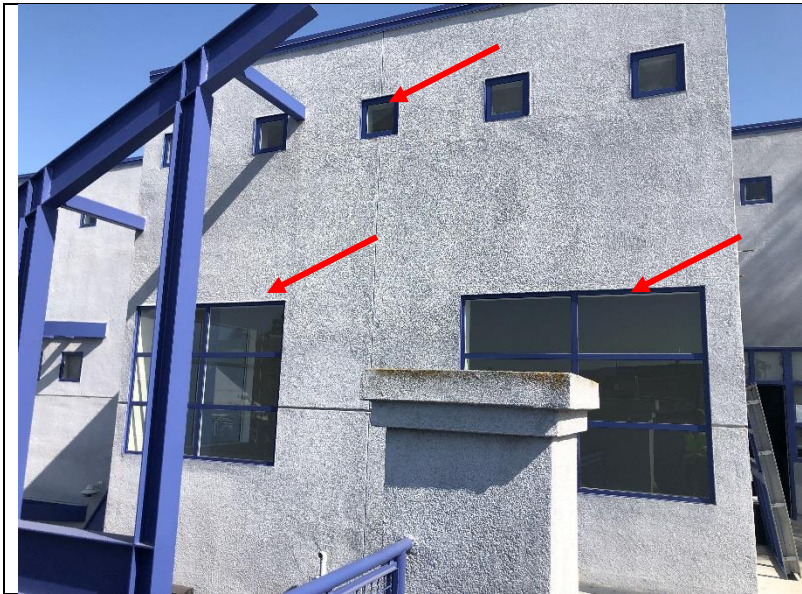
**Photo 102:**

Aluminum framed windows on the north side of building B.

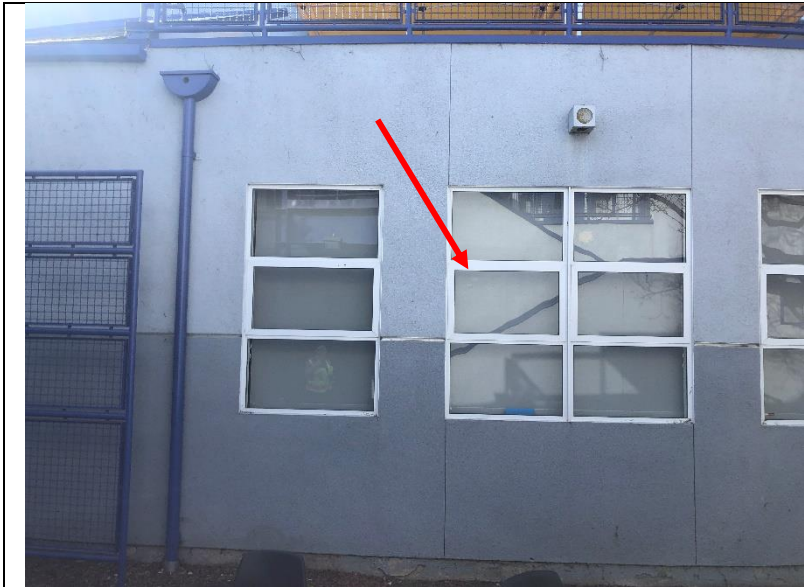
**Photo 103:**  
Aluminum framed windows on the north side of building A.

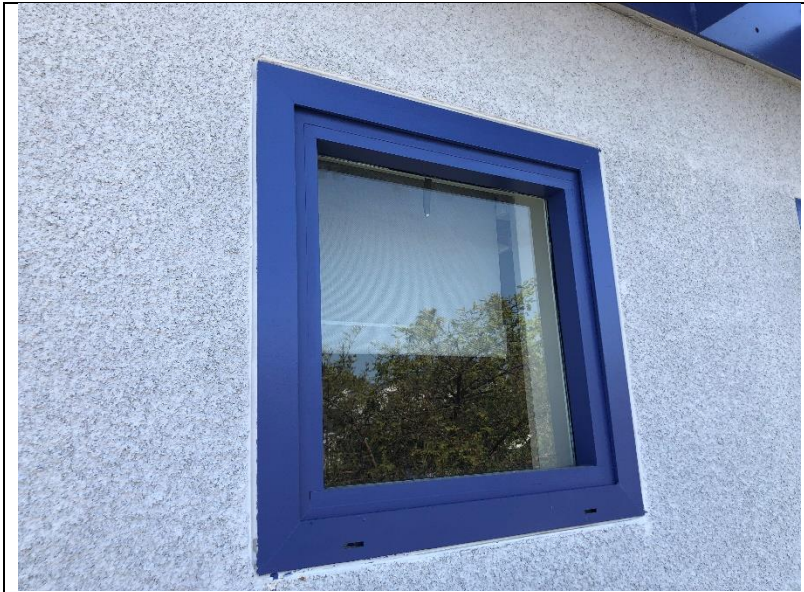
**Photo 104:**  
An aluminum-framed window.

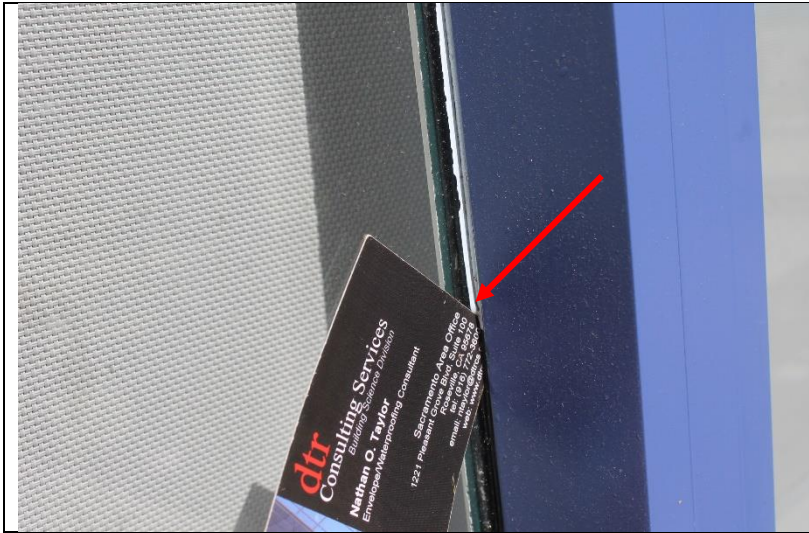
**Photo 111:**

A glazing gasket failure at the perimeter of the glazing at an aluminum-framed window.

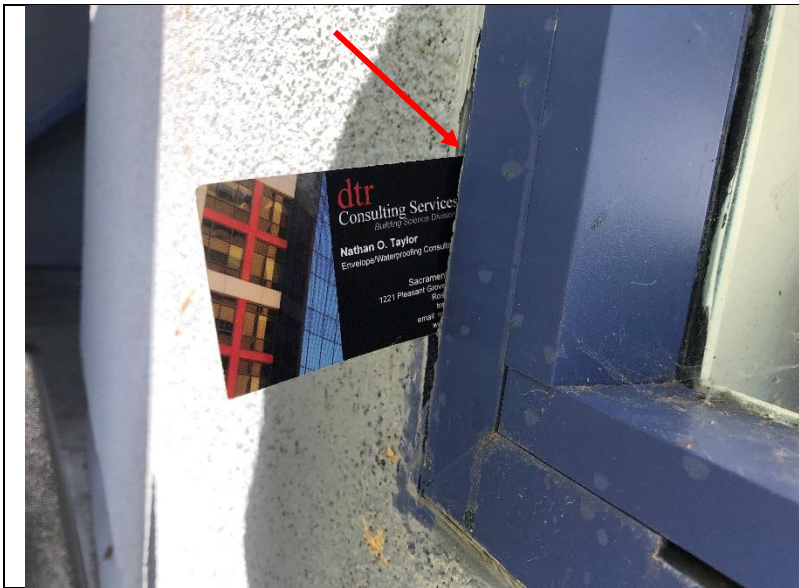
**Photo 112:**

A sealant failure at the perimeter of an aluminum-framed window.

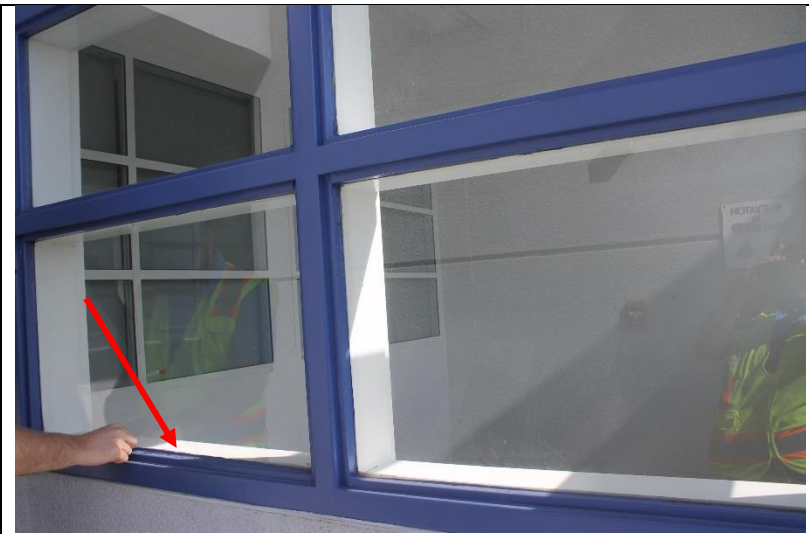
**Photo 114:**  
Silicone sealant was applied at the glazing of this hollow-metal framed window.

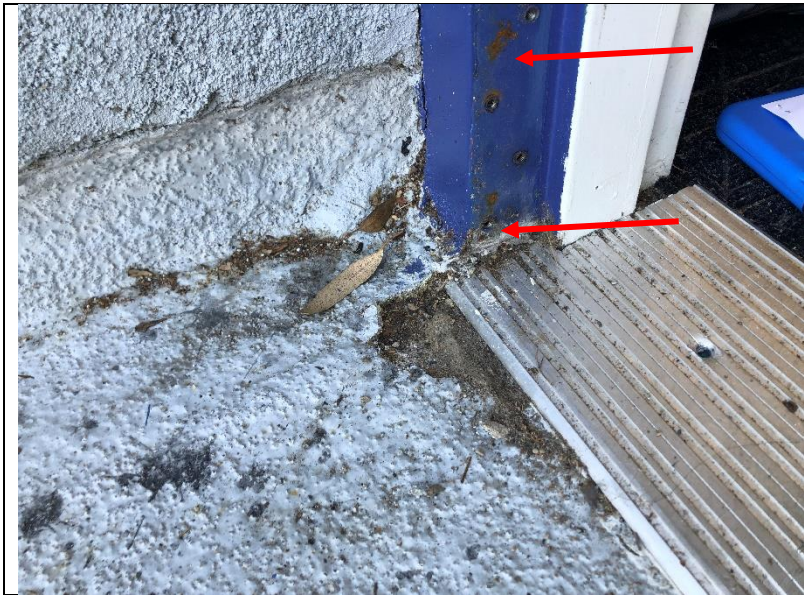
**Photo 121:**  
Corrosion damage at the bottom of a door jamb.

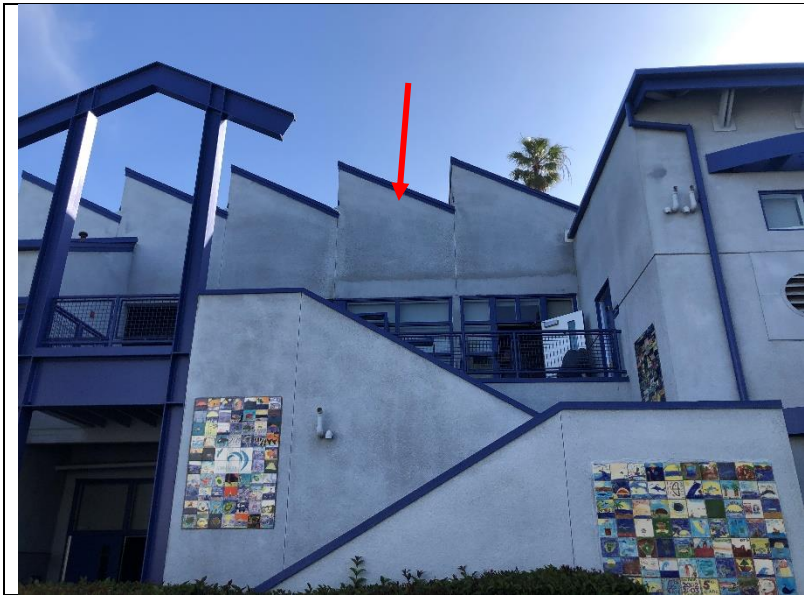
**Photo 125:**  
The saw-tooth roof over building D.

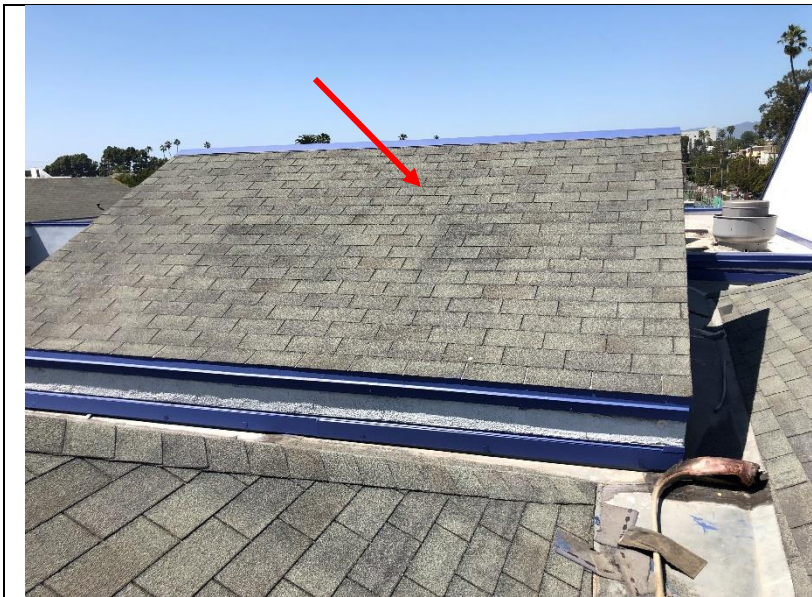
**Photo 126:**  
The shingle assembly on the roof of building D.

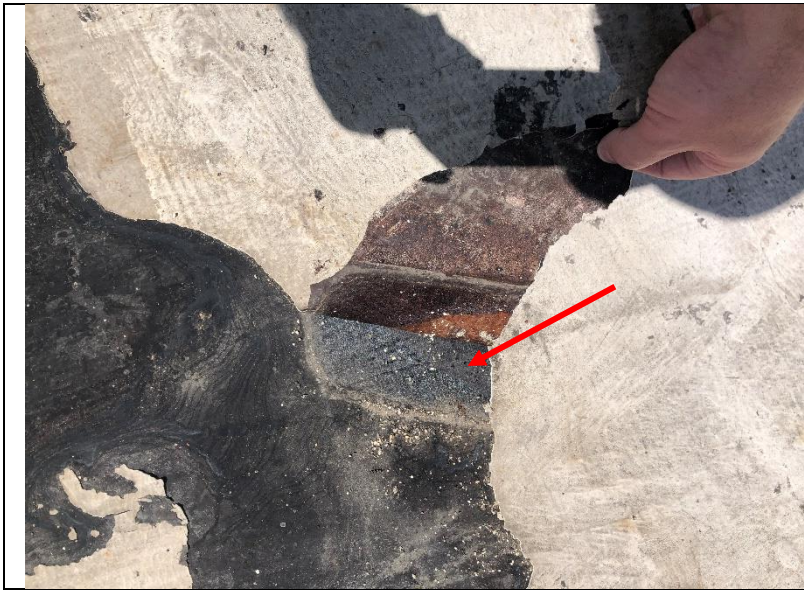
The BUR systems are past their useful life. Failures were observed in numerous locations. The white coating that had been applied over the BUR had also failed. Large areas of the coating had been worn thin over time. The coating was no longer fully adhered to the BUR roof, or had been damaged in many locations. Holes were also observed in the BUR system at some locations (**Photos 128 – 131**).

**Photo 128:**  
A coating failure at the BUR roof over the multipurpose room.

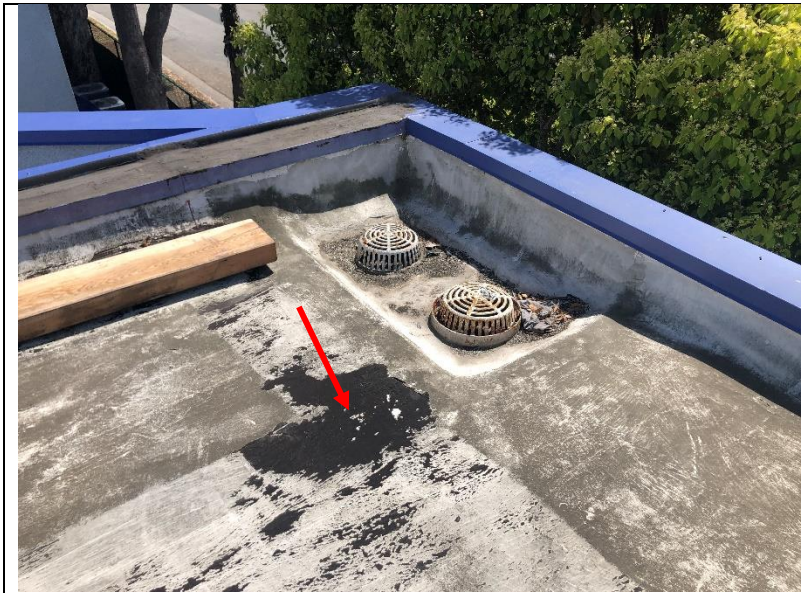
**Photo 129:**

A coating failure at the BUR roof over the multipurpose room.

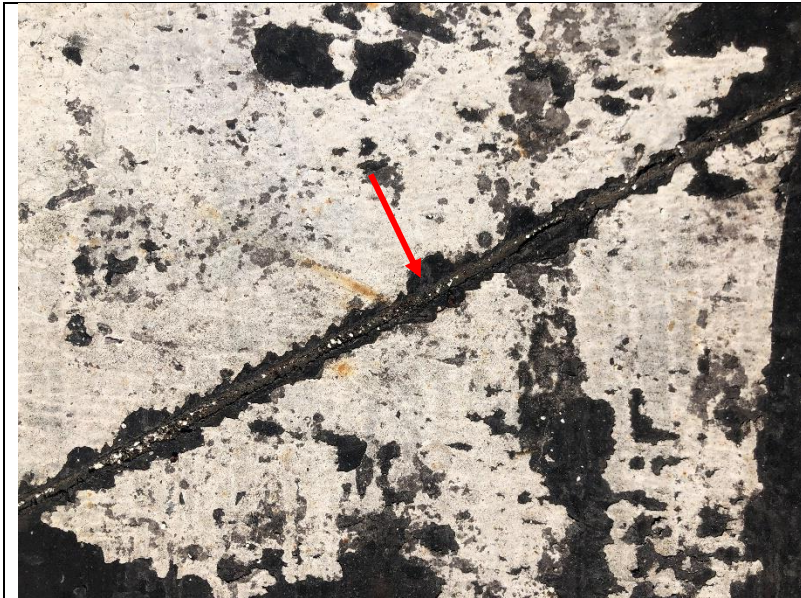
**Photo 130:**

A cut mark in the BUR roof over the multipurpose room.

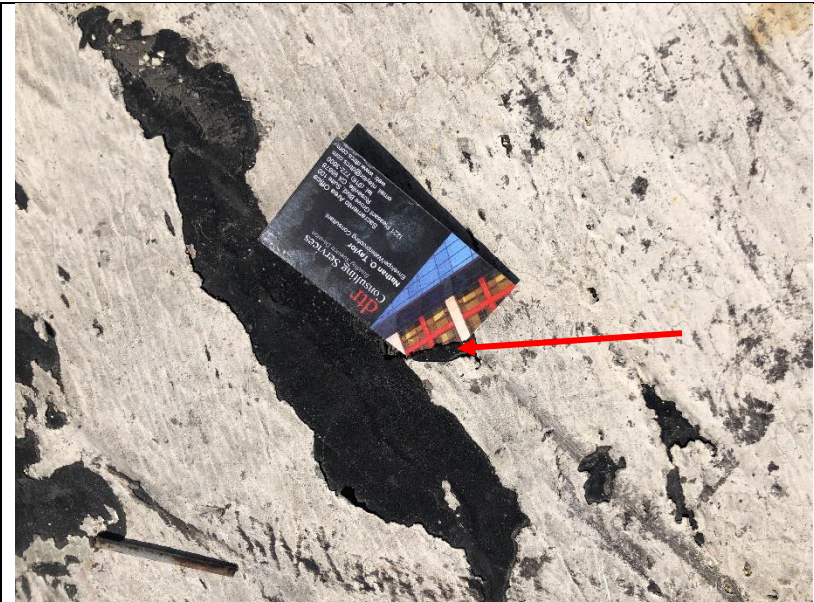
**Photo 131:**

The horizontal building enclosure systems are failing at the material level as well as at transitions, accessories, and drainage systems. Roofing materials (at both steep-slope and low-slope roofs) are mostly at or beyond the end of their useful life (e.g., photo 131). Pedestrian traffic coatings are installed in a manner that is leading to water intrusion and damage (e.g., photo 53). Doors lack sill pans and expansion joints are collecting water and leaking.

A hole in the BUR roof over the multipurpose room.

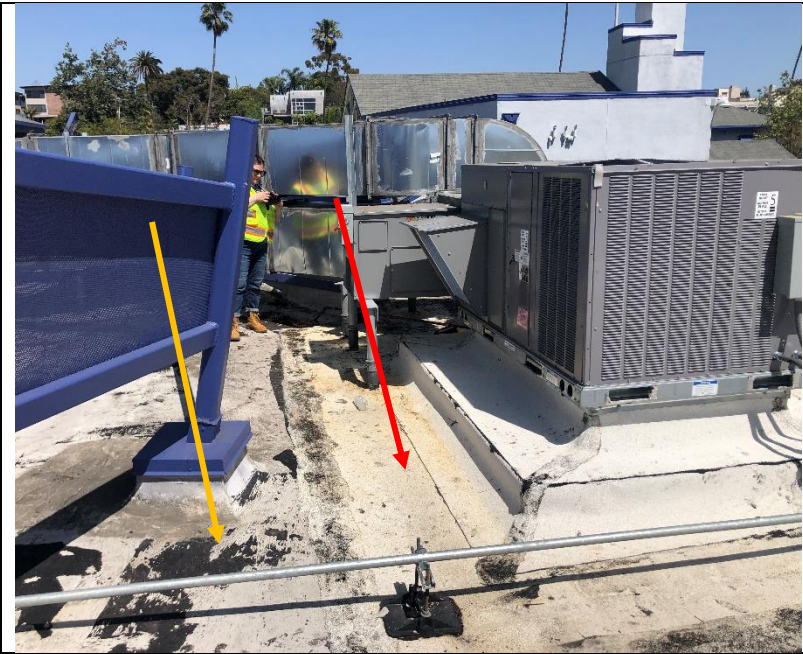
**Photo 132:**

During the recent installation of HVAC systems over the multipurpose room, new mechanical curbs were built on several of the low slope roofs. DTR observed that a granulated cap sheet was installed over the new curbs and lapped onto the existing roof membrane. DTR was not present during this work. It is unclear if the coating was removed before the new granulated cap sheet was installed. There is concern that, given its condition, if the coating was not removed, the coating would not allow for proper adhesion of the new granulated cap sheet to the waterproofing layers of the BUR. It is also probable that the existing BUR membrane was too deteriorated to lap a new cap membrane into it (**Photos 132 – 134**).

The existing BUR with a coating (yellow arrow) and the new granulated cap sheet (red arrow) were installed at the new mechanical curbs.

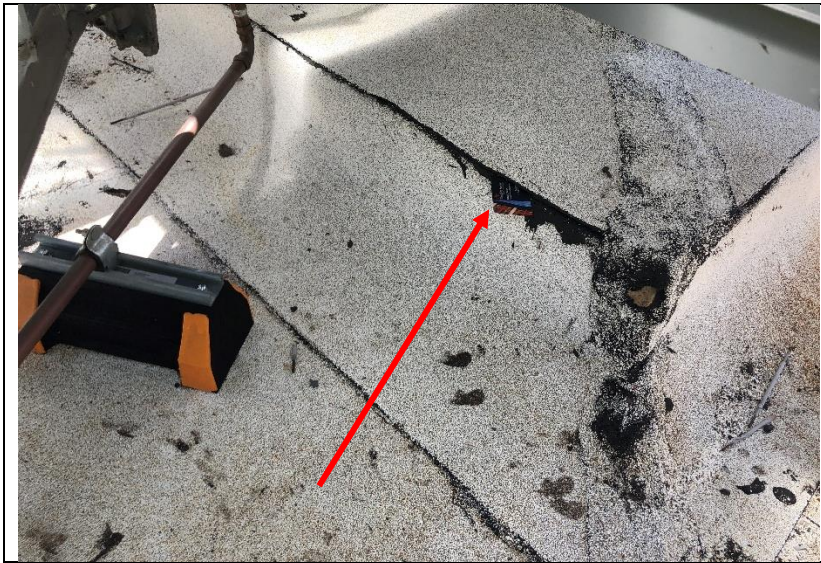
**Photo 133:**

A business card was inserted into a gap in the new granulated cap sheet installed at the new mechanical curbs.

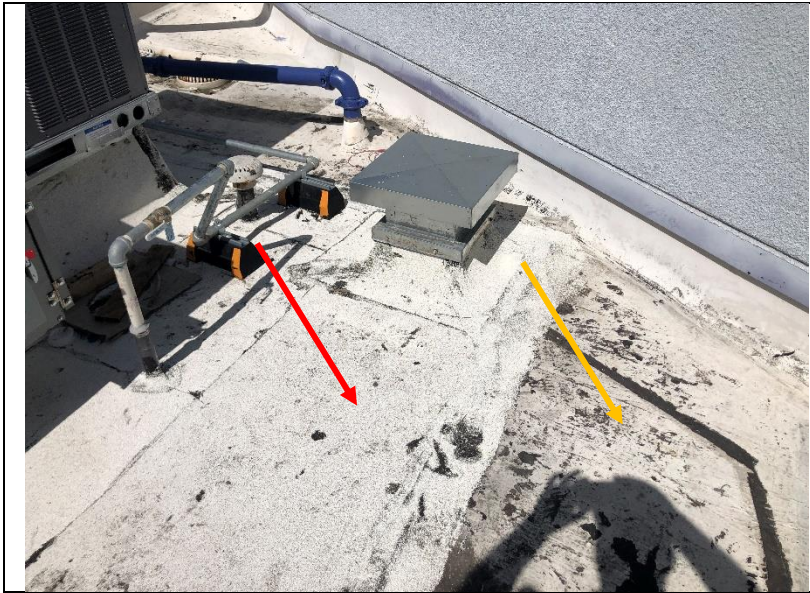
**Photo 134:**

The existing BUR with a coating (yellow arrow) and the new granulated cap sheet (red) were installed at the new mechanical curbs.

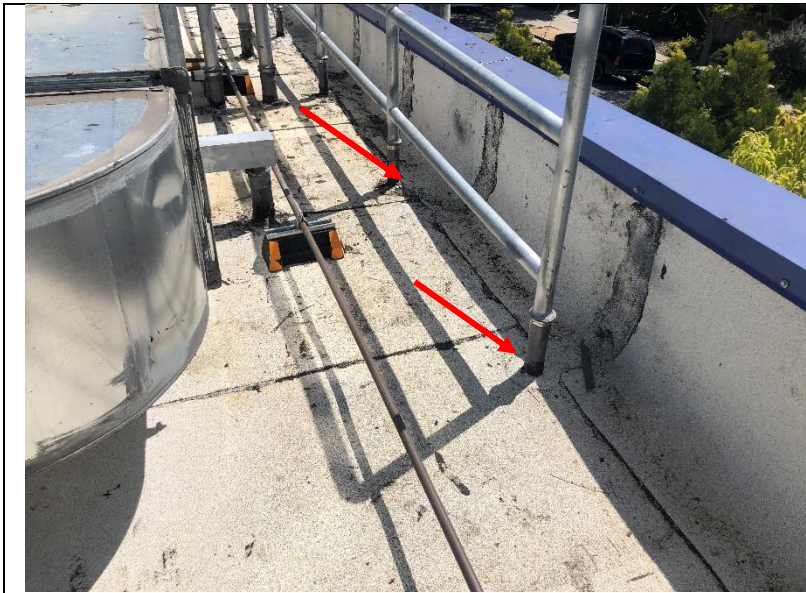
**Photo 141:**

Numerous deficiencies were observed in the BUR roofing system. A variety of penetration flashings had been installed including lead flashings capped with sealant joints, abandoned conical flashings, and coating flashings with drip guards. Some of the penetration flashings appeared to be new and part of the HVAC project, while other penetration flashings were aged and appeared to have been part of previous project work (**Photos 138 – 146**).

Lead flashings were installed at the fall protection rail at the newly installed granulated cap sheet on the roof of the multipurpose room.

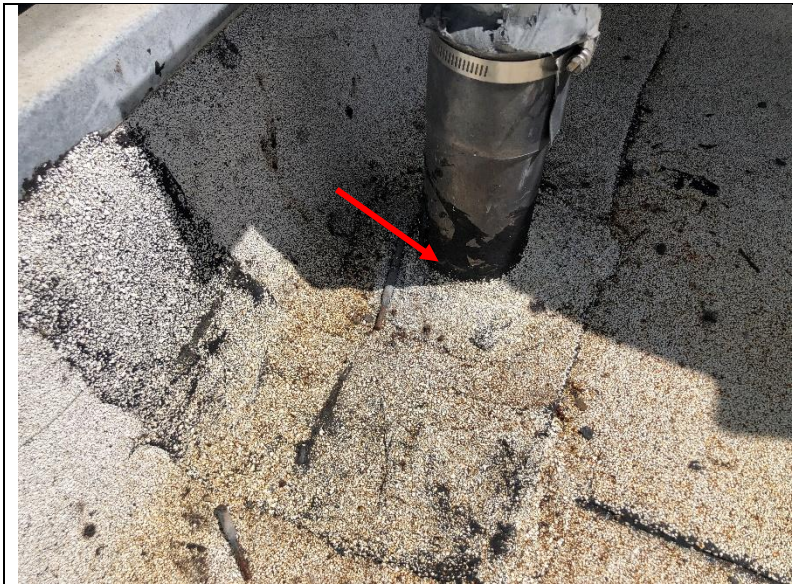
**Photo 142:**

Lead flashings were installed in the newly installed granulated cap sheet on the roof of the multipurpose room.

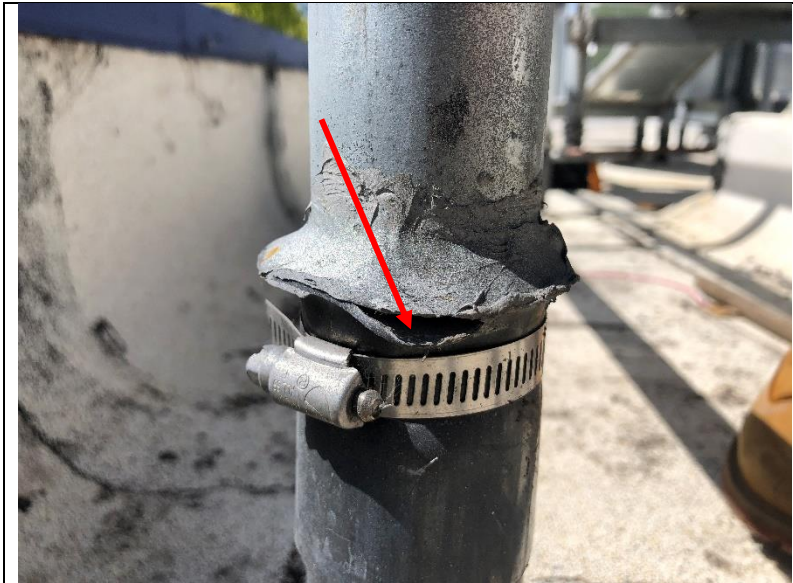
**Photo 143:**

An opening at a lead flashing was installed in the newly installed granulated cap sheet on the roof of the multipurpose room.

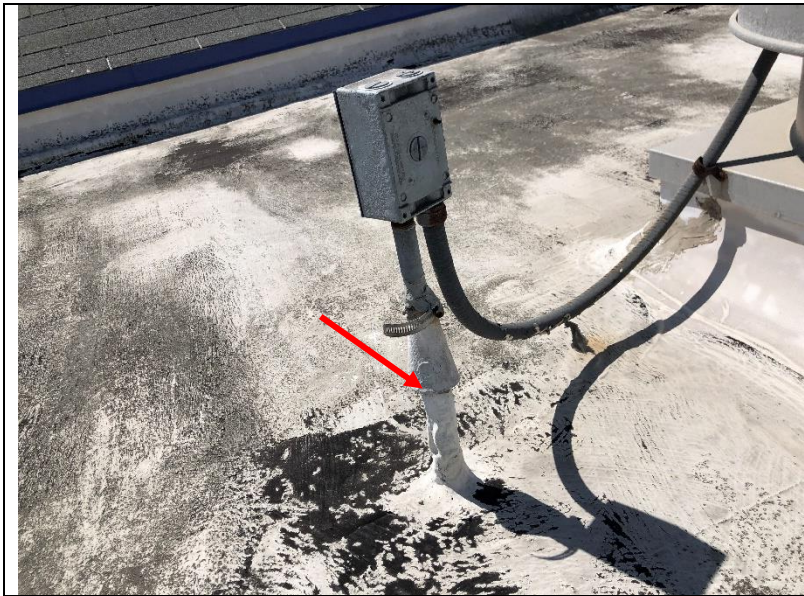
**Photo 144:**

An electrical conduit flashing with a drip guard on the roof of the multipurpose room.

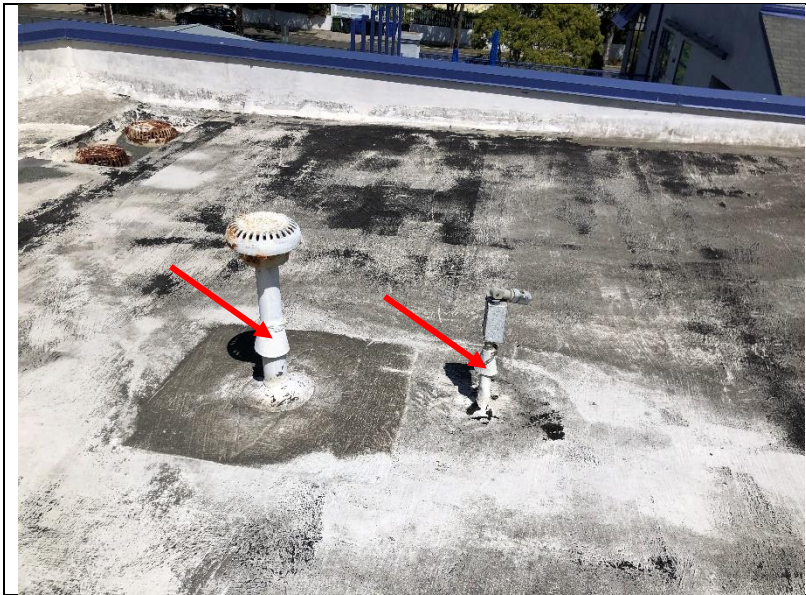
**Photo 145:**  
Penetrations with drip guards on the roof of the multipurpose room.

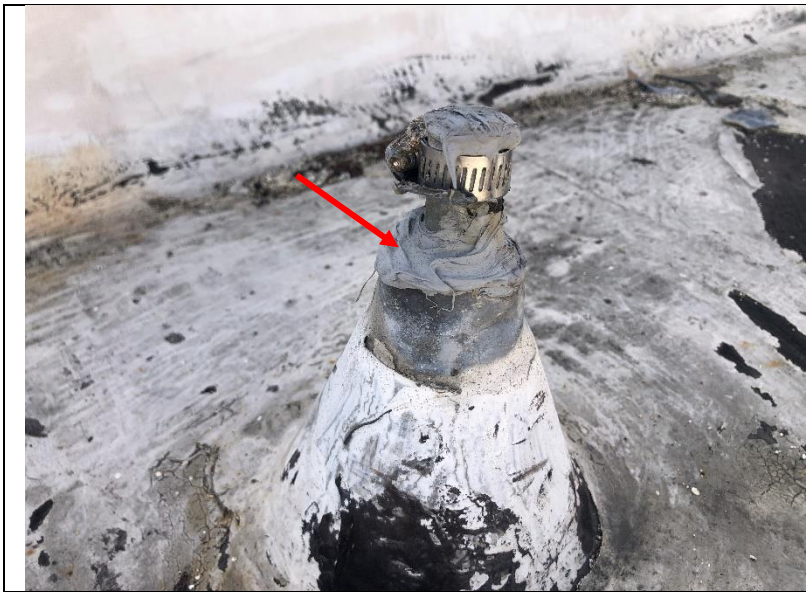
**Photo 146:**  
An abandoned conical penetration flashing on the roof of the multipurpose room.

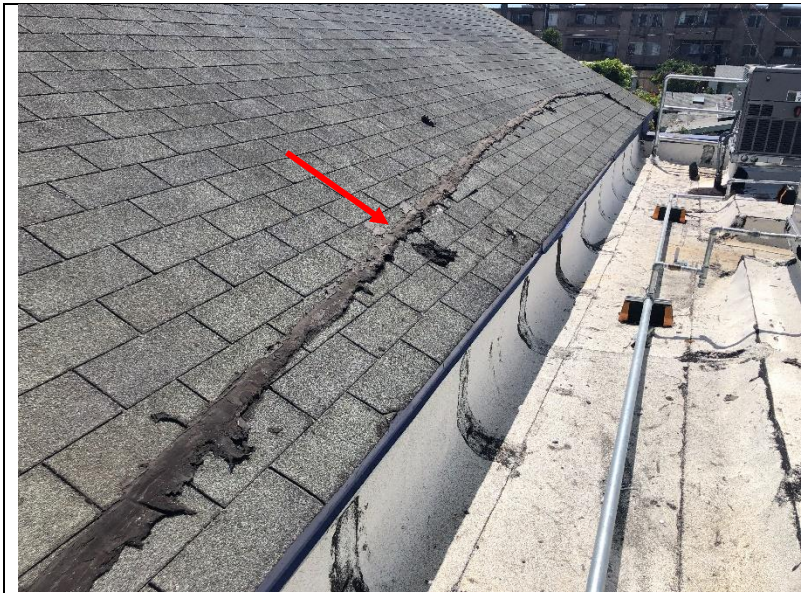
**Photo 149:**  
A swath of mastic was observed at the asphalt shingle roofs.

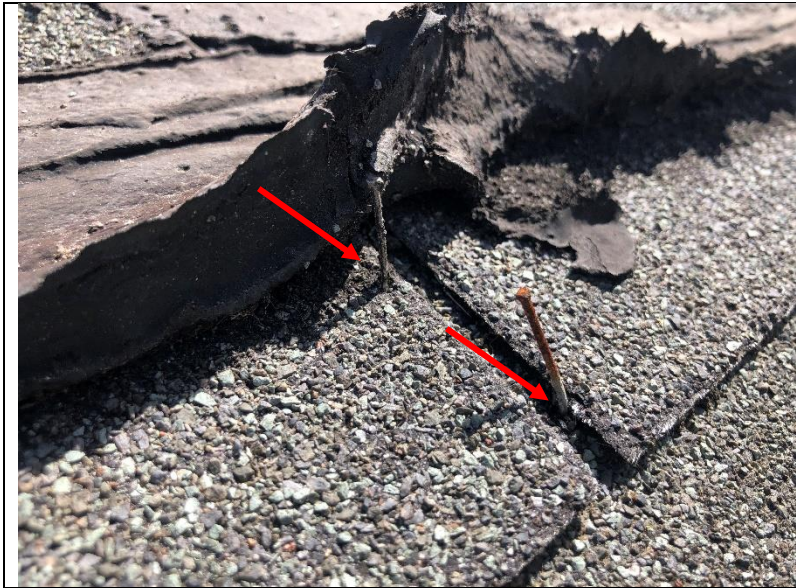
**Photo 150:**  
Staples and nails were observed at the mastic swath.

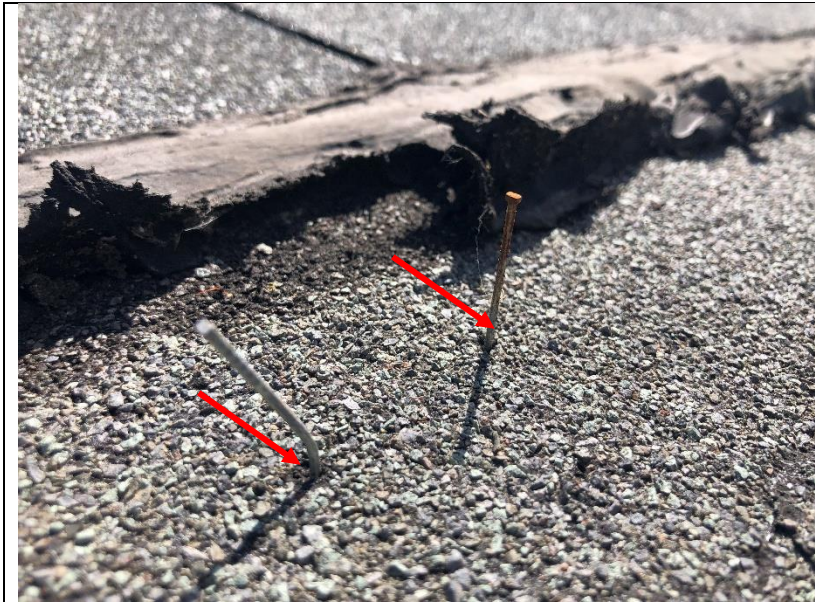
**Photo 151:**

Staples and nails were observed at the mastic swath.

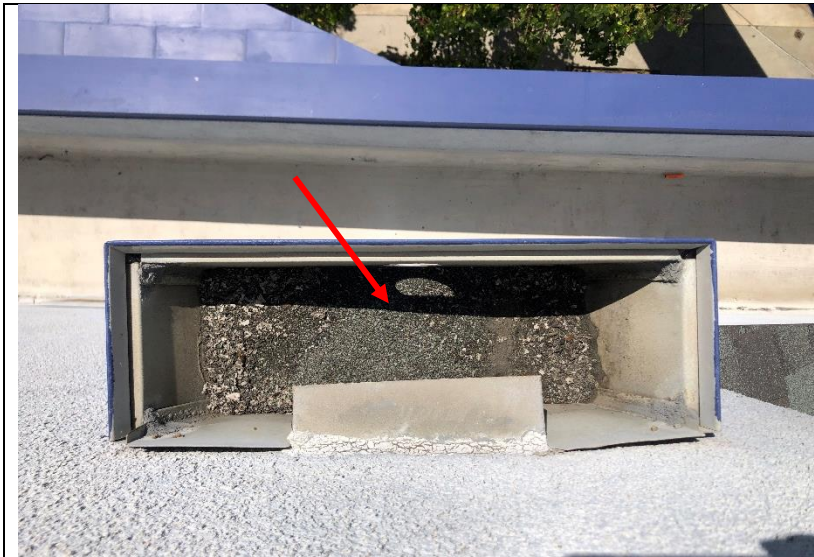
**Photo 153:**  
Granules had filled and blocked a scupper downspout.

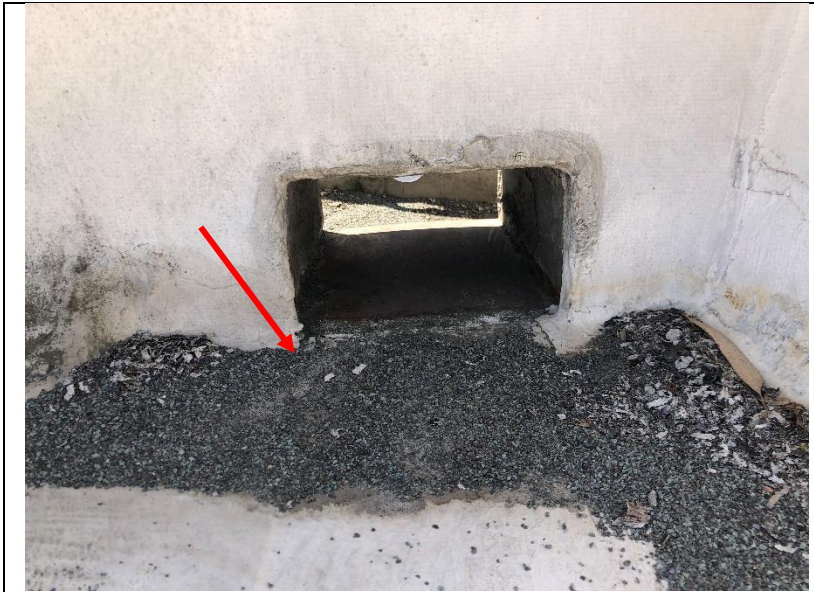
**Photo 154:**  
Granule loss was significant at all of the asphalt shingle roofs.

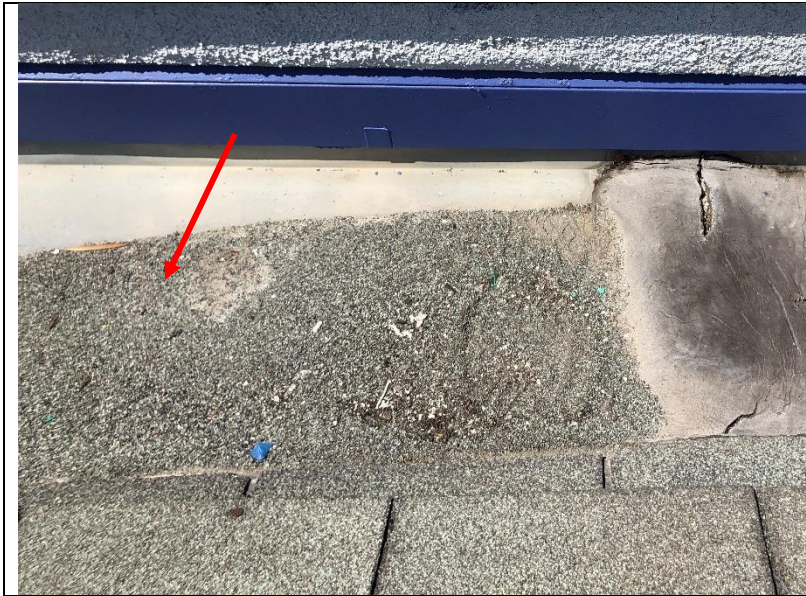
**Photo 155:**  
Granule loss was significant at all of the asphalt shingle roofs.

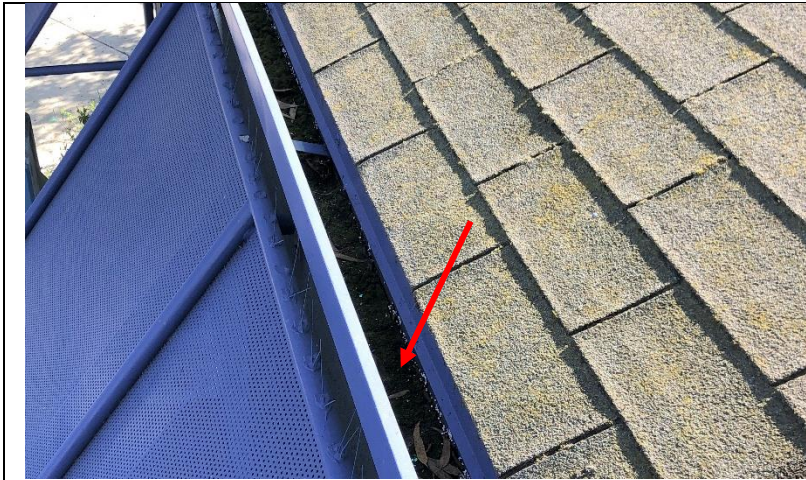
**Photo 156:**  
A gutter on building B was filled with granules and debris.

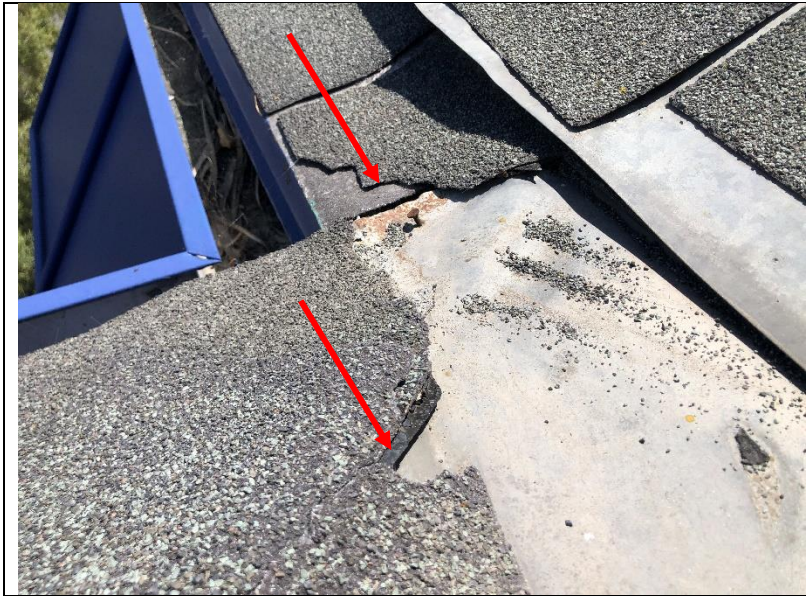
**Photo 159:**

In several locations, shingle tabs were observed on the roof deck or were missing altogether. Vent pipe penetrations on the shingle roofs were corroded. At one location at building C, a leak was reported under one of these vents. The vent is adjacent to other deficiencies on the roof and the location of water ingress could have more than one contributing factor. Similar corroded vents at other buildings had a self-adhered membrane flashing it to the roof in a nonstandard installation (**Photos 159 – 162**).

Shingle tabs were observed on the roof deck, damages on the roof, or were missing altogether.

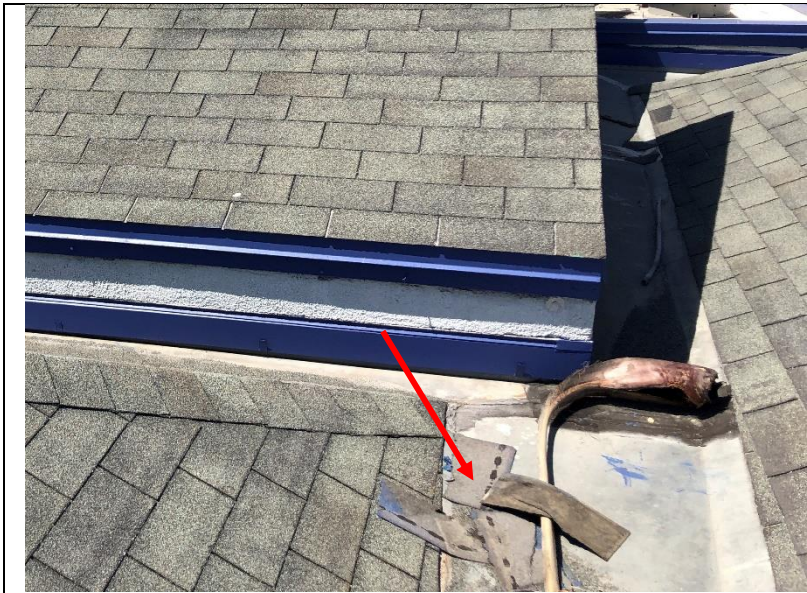
**Photo 161:**

Shingle tabs were observed on the roof deck, at damaged areas on the roof, or were missing altogether.

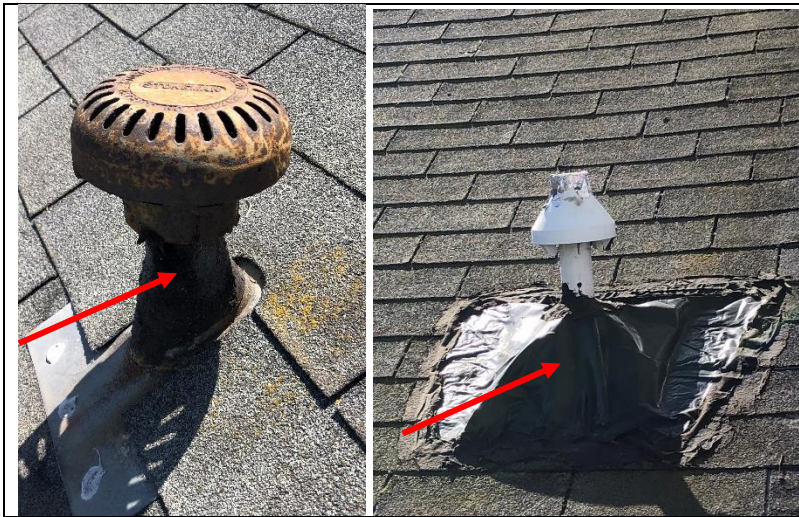
**Photo 162:**

Corroded vent stacks with deficient flashing were observed in several locations.

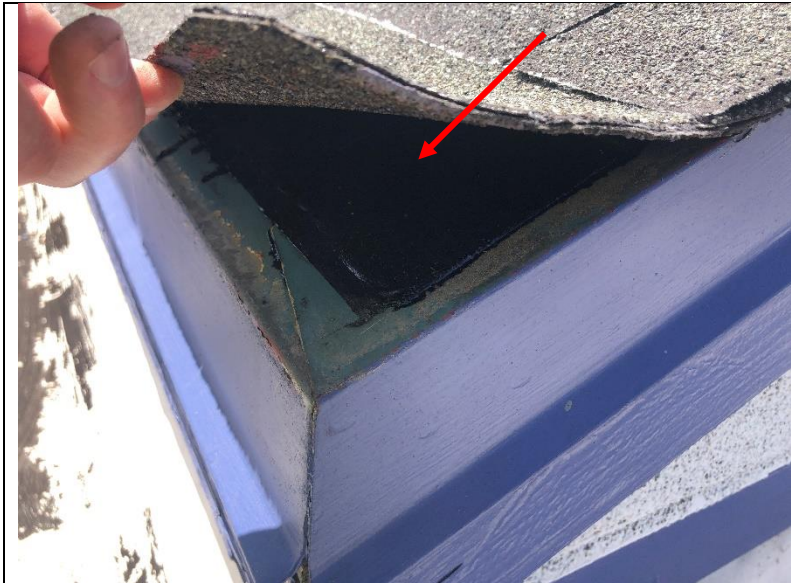
**Photo 163:**

A black self-adhered underlayment was present under the asphalt shingles. In many locations, the shingles could be lifted to view the underlayment. In some locations, the underlayment was not fully adhered to the edge-of-roof metal (**Photos 163 - 164**).

A black peel-and-stick underlayment was present under the asphalt shingle.
