**Santa Monica-Malibu  
Unified School District**  
John Muir - SMASH Elementary School

**Findings Report**  
**Building Envelope Investigation**

Report Date: June 30, 2022

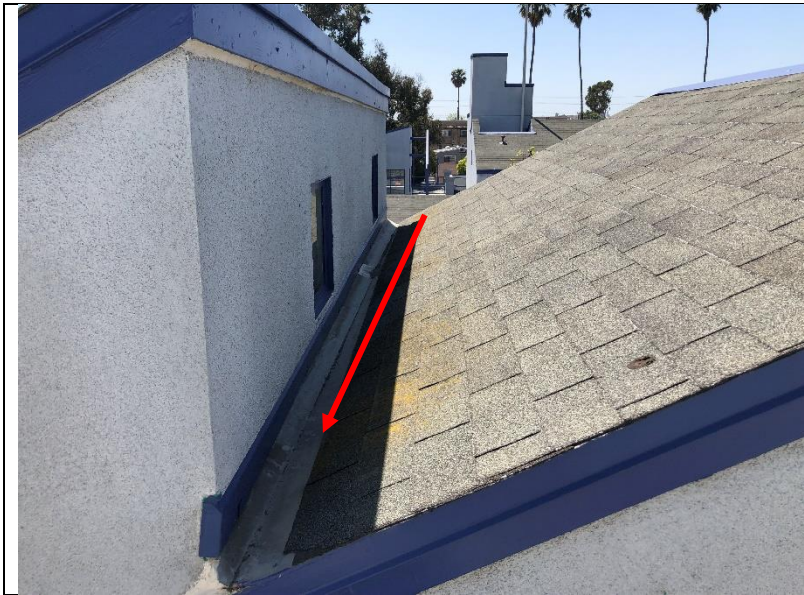
**Photo 164:**

A black self-adhered underlayment was present under the asphalt shingles. In many locations, the shingles could be lifted to view the underlayment. In some locations, the underlayment was not fully adhered to the edge-of-roof metal (**Photos 163 - 164**).

The black peel-and-stick underlayment was not fully adhered at some locations.

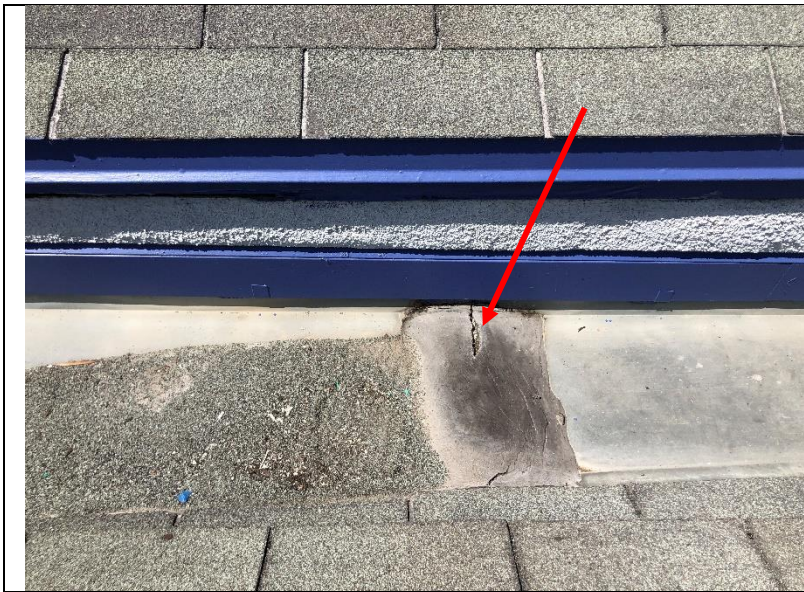
**Photo 165:**

Sheet metal flashing on the asphalt shingle roofs showed various signs of age degradation. In some locations, the sheet metal was corroded. A black mastic had been applied to the sheet metal along a roof-to-wall valley. It was unclear if the mastic had been applied as a patch or for some other reason. The mastic was not allowing proper drainage in the valley, granules had built up against the mastic. The mastic was also cracked and had failed (**Photos 165 – 167**).

Sheet metal flashing on the asphalt shingle roofs showed various signs of age degradation.

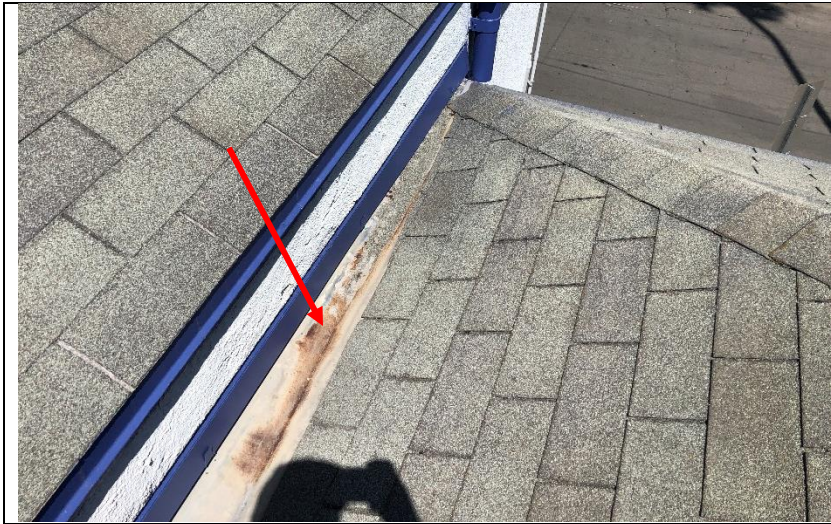
**Photo 166:**

A black mastic had been applied to the sheet metal along a roof-to-wall valley.

The mastic was cracked and had failed.

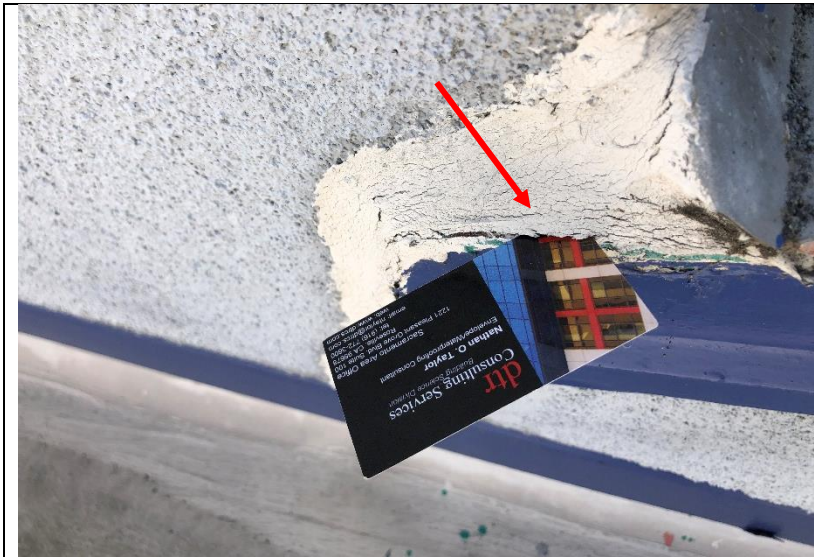
**Photo 168:**  
Sealant was observed at the ends of the sheet metal valley

Sealant was observed at the ends of the sheet metal valley, at the downturn onto the wall. The sealant was cracked and openings were visible. This condition was systemic in many of the sawtooth valleys (**Photos 168 – 169**).

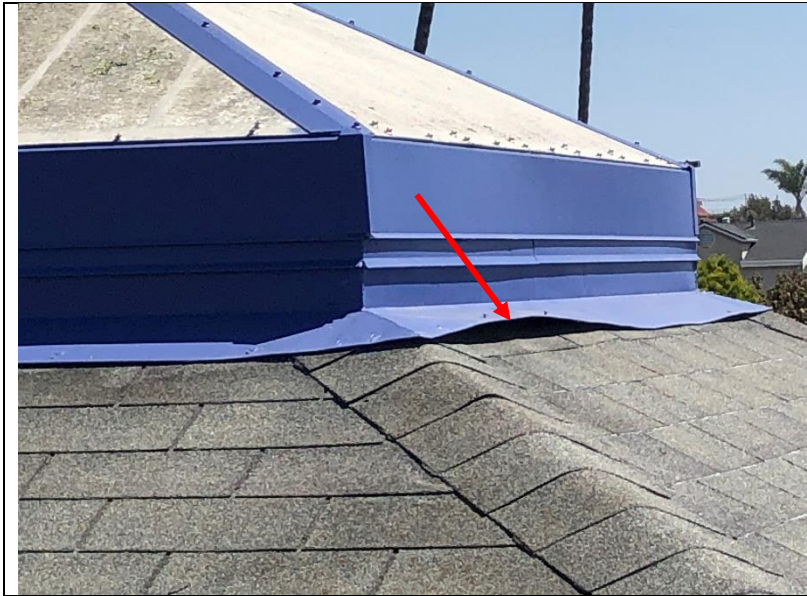
**Photo 170:**

Sheet metal skirt flashing at the skylights was not flat and flush to the roof. In many locations, the fasteners had been pulled loose and were no longer holding the flashing to the roof. The sheet metal has likely been raised by wind over time. Openings left by loose penetrations are possible leak locations and the raised flashings make it easier for wind-driven rain to penetrate the roofing system (**Photos 170 – 172**).

Sheet metal skirt flashing at the skylights was not flat and flush to the roof.

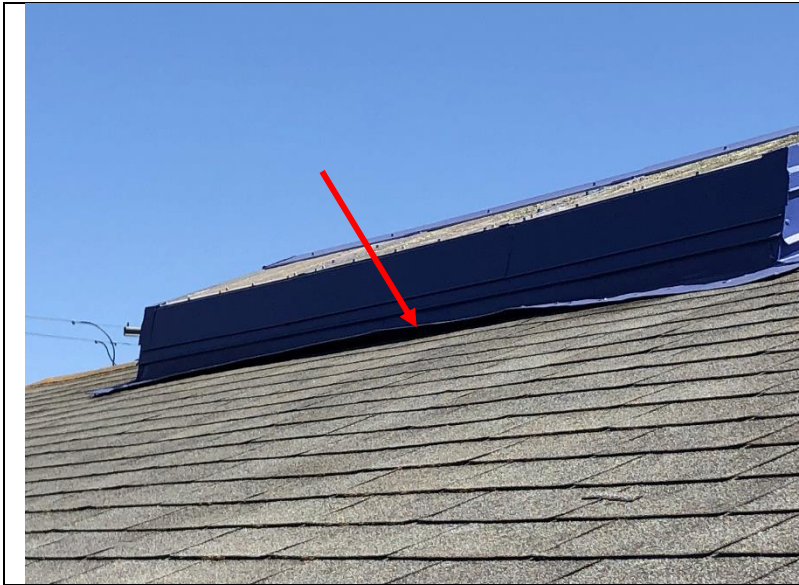
**Photo 171:**

Sheet metal skirt flashing at the skylights was not flat and flush to the roof.

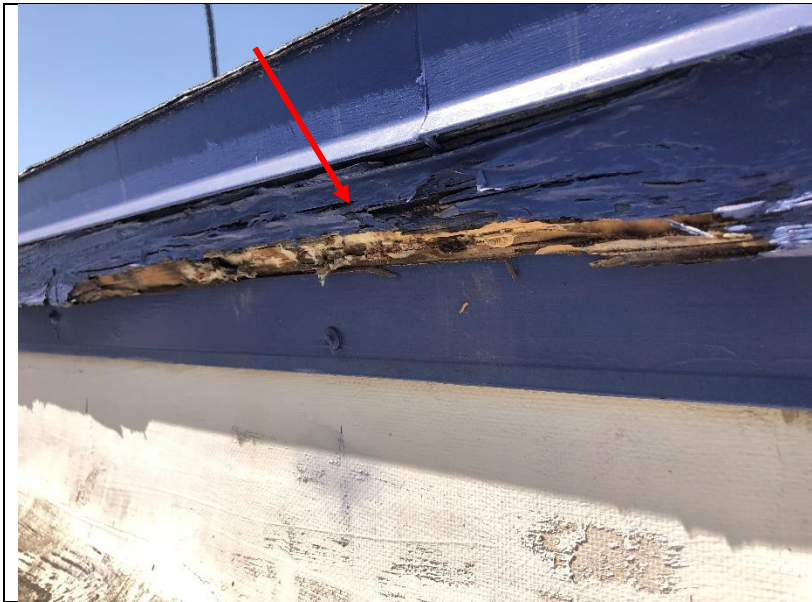
**Photo 172:**

Sheet metal skirt flashing at the skylights was not flat and flush to the roof.

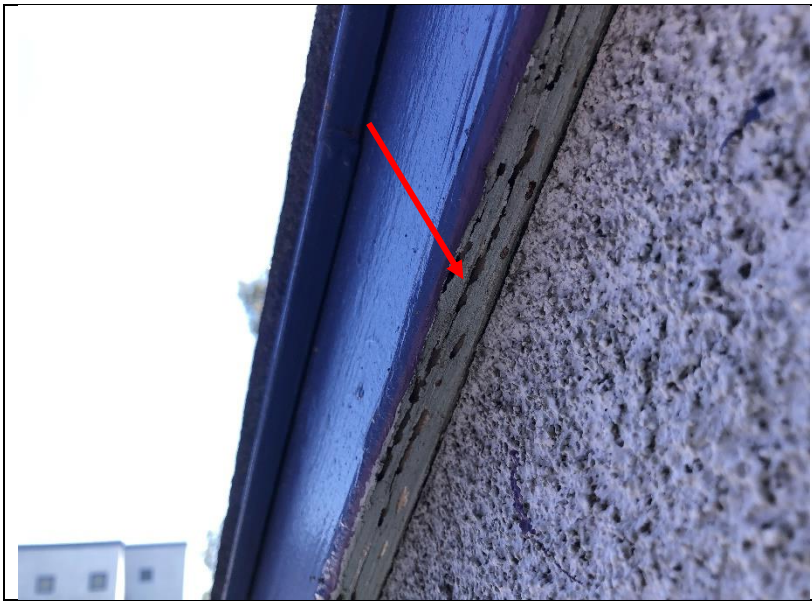
Over the entire length of the wood trim of the sloped roofs, what appeared to be dry rot and insect damage was visible. In one location, approximately 12 inches of trim had broken off the building. In some locations, it appeared that previously damaged areas had been painted over. Similar dry rot and suspected insect damage were observed at the edge-of-roof trim at the bathrooms near the outdoor lunch area. The trim was close to the awning structure and this damage was only visible from directly under the trim. These bathrooms were also reported by Little to have had mold remediation (**Photos 173 – 178**).

**Photo 173:**  
Dry rot and suspected insect damage at the wooden roof trim.

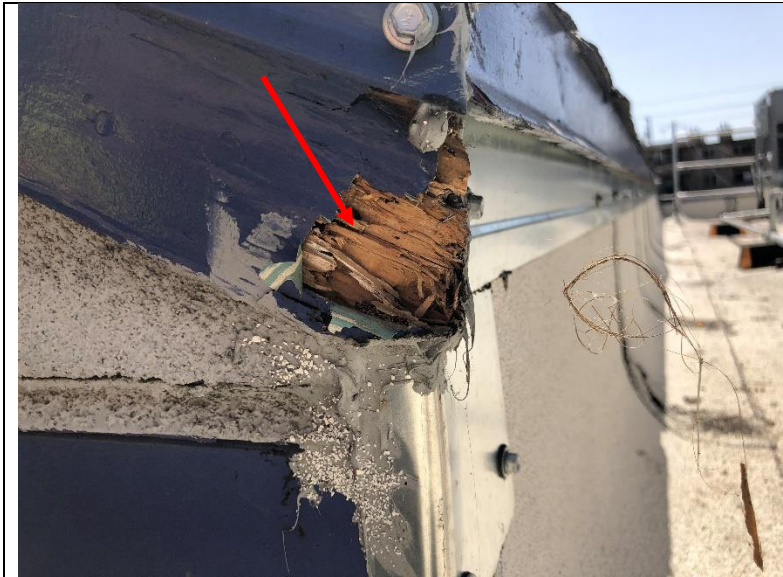
**Photo 174:**  
Dry rot and suspected insect damage at the wooden roof trim.

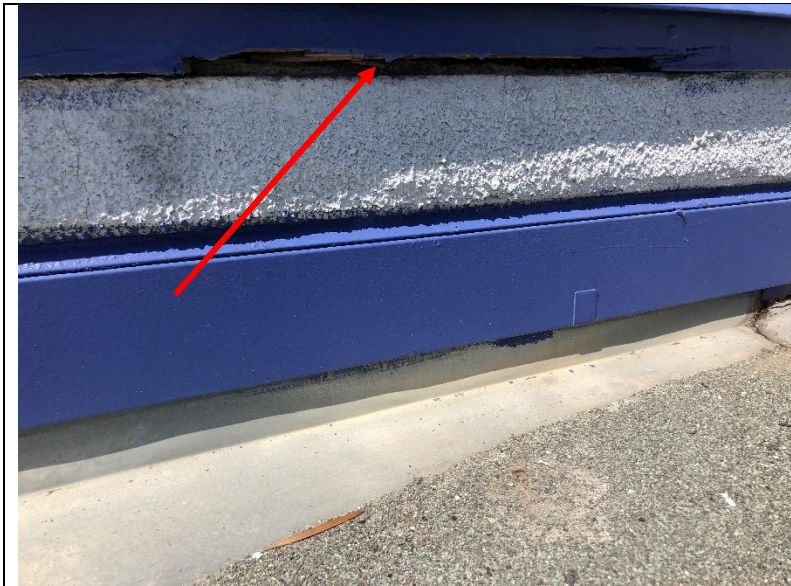
**Photo 175:**  
Dry rot and suspected insect damage at the wooden roof trim.

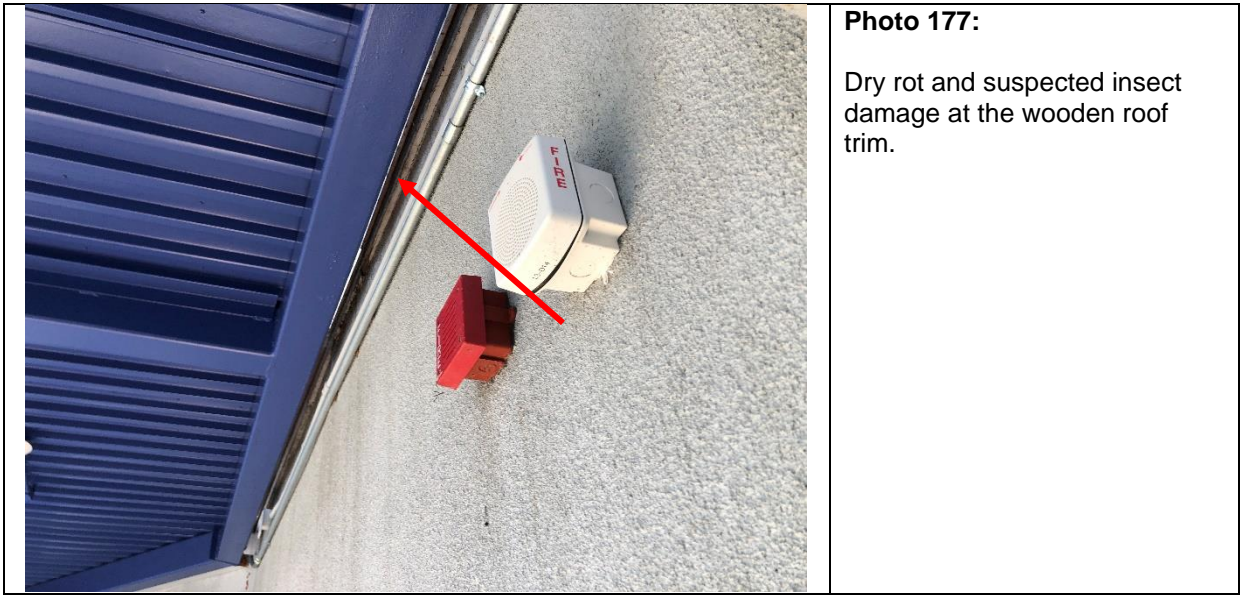
**Photo 176:**  
Dry rot and suspected insect damage at the wooden roof trim.

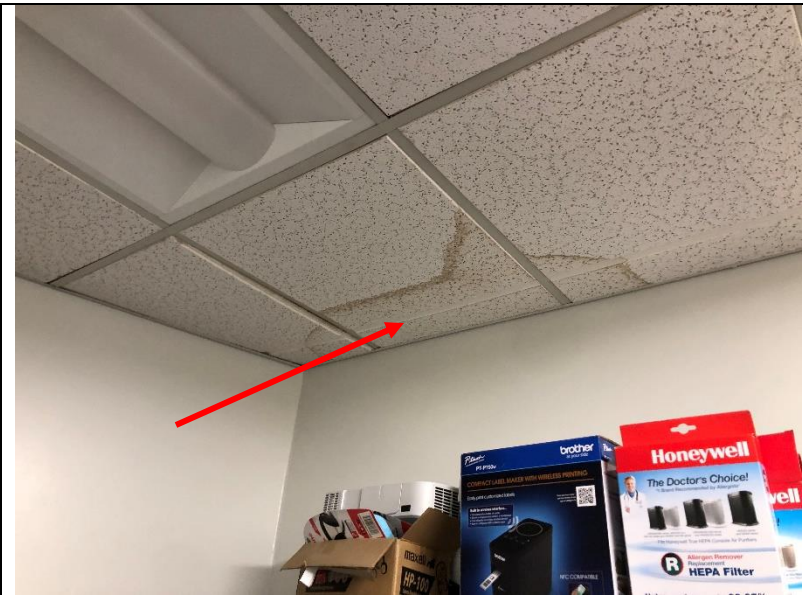
**Photo 179:**

Water stains, corrosion, and staining were visible at numerous interior locations of building A. Staining was visible on the ceiling tiles along the outside wall in Room 210B Media Equipment. A hollow metal-framed door and blocked cement plaster weep screeds are located above the Media Equipment Room leak location. (**Photos 179 – 180**).

Staining was visible on the ceiling tiles in room 210B Media Equipment

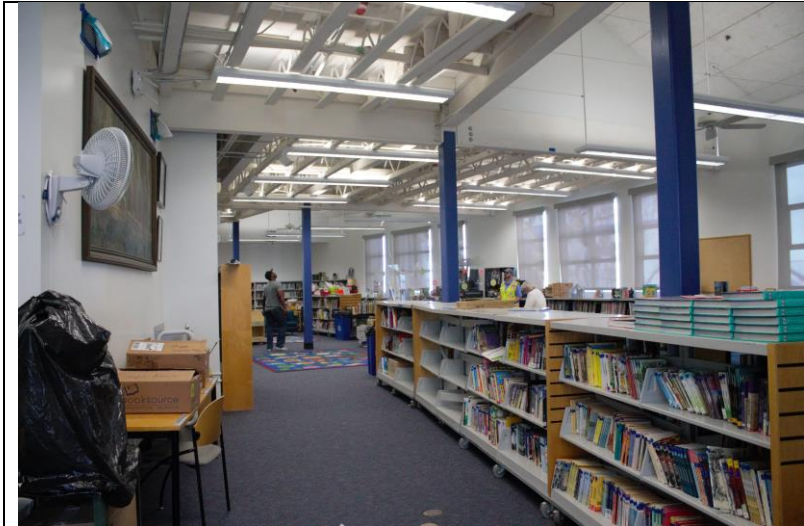
School District staff informed DTR that several leaks had been observed in Room 200 Media Center/Library. Locations in the library had recently been repainted. Many of the reported leaks were at the wall-to-roof juncture of the patio deck above the center of the north side of the library. A leak was confirmed over the east entry to the Media Center/the Library. Some water marks were still visible. Two (2) HVAC wall vents are located on the exterior of the 2<sup>nd</sup> floor covered walkway, above the east entrance to the library. The perimeter of those vents was not flashed or sealed and exterior light could be seen at the seams from the interior of the building. Water marks were observed on the ceiling tiles of room 205 communications on the east side of building A. The water stains were along the north perimeter wall, at the junction of the building and the walking deck above (**Photos 181 – 184**).

**Photo 181:**  
DTR made observations in the library. Many reported leak locations had been obscured by new paint.

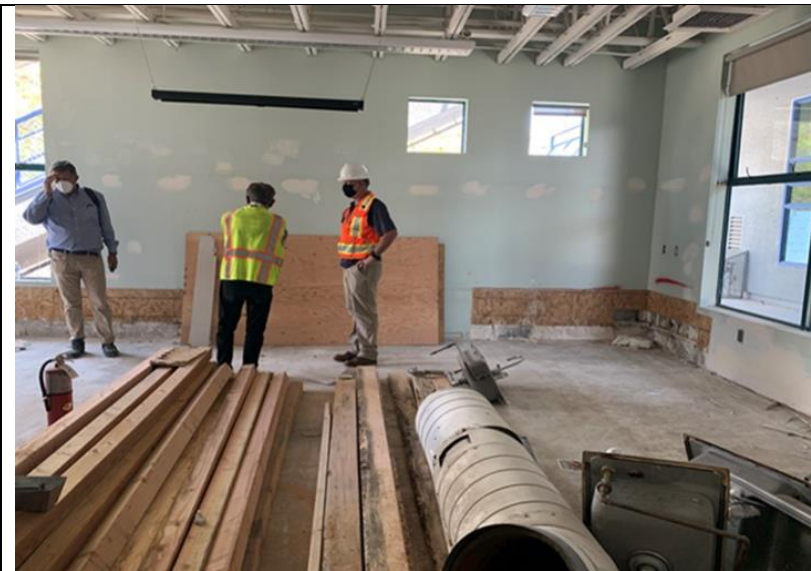
Water marks, corrosion, and staining were visible at numerous interior locations of Building B. Classroom 415 was reported to have had water intrusion issues at numerous locations and at different times. During the previous mold remediation, the shelves and lower portion of the gypsum board had been removed along the east wall. According to the school district, leaks had continued at the location. The south wall of the classroom was not part of the previous mold remediation. The south wall is directly under the door of classroom 480 where standing water was observed in the expansion joint and the exterior sheathing was found to be damp to the touch. Water stains, peeling paint, and staining were visible on the south wall of the classroom. Towels had been left on the classroom floor in the event of a rain event during the school break. Staining was visible at electrical outlets and the school district stated that water had also percolated through a floor outlet in the center of the classroom during a previous rain event. Staining was observed on the ceiling as well, both adjacent to the south wall and at beams on the north side of the classroom (**Photos 185 – 190**).

**Photo 185:**  
Temporary water intrusion remediation was carried out by the teacher in classroom 415

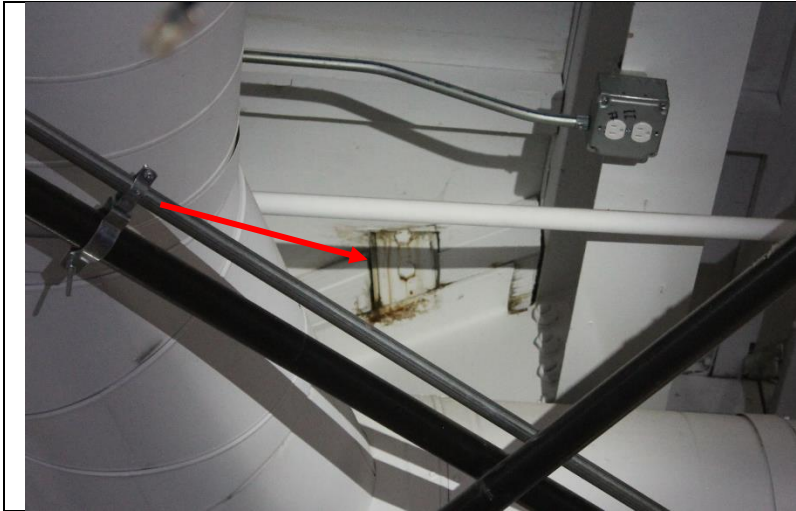
Water stains, peeling paint, and staining were visible at several locations in the Multipurpose Room in Building B. Staining was clear above the hanging ceiling over the stage area as well as on the lower surface. Corrosion was visible on many of the structural beams. The south side of the Multipurpose Room ceiling was exposed without finishes (**Photos 191 – 197**).

**Photo 191:**  
Water stains on the recessed ceiling in the multipurpose room.

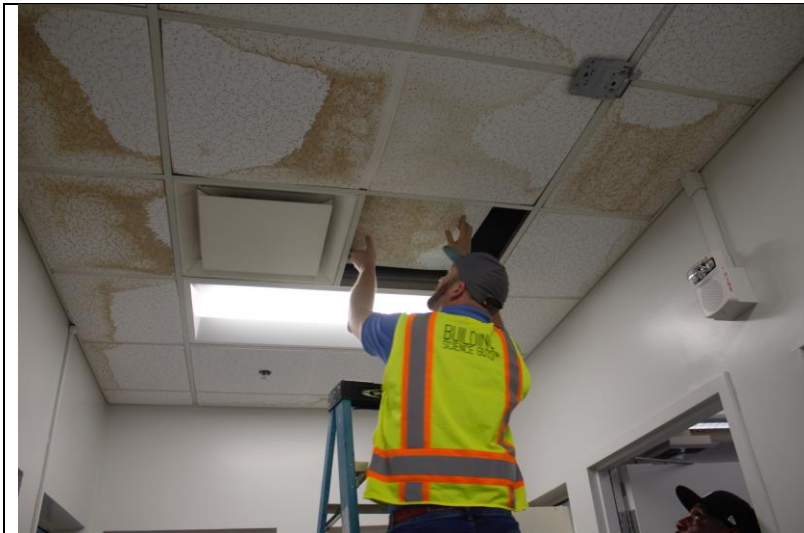
**Photo 201:**

Water marks, corrosion, and staining were visible at numerous interior locations of Building C. During the flood testing deck drains, DTR was able to make observations of drain assemblies below the decks. While no leaks were observed at the drain assemblies during the testing, DTR was able to observe that multiple drain assemblies had been moved or replaced. While no active water was observed at those drains, evidence of previous leaks were visible in multiple locations. Water marks were found on plumbing pipes, on the top of storage bins, and on the tops of the shelves (**Photos 198 – 201**).

Water staining on top of a storage bin in a classroom in building C.

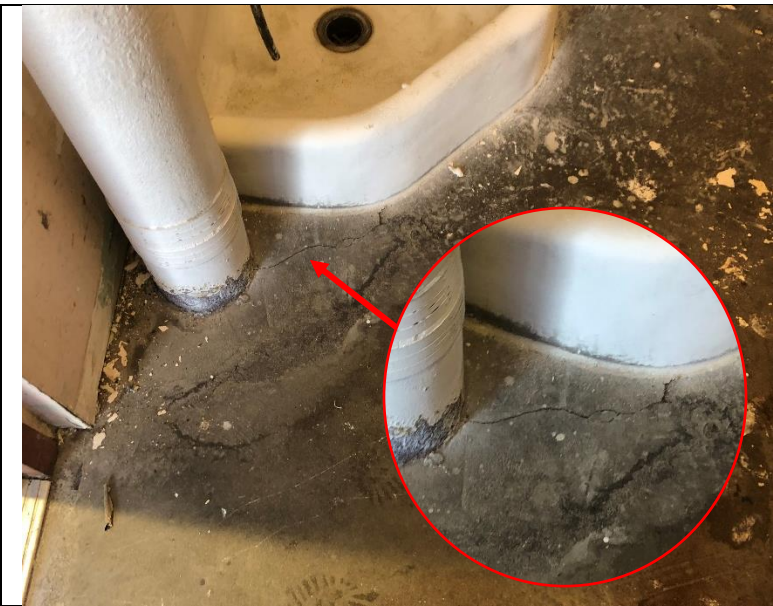
Water marks, corrosion, and staining were visible at numerous interior locations of building D. Ceiling tiles in Room 205 Teacher's Prep were heavily stained. DTR made observations above the ceiling tiles and noted corrosion at several plumbing pipes, water stains on wood surfaces, and possible organic growth. Room 500 Janitor is located above Room 205 Teacher's Prep. Cracks in the concrete floor of the janitor room 500 and the presence of plumbing and drain assemblies in the room are consistent with the corroded plumbing pipes and water stains observed above the ceiling panels in room 205 Teachers' Prep (**Photos 202 – 206**).

**Photo 205:**  
Water damage and staining above the ceiling tiles in room 205 Teacher's Prep.

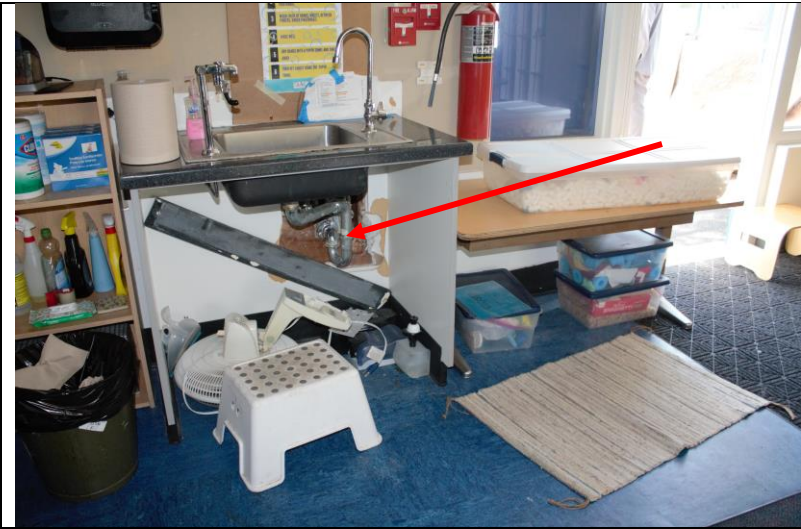
**Photo 211:**

Interior finishes had been removed at two classrooms in building D prior to the DTR site assessment, in an effort to address a leak at this location.

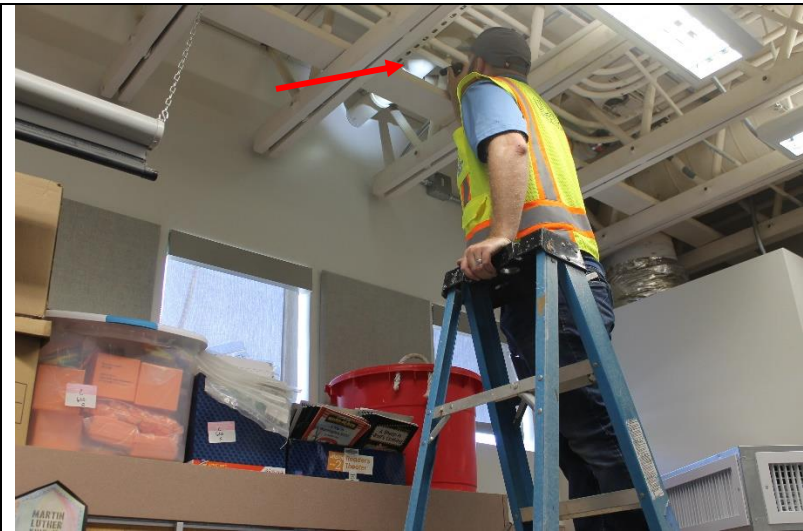
**Photo 213:**

During the flood testing of deck drains, DTR was able to make observations of the drain assemblies below the decks. While no leaks were observed at the drain assemblies, DTR was able to observe that multiple drain assemblies had been moved or replaced. DTR was not made aware of nor given any records of any work to move or replace drain assemblies. In many locations, the drain bowls were compressed to the underside of the deck with uni-strut and wood blocking. No anchor bolts were holding the drain bowl to the deck. This is a nonstandard mounting system for drains (**Photos 213 – 215**).

DTR making observations of drain assemblies during a flood test.

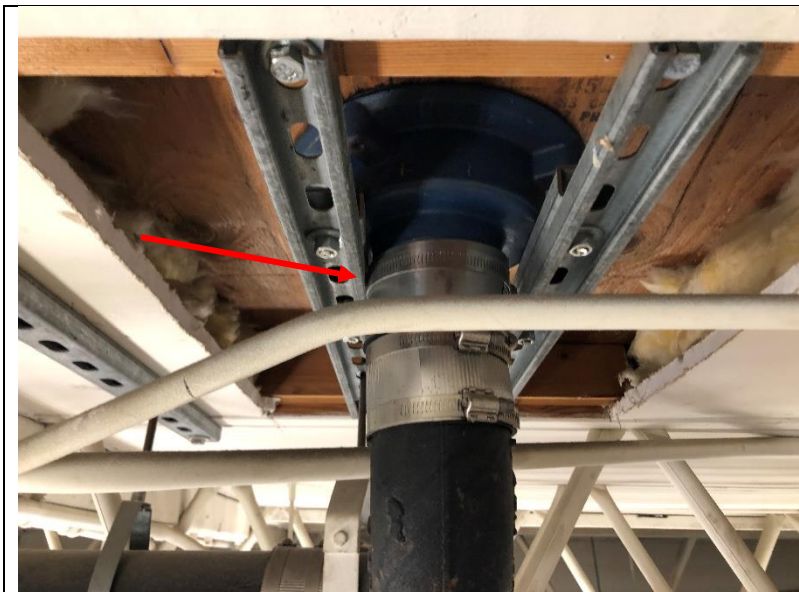
**Photo 215:**

Drain bowls were compressed to the underside of the deck with uni-strut and wood blocking.

No anchor bolts were holding the drain bowl to the deck.

This is a nonstandard mounting system for drains

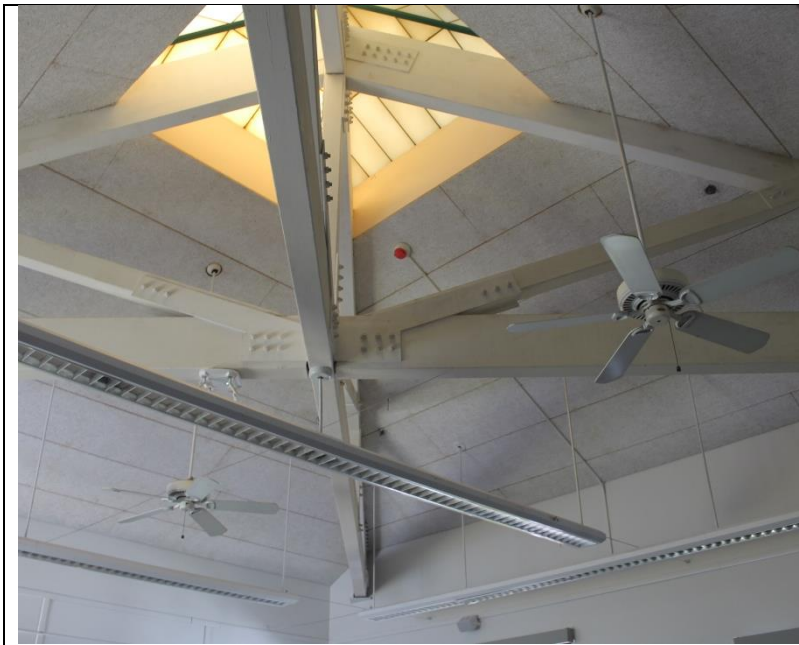
**Photo 216:**

Many of the classrooms had acoustical panels on the ceiling. The panels partially obscured water stains that may have been present. School District staff stated that the ceilings had been painted also. New paint will have further obscured evidence of water stains. Discolored areas were still visible on the acoustical panels. In one location, recessed can lighting had also come loose from the ceiling (**Photos 216 – 219**).

Acoustical panels on the ceiling of the pyramid roofed classroom in building D.

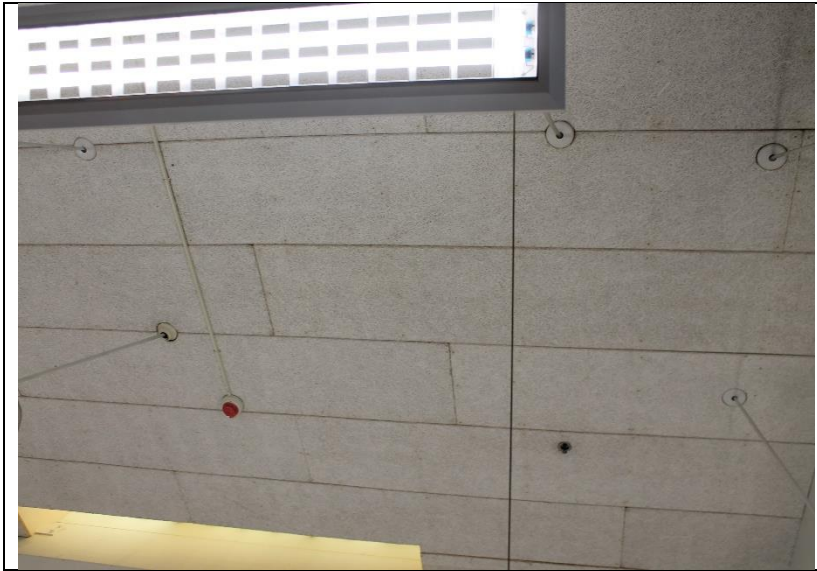
**Photo 218:**

Acoustical panels on the ceiling of the classrooms in building D.

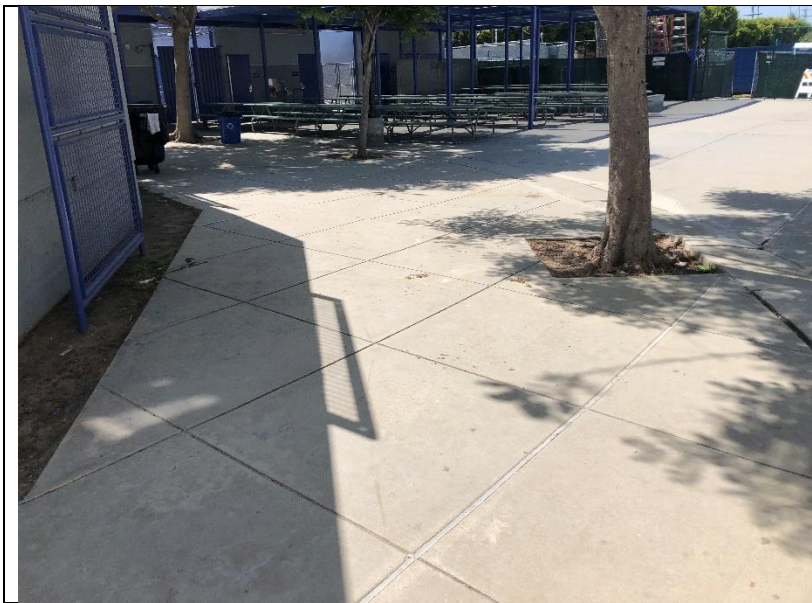
**Photo 221:**

Much of the at-grade ground surface on campus is covered in hardscape materials. Surface drains through the campus are widely spaced and in a variety of sizes. Some of the landscaping drains are partially covered by landscaping limiting their effectiveness. The hardscape is often uneven and does not promote positive drainage (**Photos 220 – 226**).

The campus is extensively hardscaped.

Hardscape has shifted in many locations.

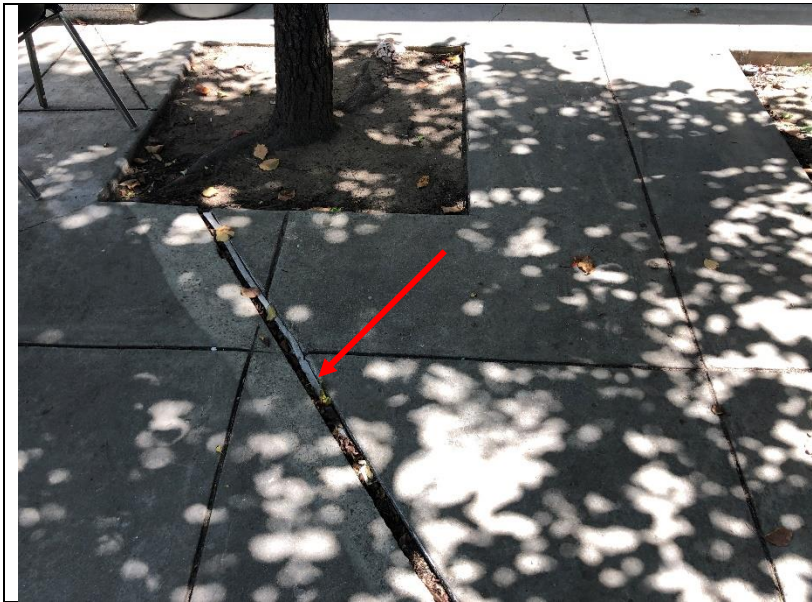
**Photo 222:**

Surface drains in the hardscape vary in size.

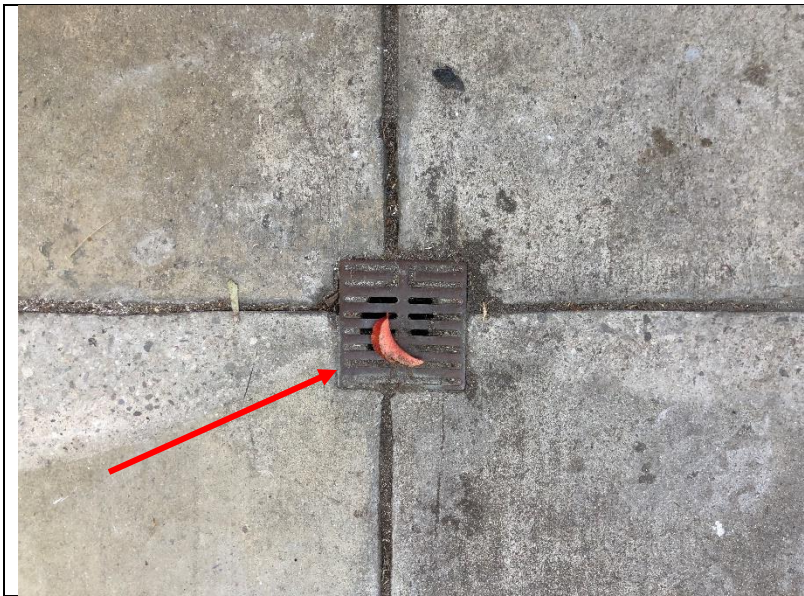
**Photo 223:**  
Surface drains in the hardscape vary in size.

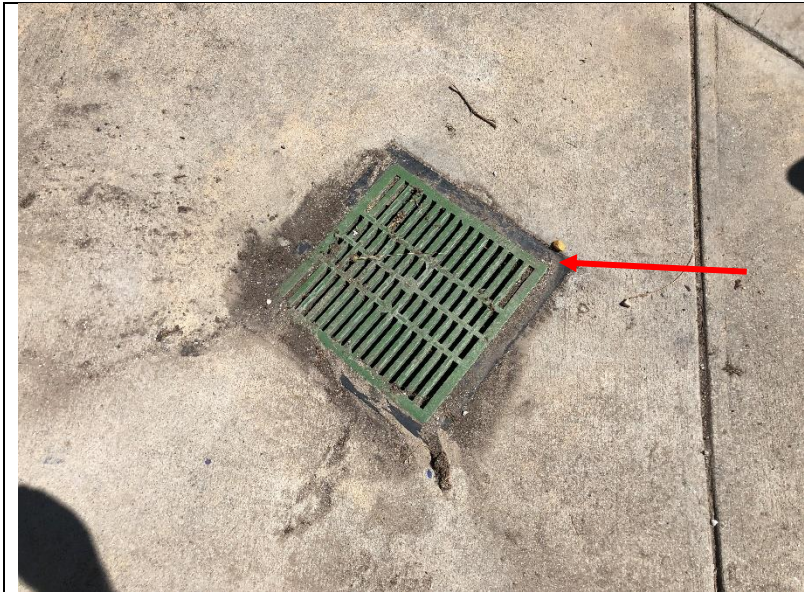
**Photo 224:**  
A surface drain at a landscaped area blocked by landscaping materials.

The site drainage systems are obstructed in several instances (e.g., photo 224) and would benefit from a professional civil engineering assessment.

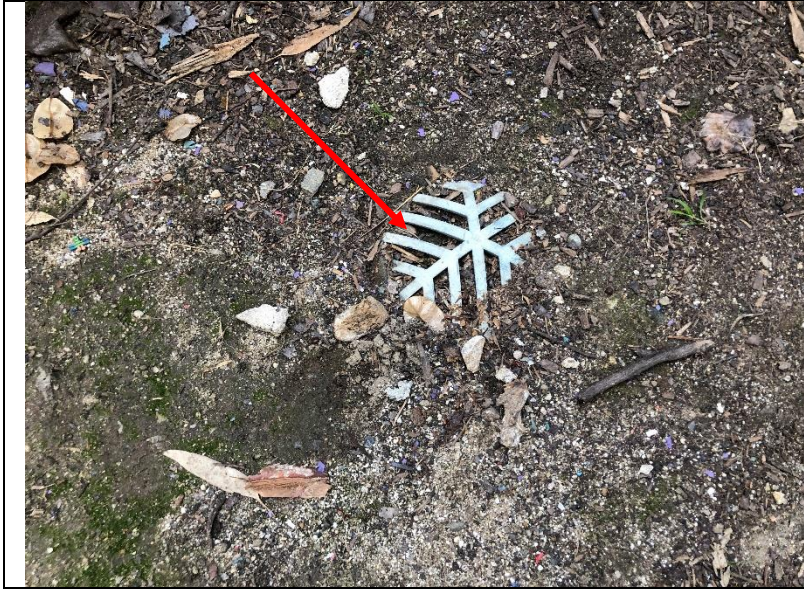
**Photo 225:**  
Drains in the hardscape were often not at the lowest points.

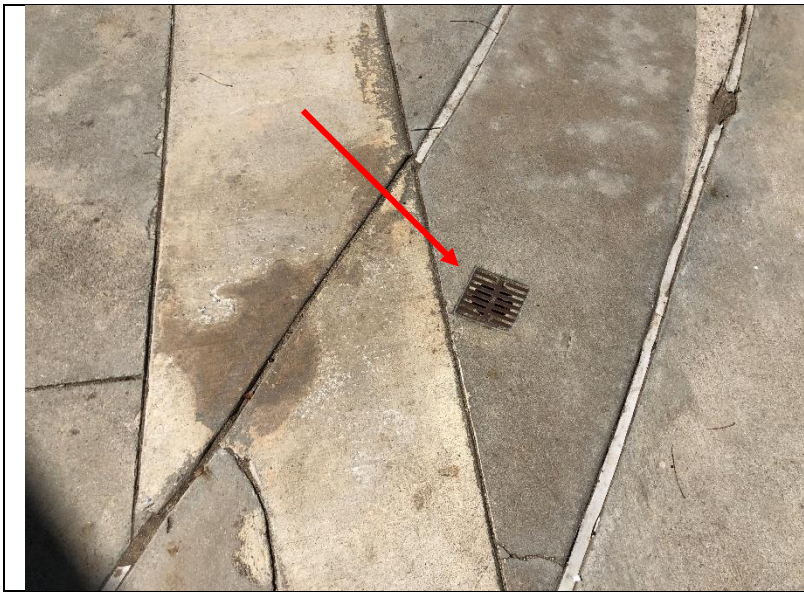
**Photo 227:**

At several locations, the awnings attached to the building were corroded at the low point of the hollow metal tubing. It is unclear how water was entering into the awning framework, but it appears to be pooling at low spots and causing corrosion (**Photos 227 – 228**).

Corrosion at metal awnings was observed at several locations.

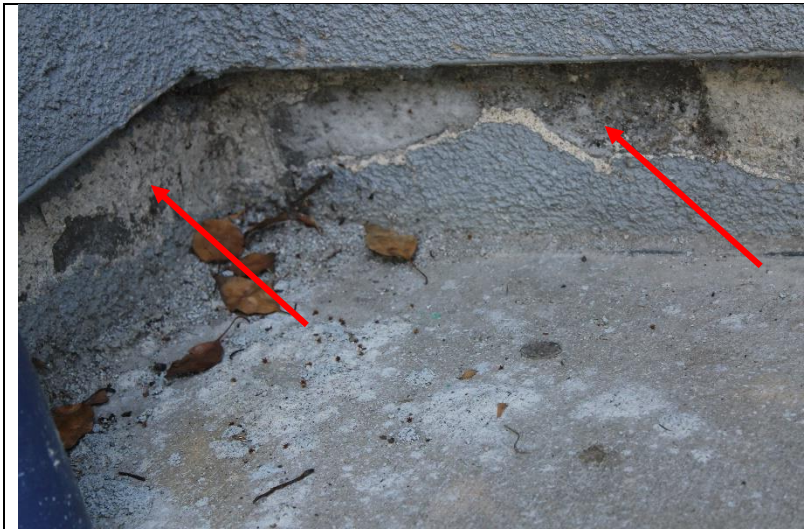
**Photo 230:**  
Cracked and broken cement plaster texture coat was observed at numerous curb locations.

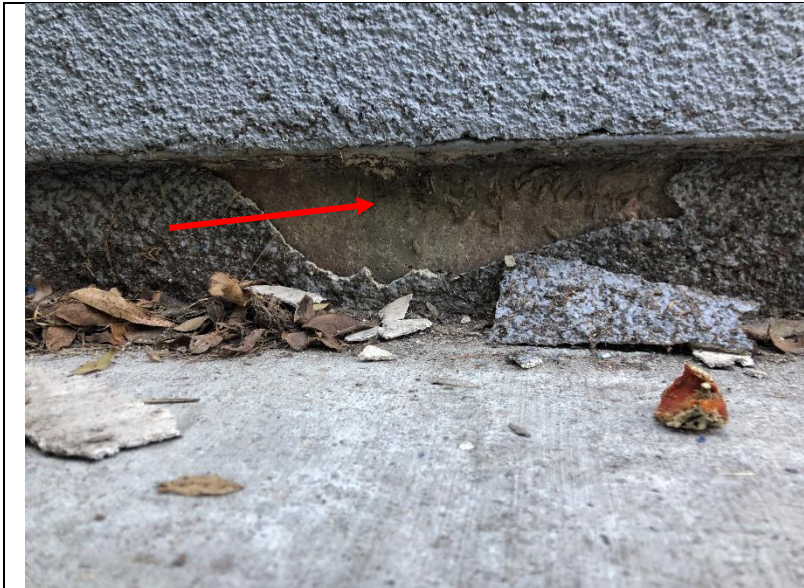
**Photo 231:**

Cracked and broken cement plaster texture coat was observed at numerous curb locations

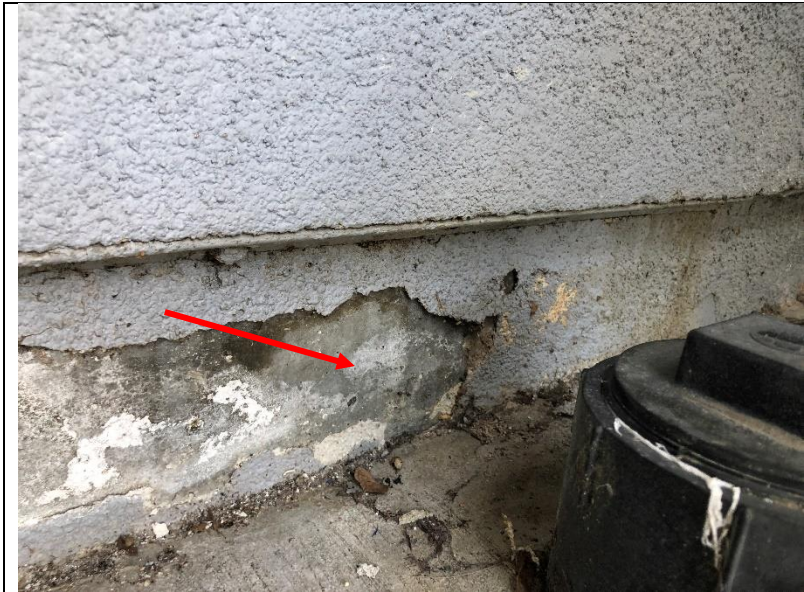
**Photo 232:**

Cracked and broken cement plaster texture coat was observed at numerous curb locations

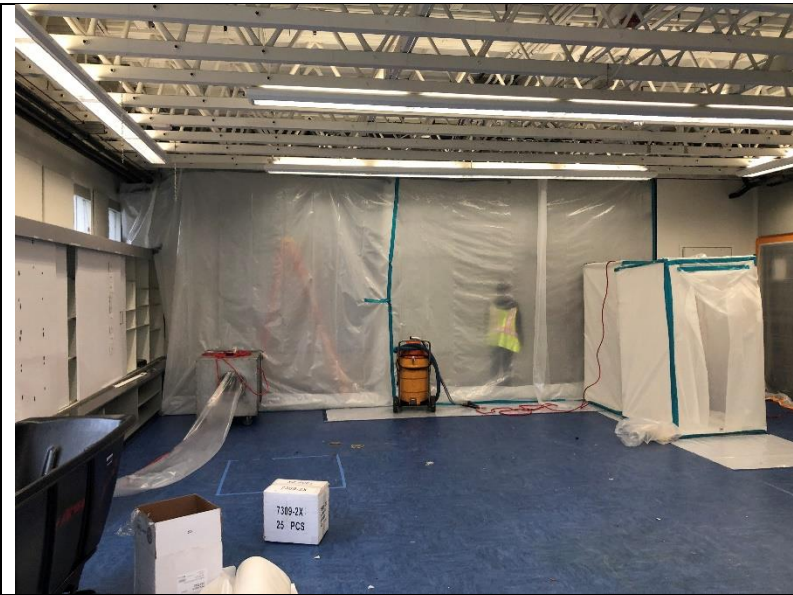
**Photo 234:**

Classroom 415 had historically leaked at several locations. Water damage was observed along the south wall during DTR's initial investigation. SMMUSD staff reported that water had saturated much of the wall and run out onto the floor on several occasions. Due to the amount of damage observed during the initial investigation, DTR recommended that a structural engineer be on-site when the wall was open to assess the potential structural damage and provide recommendations regarding remediation of any structural damage that was observed (**Photos 233 – 234**).

A view of inside the containment area in room 415 before the wall was opened.

Biological growth was found when the whiteboard was removed from the wall.

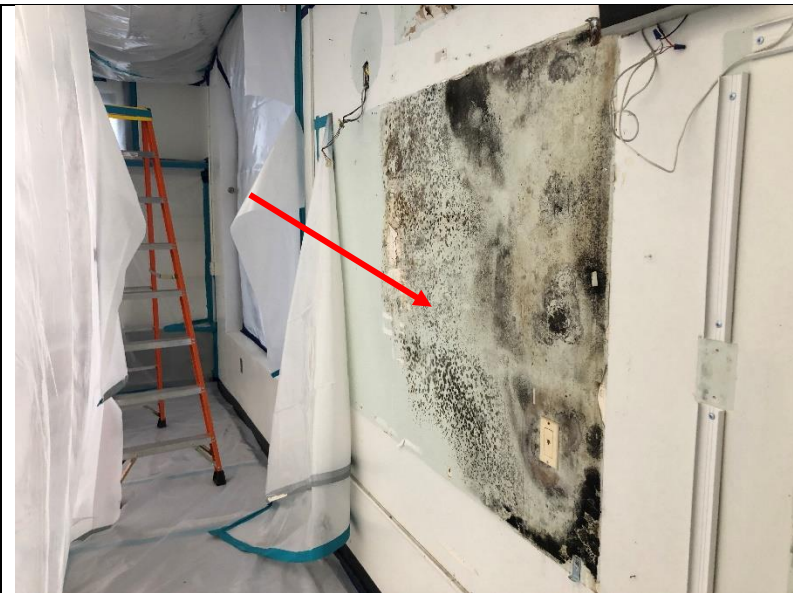
**Photo 235:**

Biological growth was observed at a junction box when the whiteboard was removed from the wall in room 415.

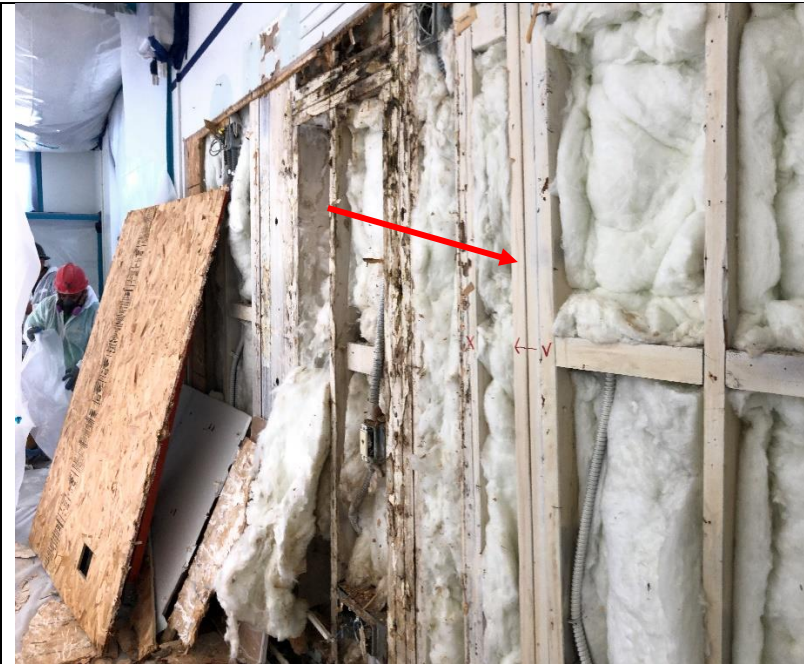
**Photo 240:**

Biological growth was noted on the exterior and interior facing surfaces of the gypsum board and the interior side of the exterior shear wall plywood. The fiberglass insulation and inside face of the exterior sheathing were wet to the touch. The interior of the stud cavities had been coated with a white encapsulation product used during mold remediation, evidence that this wall had previously been remediated. Moisture readings taken on the inside face of the exterior wood sheathing maxed out the moisture meter at 40% moisture. Moisture readings at the sill plate, studs, and blocking ranged between 18.5 and 39.8% moisture. The prolonged exposure to moisture had resulted in extensive deterioration of the wood elements. The blocking was soft to the touch and visibly cracking. The wood studs were warped and the fasteners were corroded and brittle (**Photos 240 – 244**).

Biological growth was observed at different layers of the wall assembly.

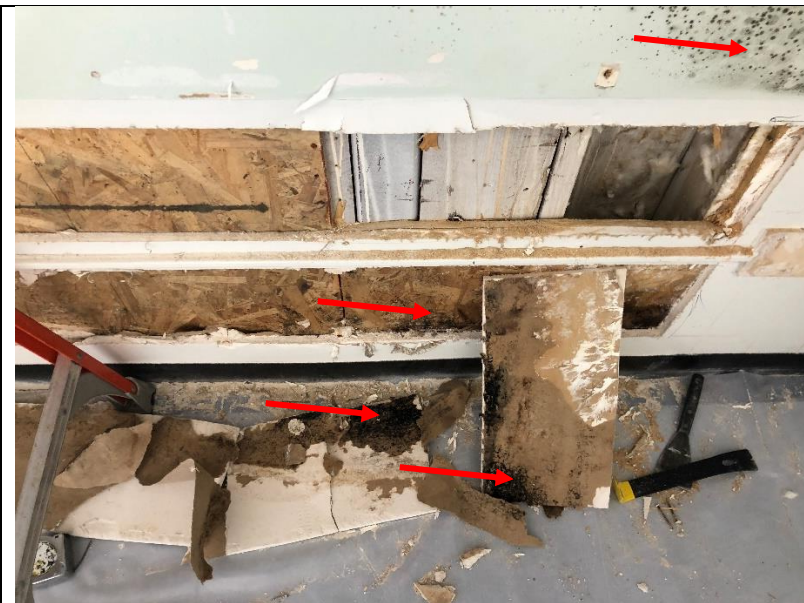
**Photo 241:**

A moisture reading was taken at the base of the interior OSB.

The moisture meter maxed out at a Moisture reading of 40.0 percent.

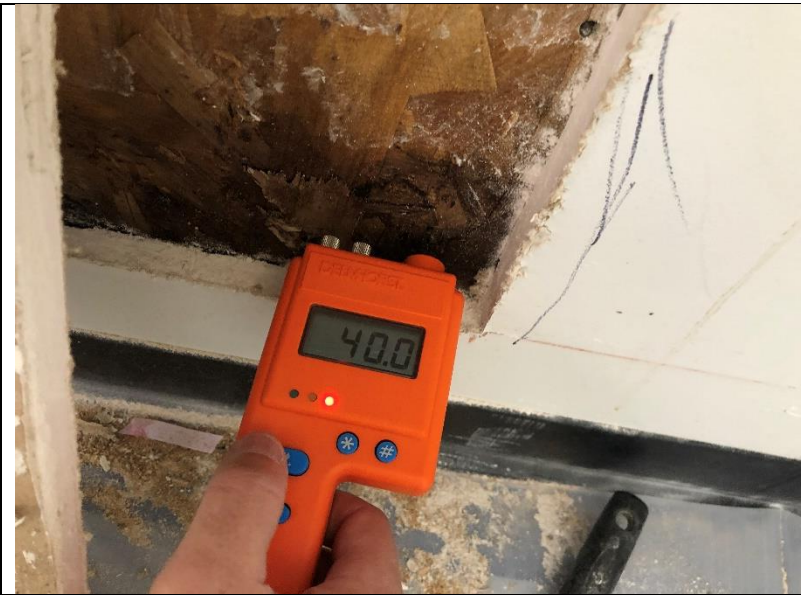
**Photo 242:**

A moisture reading was taken from the sill plate at the base of the wall.

Moisture reading is high (34.6 percent).

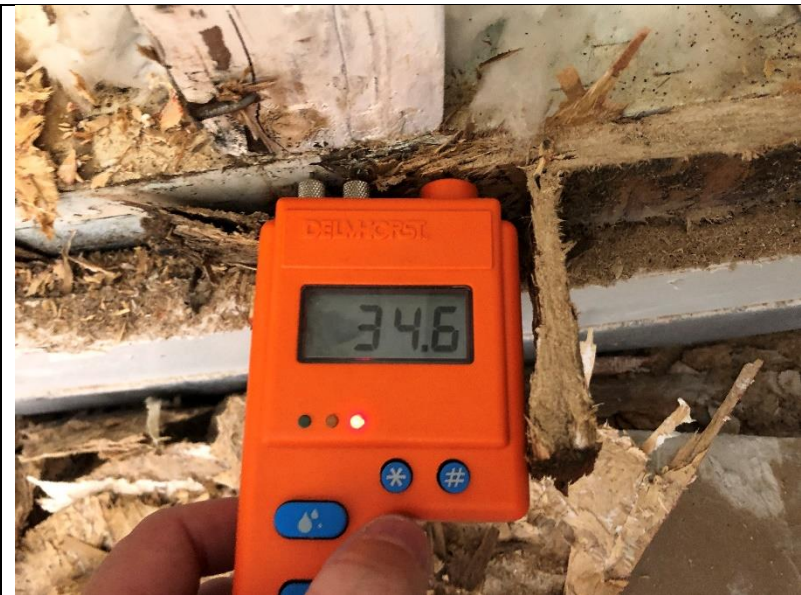
**Photo 243:**

A moisture reading was taken at a section of blocking midway up the wall.

The wood moisture reading is high, (18.5 percent).

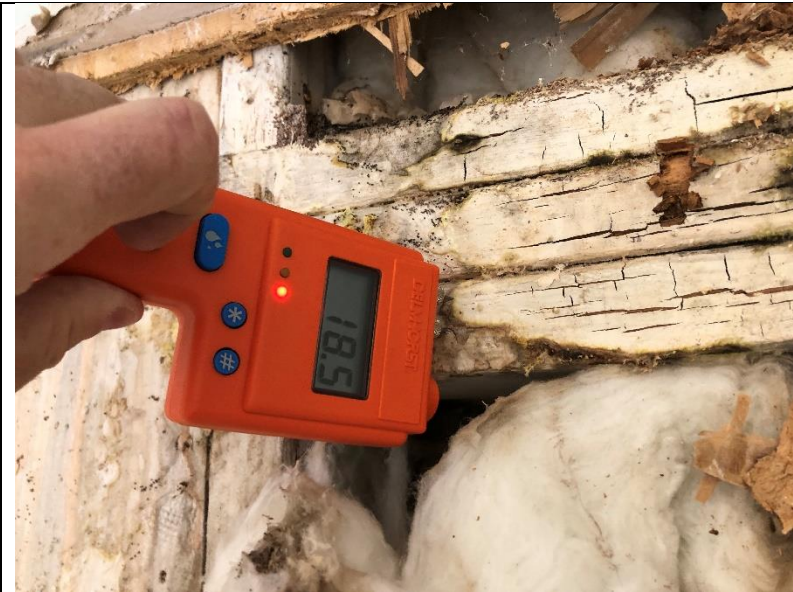
**Photo 244:**

Wood rot and decay at blocking elements inside the structure of the south wall of room 415.

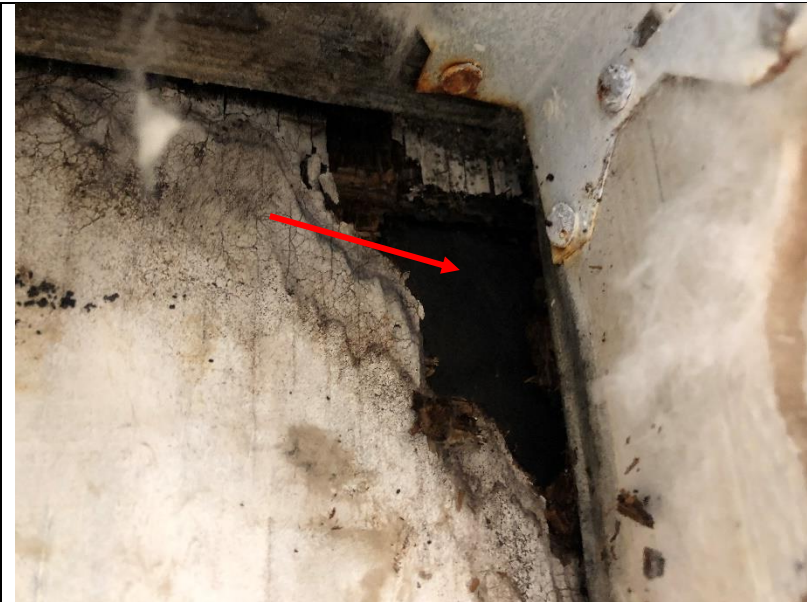
**Photo 247:**

Wood rot at the exterior sheathing in room 415. The interior (back) side of the building paper was visible and was wet to the touch.

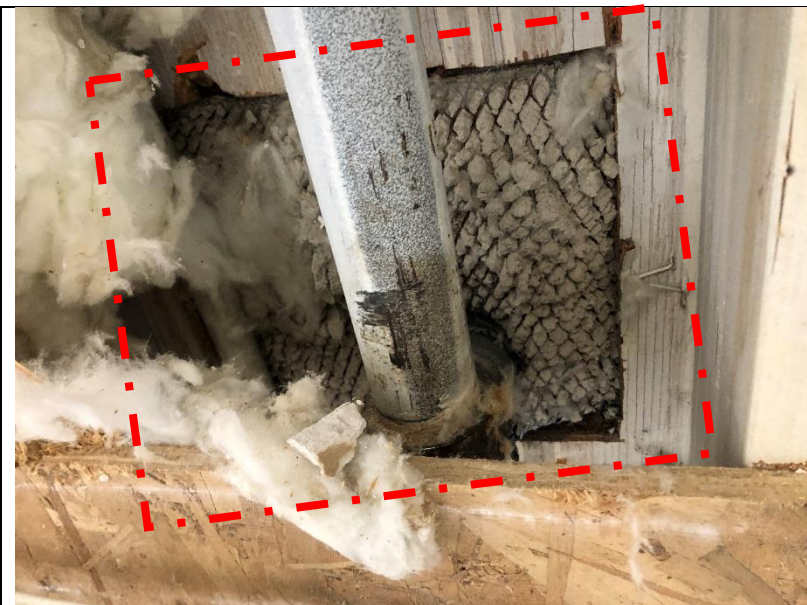
**Photo 248:**

The exterior sheathing was cut and lath and plaster were applied to the exterior of the building without a backing paper or a substrate. The lath exposed at this location in room 415 was corroded.
