**Santa Monica-Malibu  
Unified School District**  
John Muir - SMASH Elementary School

**Findings Report**  
**Building Envelope Investigation**

Report Date: June 30, 2022

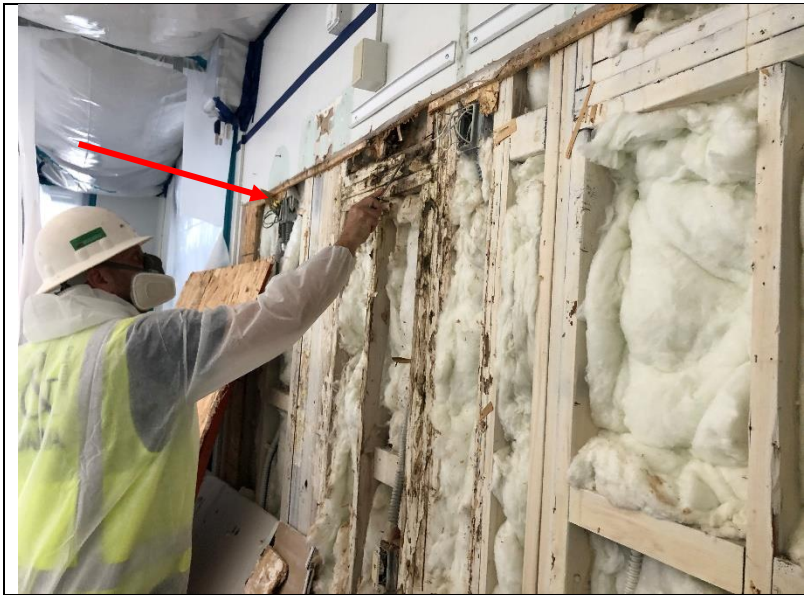
Additional areas of the wall in 415 were opened extending to the west along the south wall until the visual presence of water damage and biological growth ended. DTR measured the locations where damage was concentrated as reference points for the upcoming demolition at the exterior horizontal expansion joint above and in the upper classroom (room 480) (**Photos 253 – 256**).

**Photo 253:**  
Martin & Associates making observations of wood rot and deterioration to the south wall of room 415.

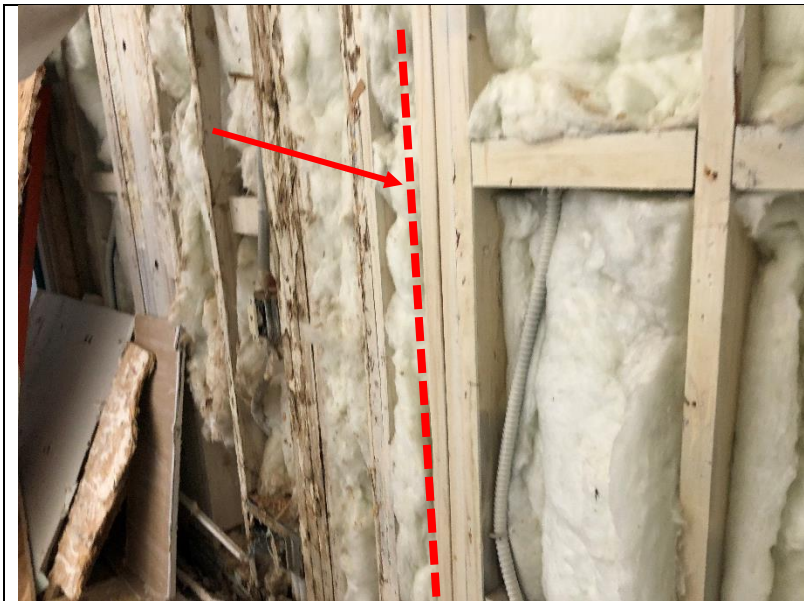
**Photo 254:**  
Delineation of damaged (left of dashed line) and undamaged areas on the south wall of room 415.

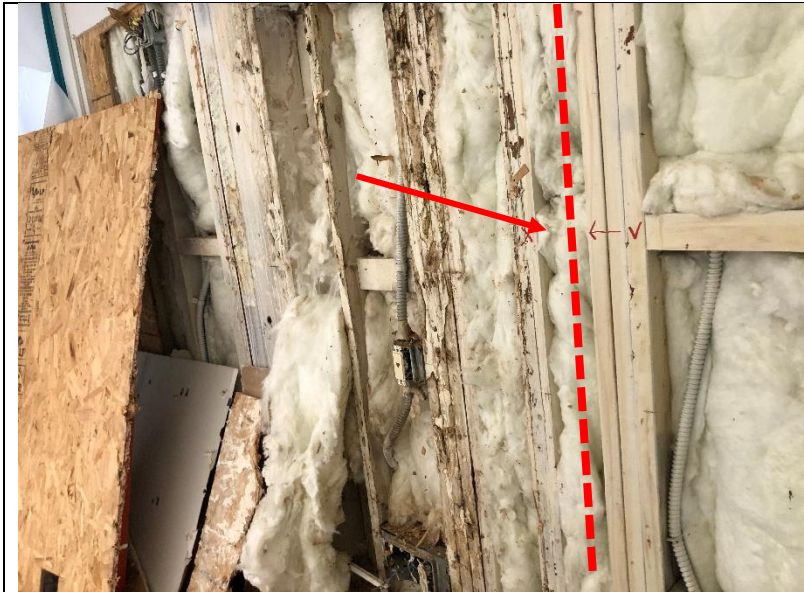
**Photo 255:**  
Another view showing the change between damaged and undamaged areas on the south wall of room 415.

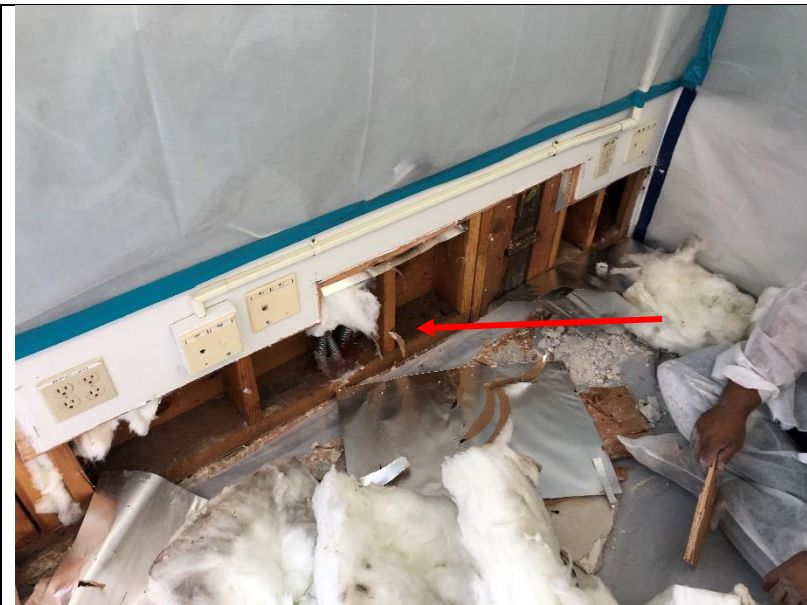
**Photo 260:**

Removal of the interior finishes and shear wall plywood from the interior of room 480.

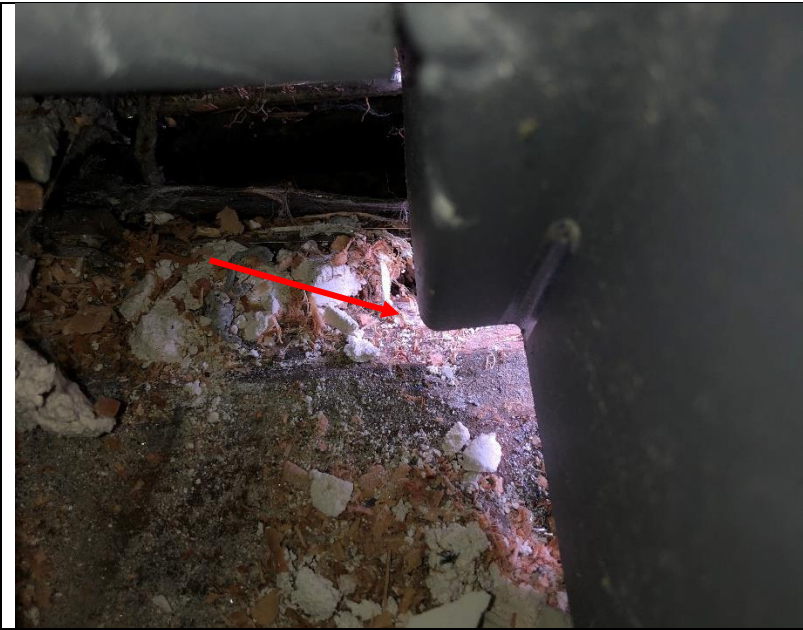
**Photo 263:**  
Exterior light is visible in this closer view of the base of the room 480 hollow metal door frame (viewed from the interior).

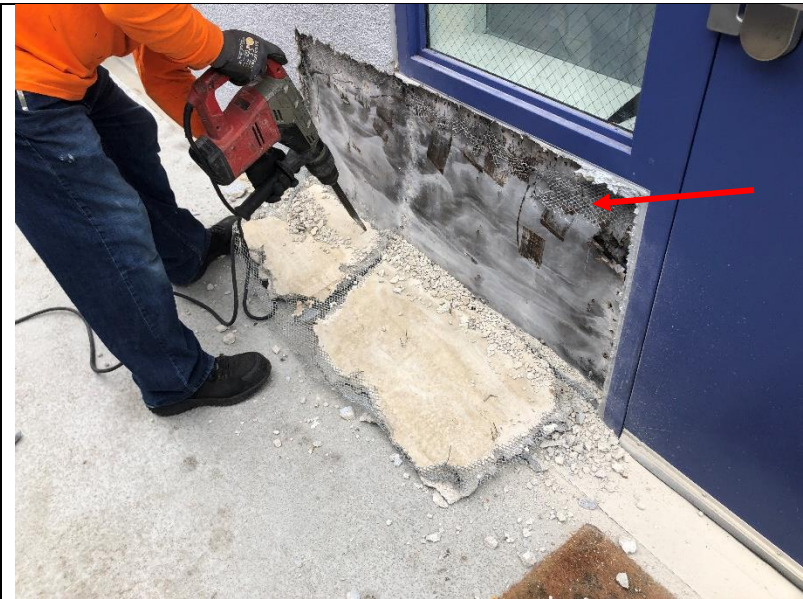
**Photo 264:**  
The contractor removed exterior cladding from the wall outside of classroom 480.

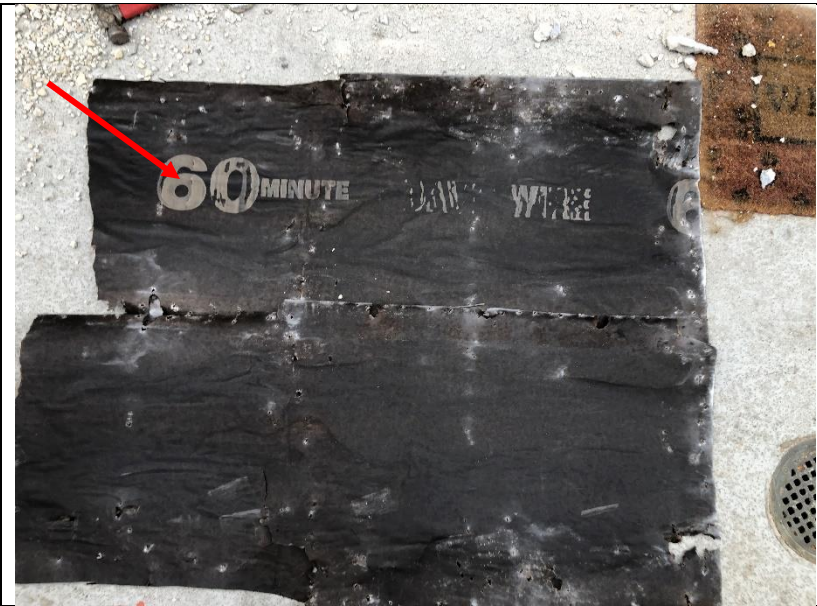
**Photo 265:**  
Two layers of 60-minute building paper were removed from behind the cement plaster assembly at the exterior of building B room 480.

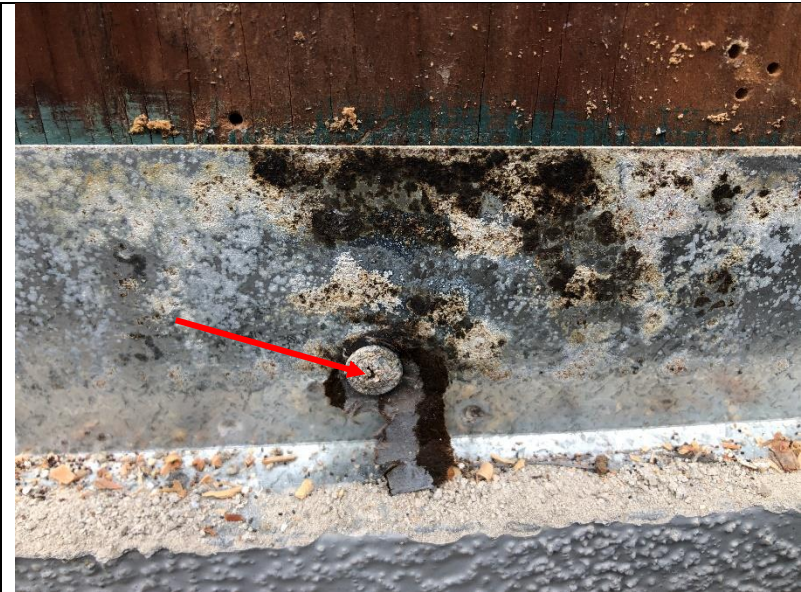
**Photo 267:**

Fasteners at the top flange of the z-flashing outside of room 480 penetrated the building paper.

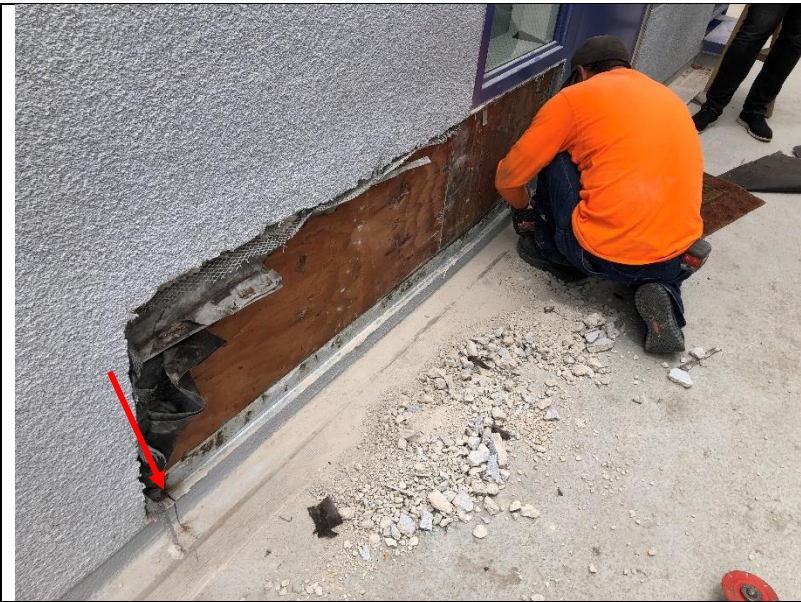
**Photo 268:**

The fasteners along the top edge of the base of wall z-flashing on the south exterior wall of Building B, Room 480 were removed and the z-flashing was cut vertically so that it could be pulled away from the wall. The mounting flange of the horizontal expansion joint assembly was attached to the building sheathing with screws and the top of the flange was mounted flush (level) with the top of the pedestrian deck. DTR observed that a line of sealant had been applied along the base of the mounting flange which partially covered the mounting fasteners. Some openings were visible at the fastener penetrations. A backer rod had been placed in the top side of the sealant. When removed, the sealant that had been applied inside the expansion joint and to the face of the building-side mounting flange showed signs of reversion, (returning to its original tacky state due to prolonged exposure to water) (**Photos 268 – 270**).

The contractor cut vertically through the z-flashing to allow for it to be pulled down and removed from the building.

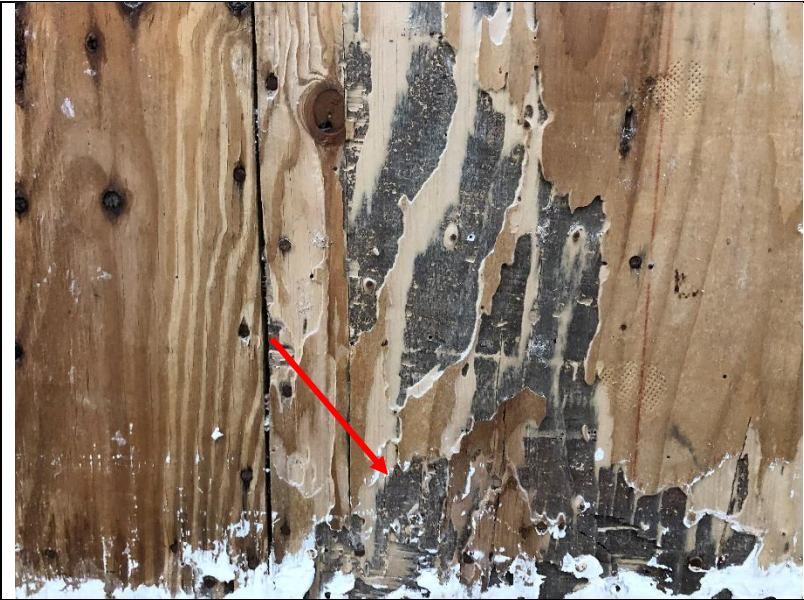
**Photo 276:**  
Insect damage at the interior shear wall plywood on the south wall of room 400.

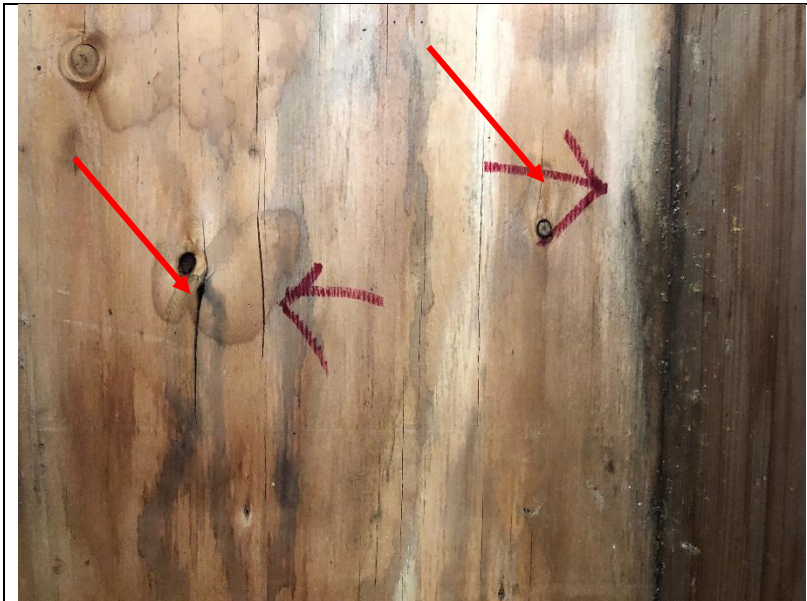
**Photo 278:**  
Delamination and water staining were observed on the exterior sheathing plywood on the south wall of room 400.

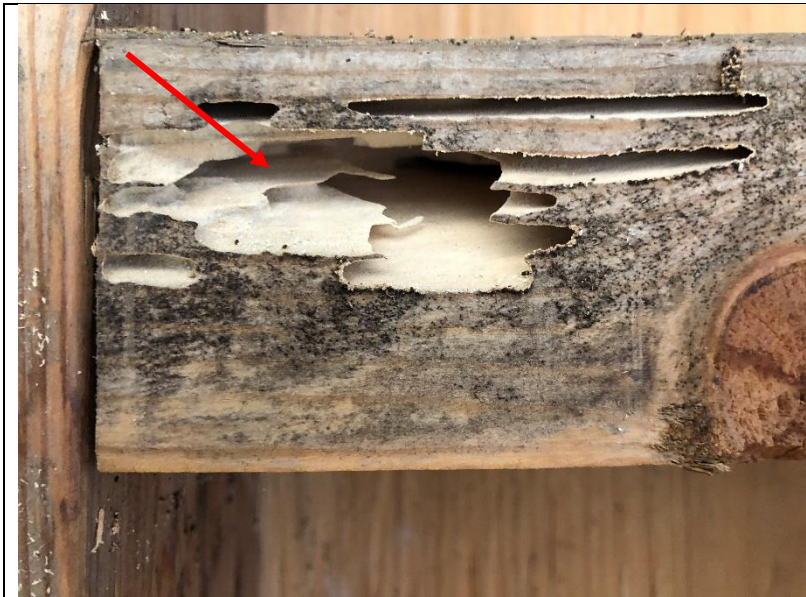
**Photo 281:**  
Insect damage at blocking  
inside the west wall of room  
400.

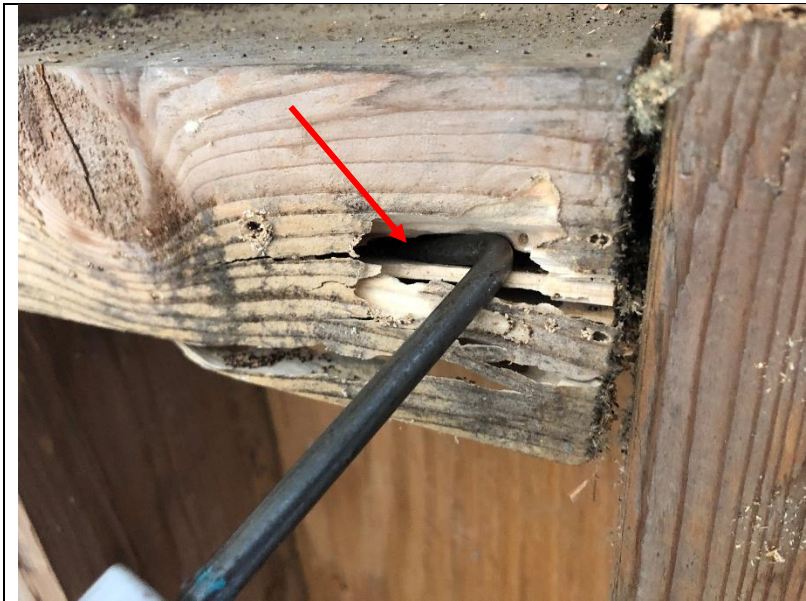
**Photo 282:**  
Insect damage at blocking  
inside the west wall of room  
400.

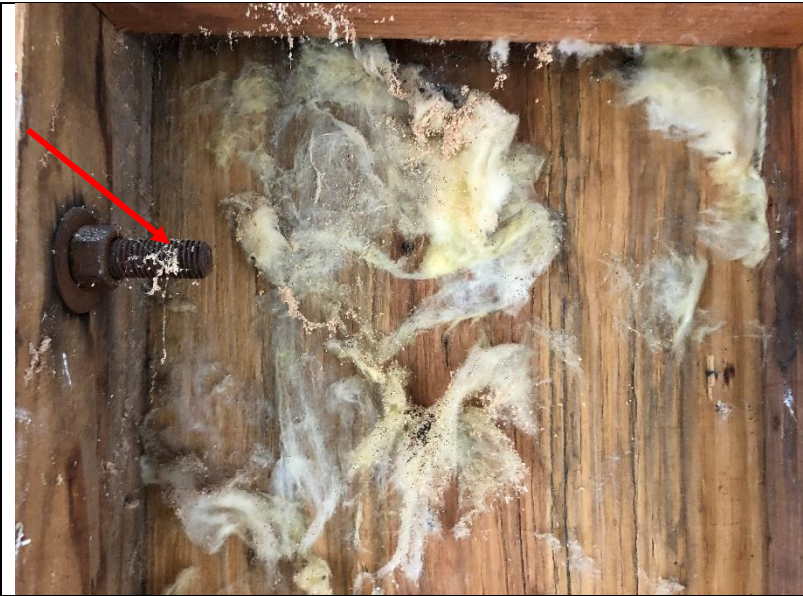
**Photo 283:**

Some water staining and corrosion were observed inside the west wall of room 400.

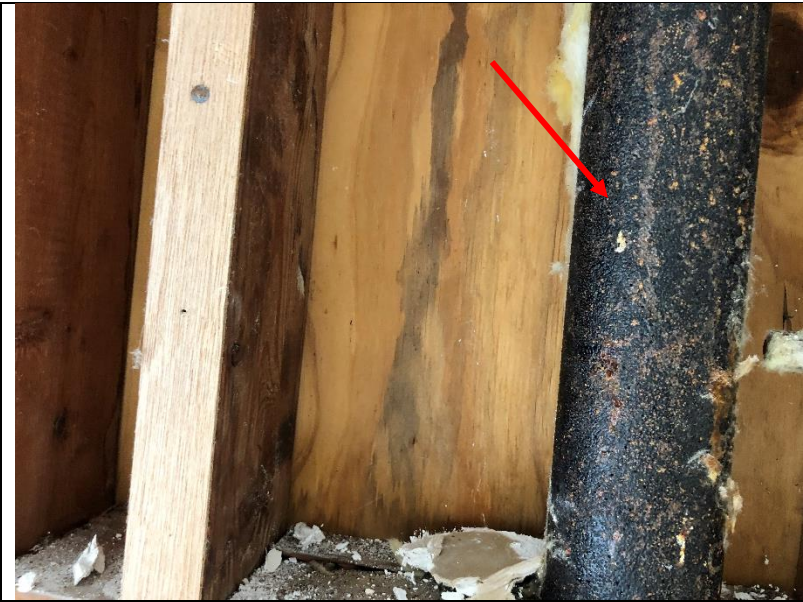
**Photo 284:**

Some corrosion was observed on the drain pipes inside the west wall of room 400.

The pipes were not wrapped in insulation.

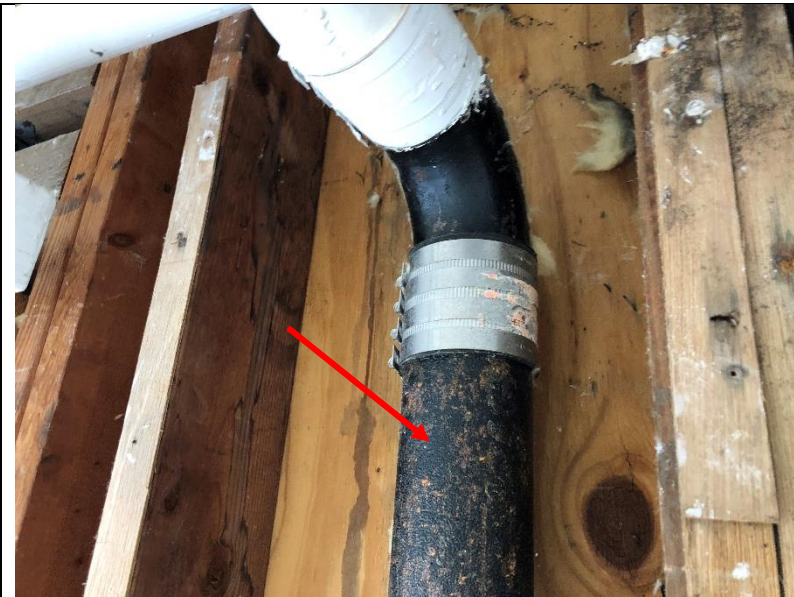
**Photo 285:**

Some corrosion was observed on the drain pipes inside the west wall of room 400.

The pipes were not wrapped in insulation.

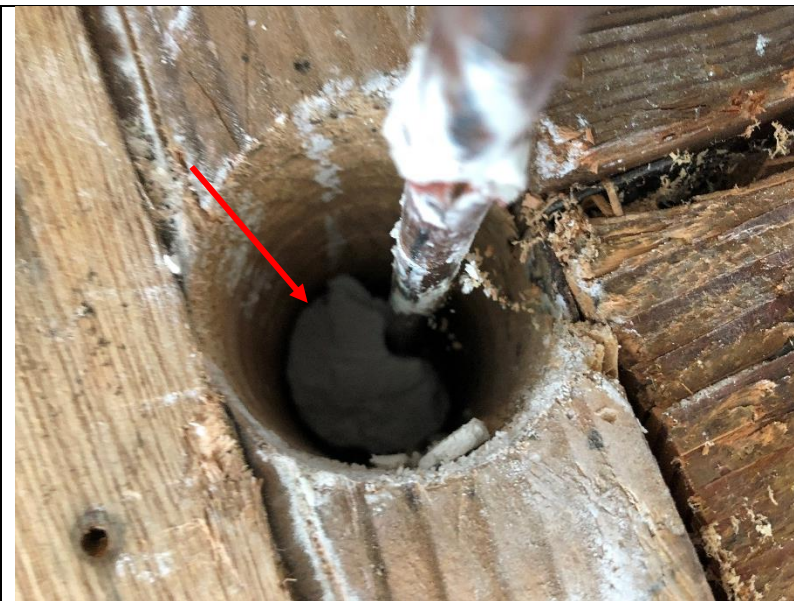
**Photo 286:**

It is unclear if the new HVAC penetrations on the west wall of room 400 are properly flashed at the exterior sheathing.

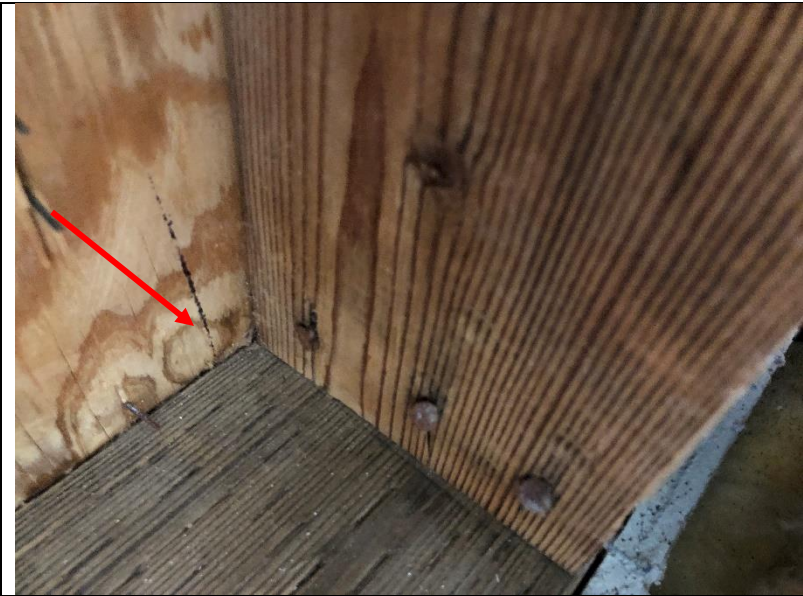
**Photo 287:**  
Evidence of abrasion and previous mold remediation were visible inside the west wall of room 400.

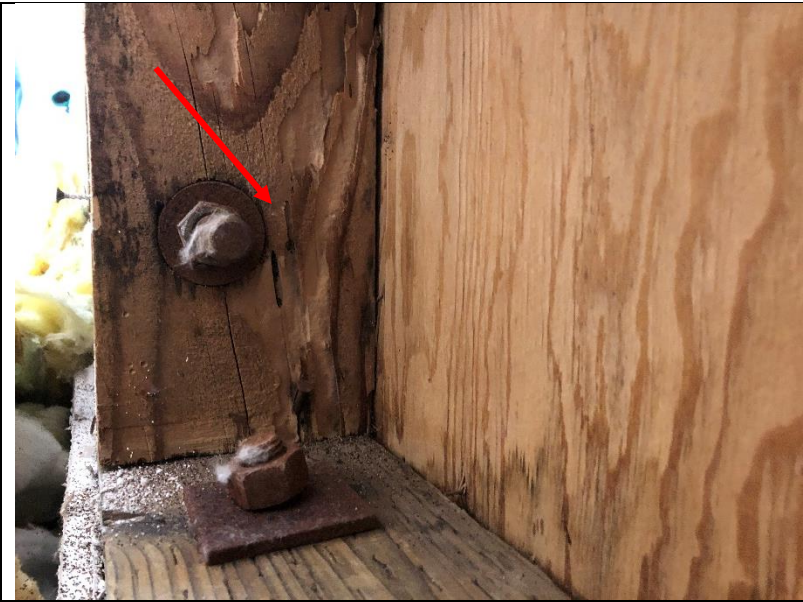
**Photo 288:**  
Evidence of abrasion and previous mold remediation were visible inside the west wall of room 400.

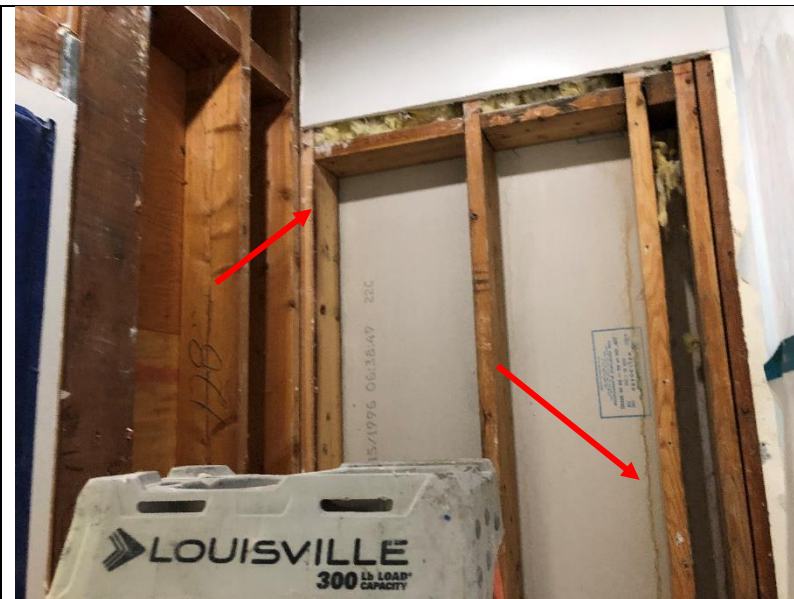
**Photo 293:**

Water damage was present on the wing wall but also wrapped the corner onto the entry wall of room 513.

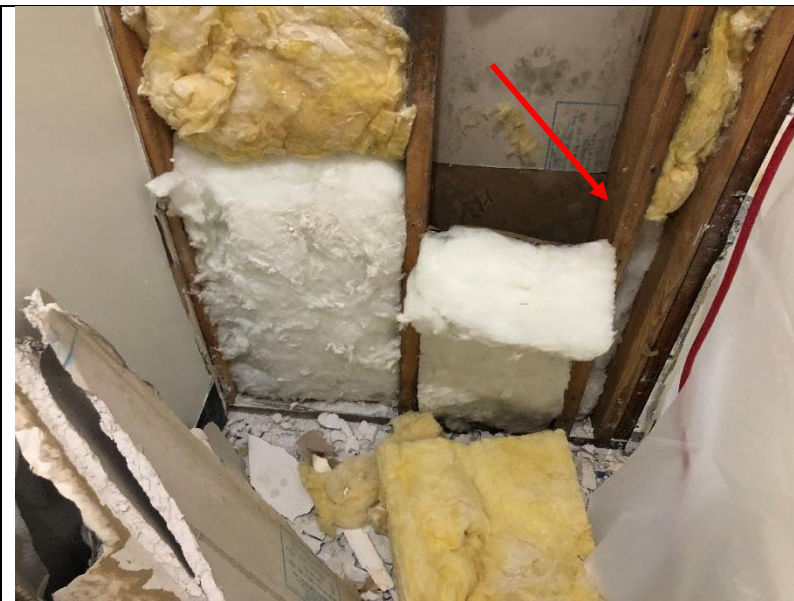
**Photo 294:**

Two different insulations were observed in the wing wall outside the entry of room 513.

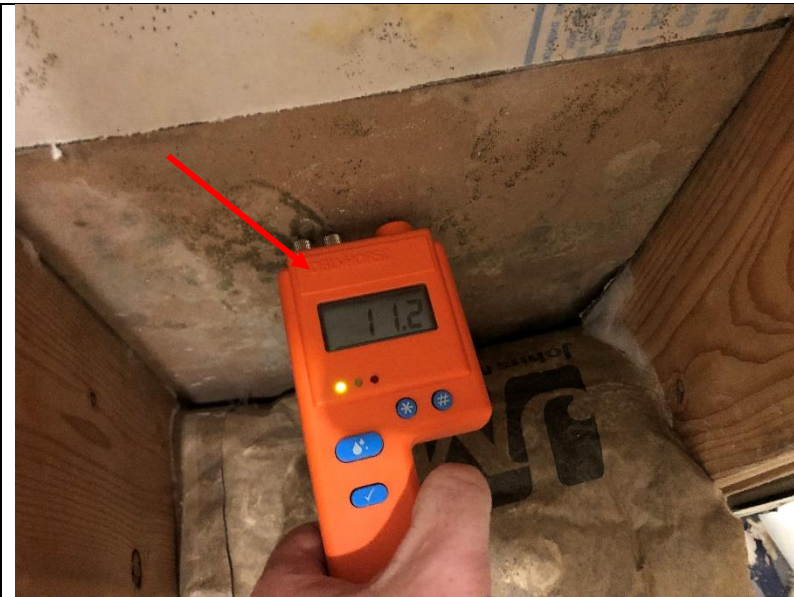
**Photo 297:**

Moisture readings were taken on the gypsum board inside the wall cavity outside room 513.

Moisture readings were taken using the moisture meter's built-in wood scale, and yielded an 11.2 percent wood moisture content reading.

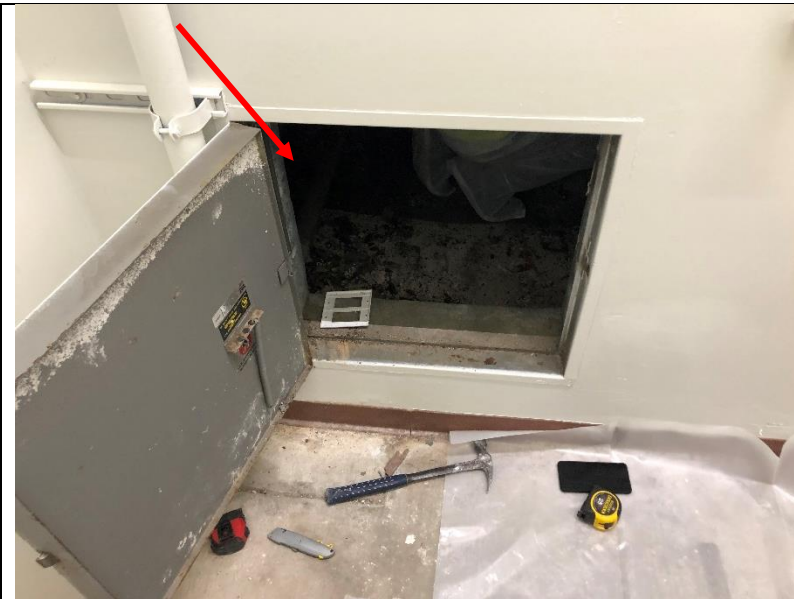
**Photo 298:**

An access hatch leading to the underside of the exterior stairs was accessible from inside room 513. DTR and Martin & Associates entered the area below the exterior stair through the hatch. The space was open to the exterior environment while closed off from entry (other than through the hatch). Extensive corrosion was observed on the steel structure and raisers of the stairs. In some locations, daylight could be seen through corroded openings in the steel. Martin & Associates stated that a corrosion inhibitor should be applied to the metal after it had been cleaned. The thickness of the metal should also be checked (**Photos 298 – 300**).

The crawl space entry access hatch to the space under the exterior stairs from inside building D janitorial room 513.

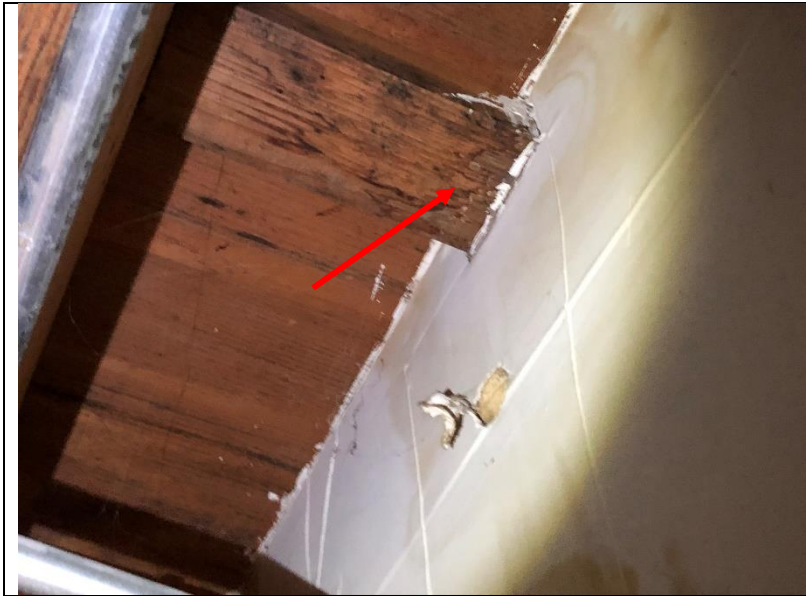
**Photo 303:**

Staining is visible at several locations adjacent to the exterior wall overhead in room 210B.

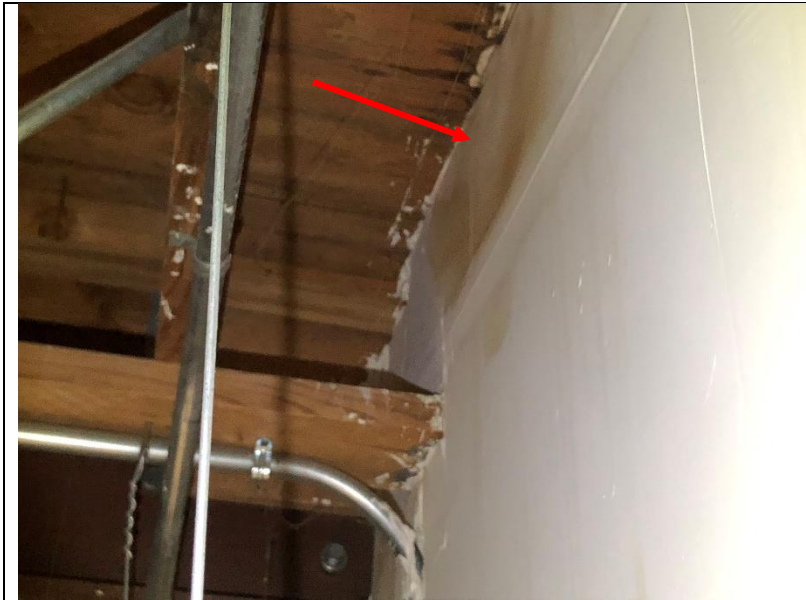
**Photo 304:**

Staining visible at several locations adjacent to the exterior wall.

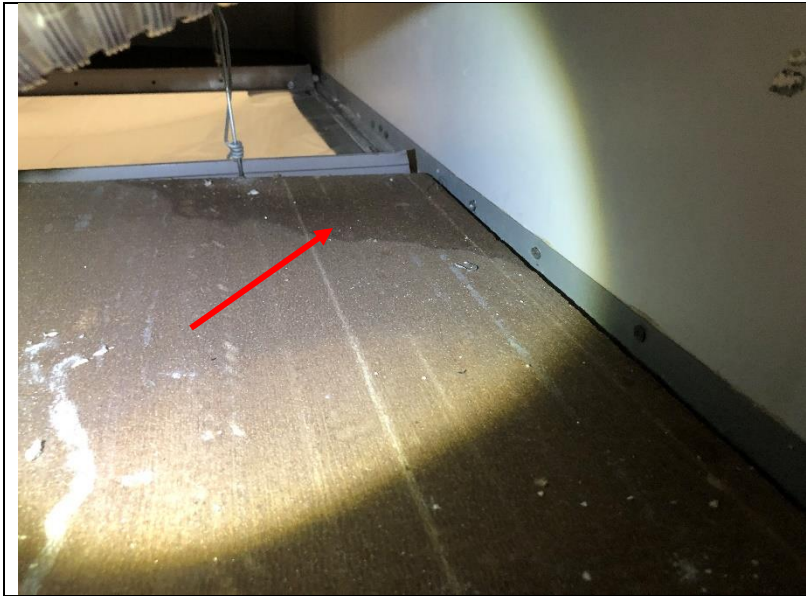
**Photo 307:**

Staining was observed on the top of the ceiling panels.

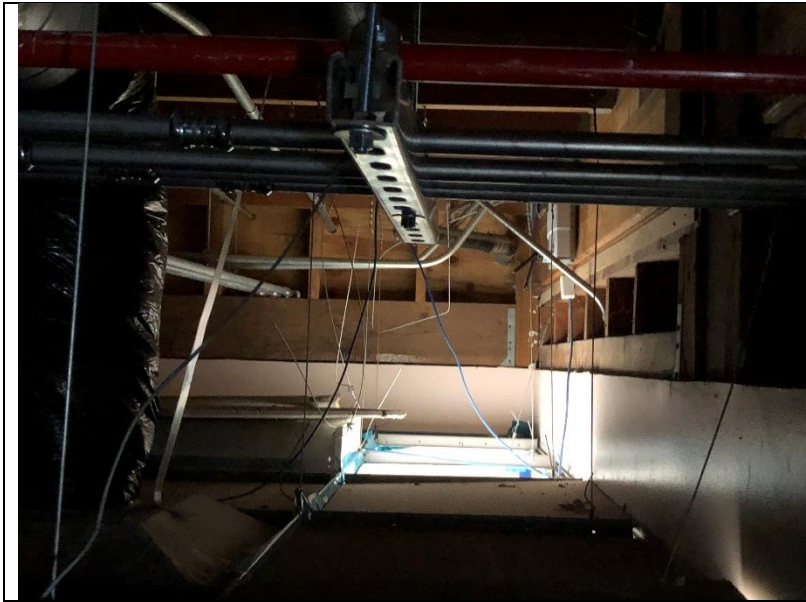
**Photo 308:**

Room 602 is a teacher's prep room. The east wall of the room is an interior wall shared with kindergarten classroom 600. However, as the wall extends to the second floor, it becomes an exterior wall adjacent to the pedestrian deck over classroom 600. Prior to the investigation on June 15<sup>th</sup> and 16<sup>th</sup>, 2022, NV5 had set up containment in the room. Ceiling tiles were removed to allow for observations above the ceiling line. DTR noted some minor staining on the wood elements above ceiling panels. Water staining appears to correlate with the junction of the exterior deck and with plumbing penetrations to a janitorial room above the space. Some biological growth was noted by NV5 on the wooden surfaces (**Photos 308 – 309**).

Observations were made above the ceiling panels in room 602.

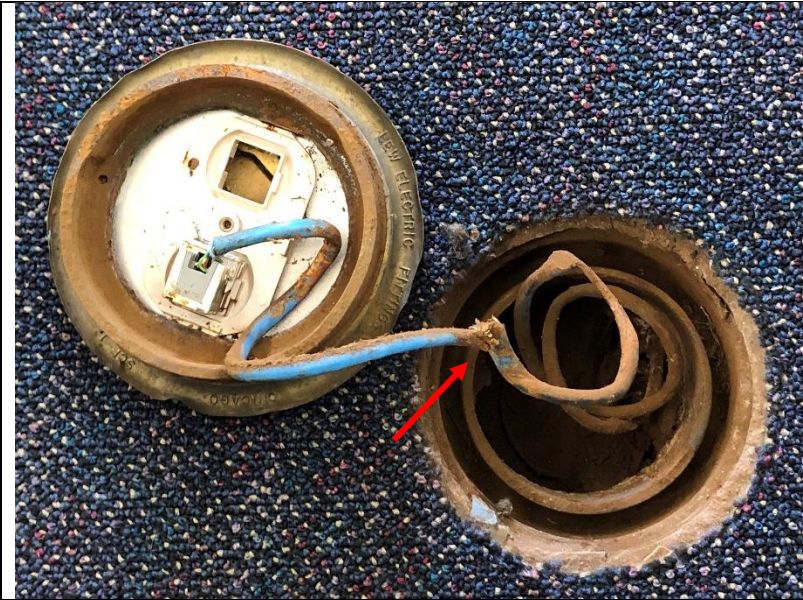
**Photo 313:**

A floor outlet in room 600 (adjacent to the entrance to room 602) was raised.

DTR noted corrosion around the flange of the outlet cover. When opened, corrosion was present in the junction box.

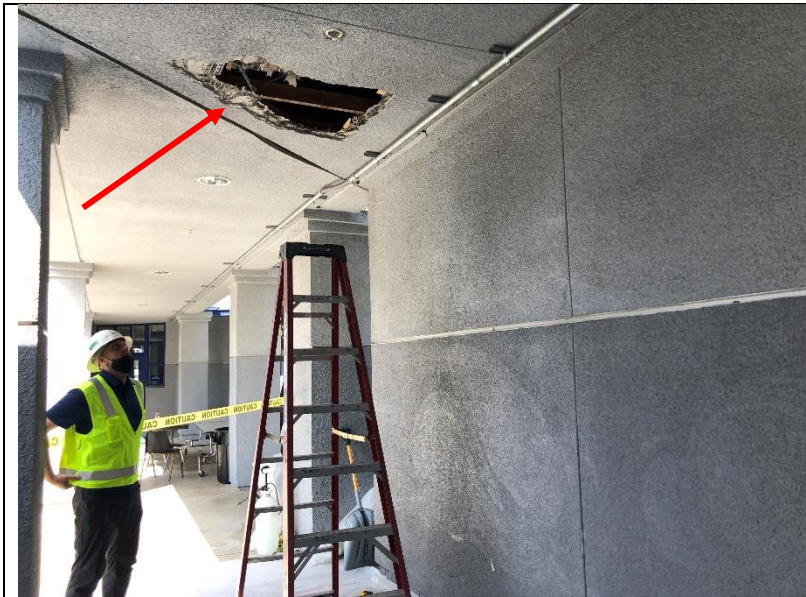
**Photo 314:**

An overview of the destructive testing (DT) location under the walkway between the building A administration and library spaces adjacent to an expansion joint.

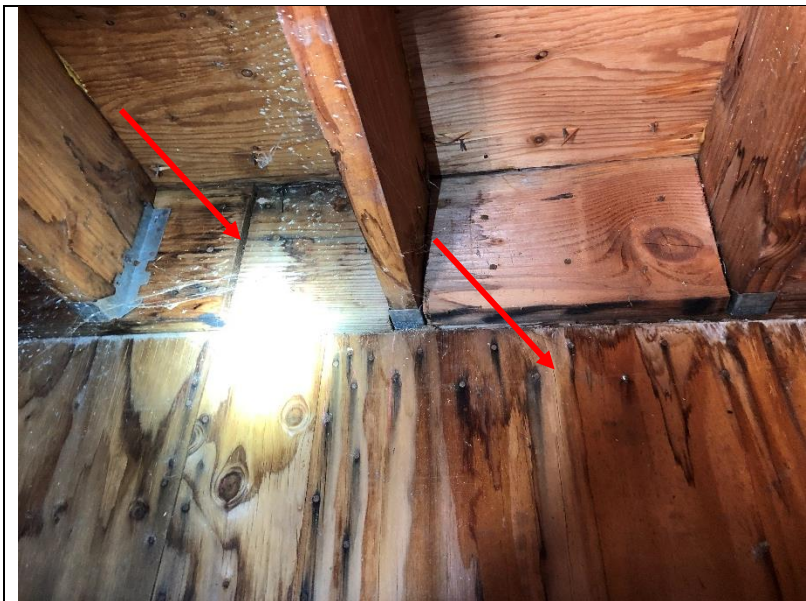
**Photo 315:**

Staining at the ledger and joist under the walkway between the administration and library spaces adjacent to an expansion joint.

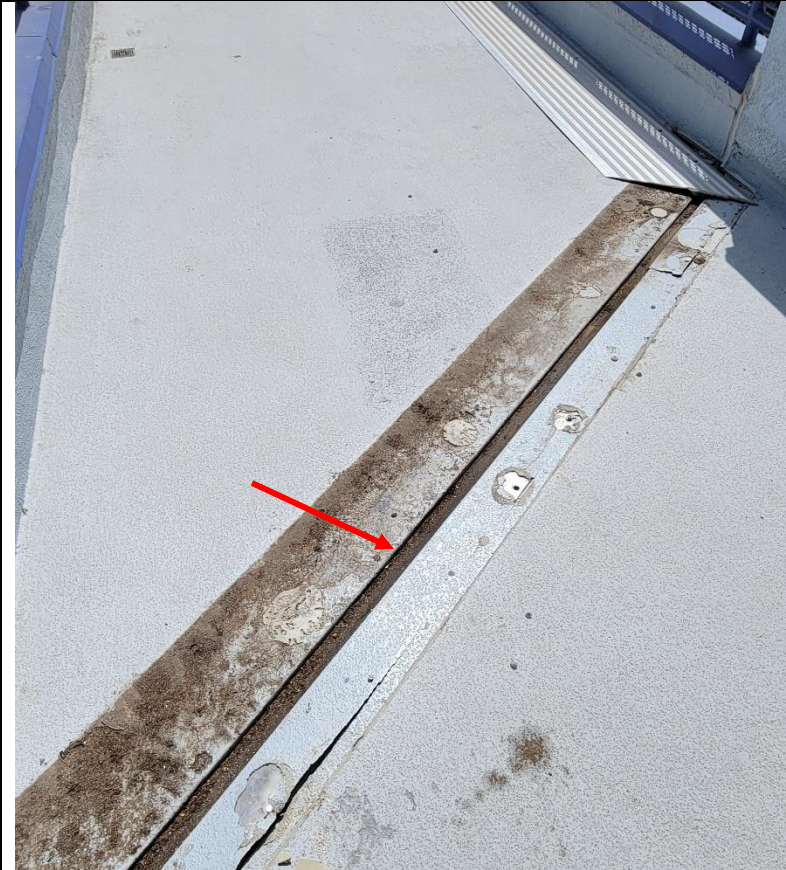
**Photo 318:**

The expansion joint above the DT location at the walkway between the administration and library spaces at building A.

The metal cover was removed to allow for observations.

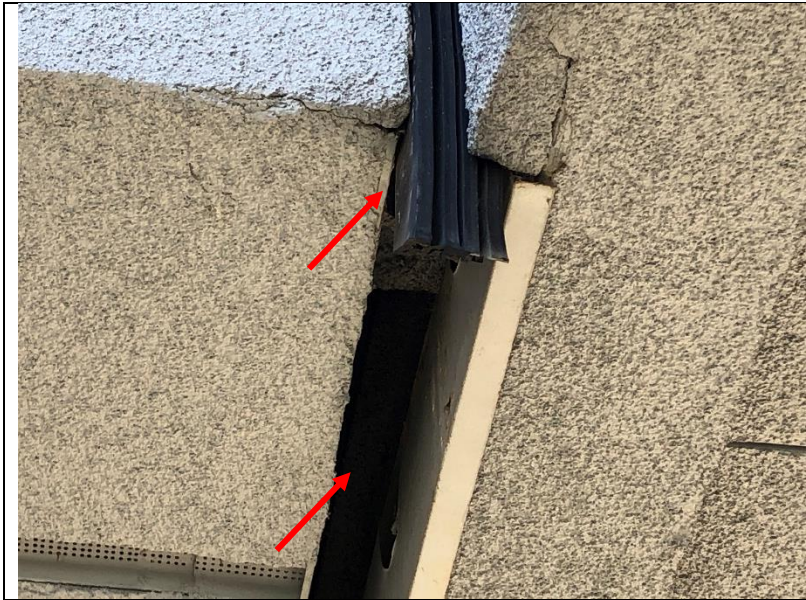
**Photo 320:**

The compressed foam at the bottom of the building A expansion joint was loose and had fallen away at some locations.

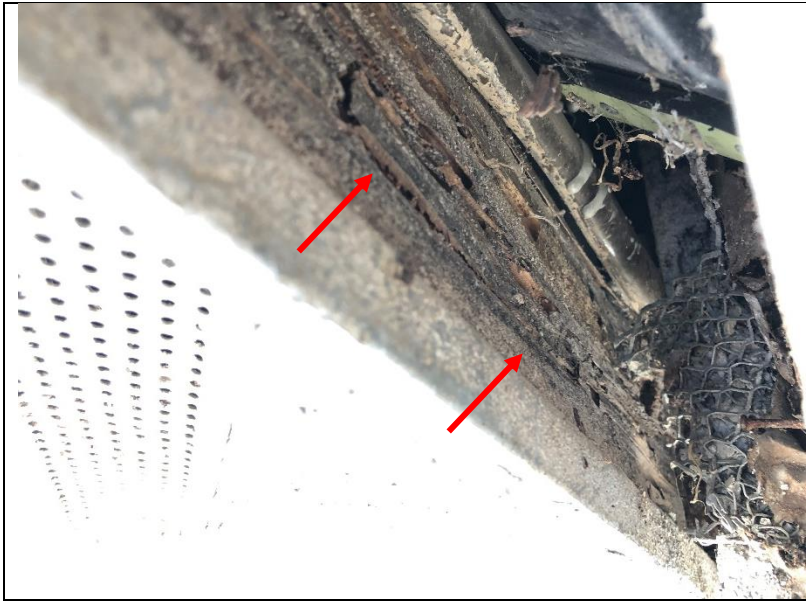
**Photo 321:**

Insect damage on wood surfaces at the bottom of the expansion joint after the compressed foam had been removed.

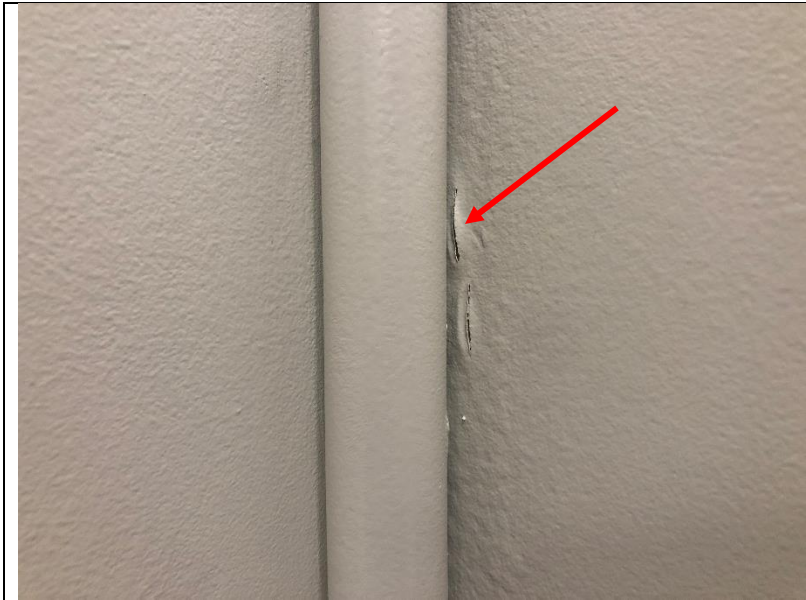
**Photo 325:**

Close view of water damage at the interior corner of the library.

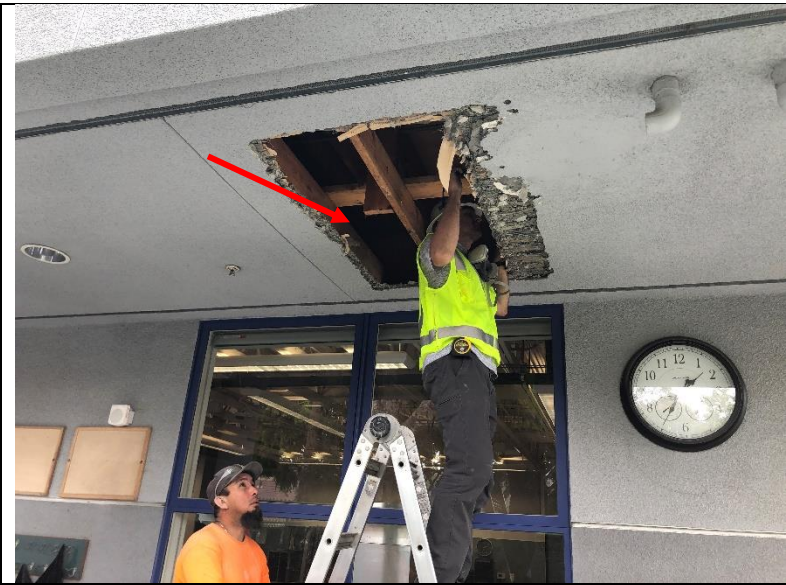
**Photo 326:**

Outside room 420 an approximately 4-foot by 8-foot opening was cut in the underside of the walkway. The soffit assembly at this location was a lath and plaster system with a plastic backing sheet. DTR noted water stains on many of the joists and joist hangers against the building wall. The joists are attached to the wall just below the pedestrian traffic coating flashing at the weep screed assembly on the wall above. Some corrosion was observed at structural anchor bolts. Leaves were also observed in the interstitial space. It is unclear how the leaves entered the space (**Photos 326 – 330**).

An overview of a DT location outside building B room 420 where an approximately 4-foot by 8-foot opening was cut in the underside of the walkway.

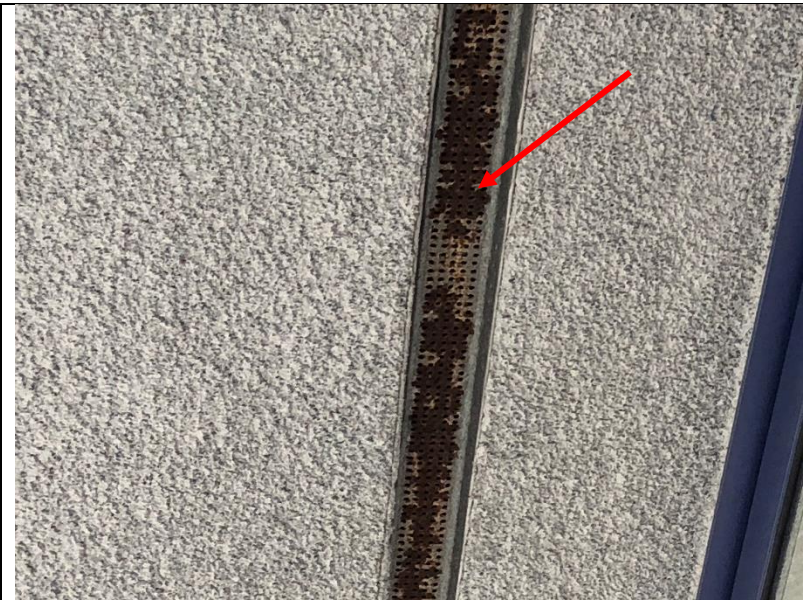
**Photo 333:**

Much of the soffit venting track that ran parallel to building B was corroded.

The location is below the water stains observed at the joist hangers and the ledger against the building.

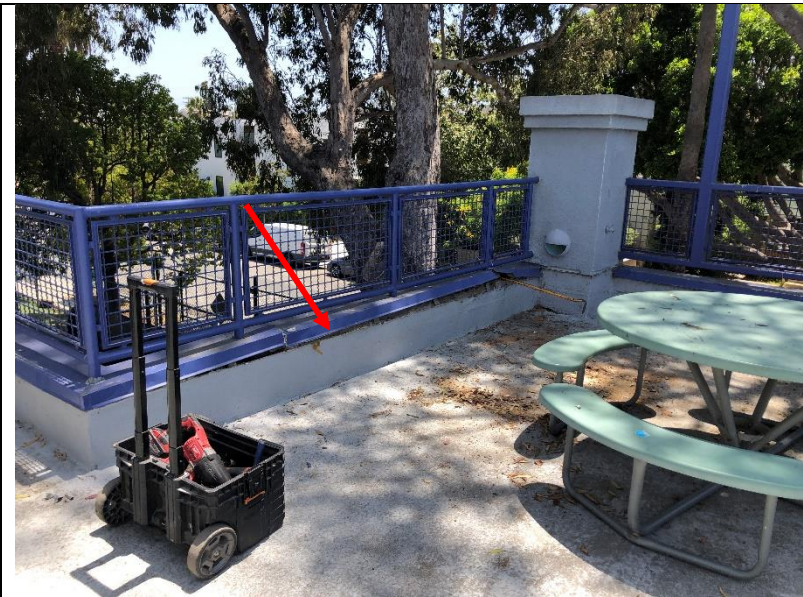
**Photo 338:**  
An overview of the DT location at the handrail curb on the south side of room 400.

The sheet metal L-flashing where the pedestrian traffic coating turned up onto the side of the curb did not appear to be attached to the curb structure. Further observations confirmed that the wood structure of the curb had not been repaired. The area was heavily dry rotted and, in some locations, the guardrail anchor plates were no longer properly attached to the structure. Water appeared to have entered the curb/wall at the guardrail penetrations in the coping cap. Seams and poor installation of the self-adhered membrane under the coping created paths for water to travel into the structural elements of the building (**Photos 338 – 341**).

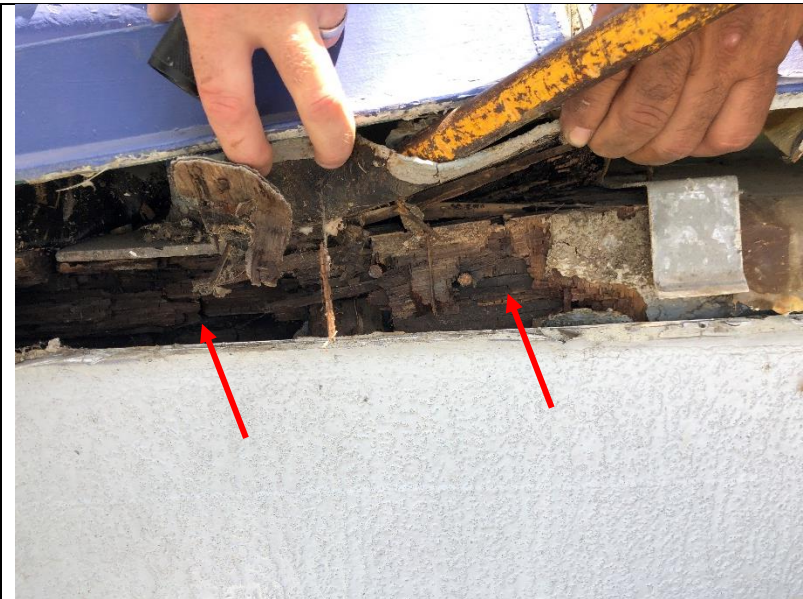
**Photo 339:**  
Wood rot and deteriorated wood materials were observed under the coping cap at the handrail curbs.

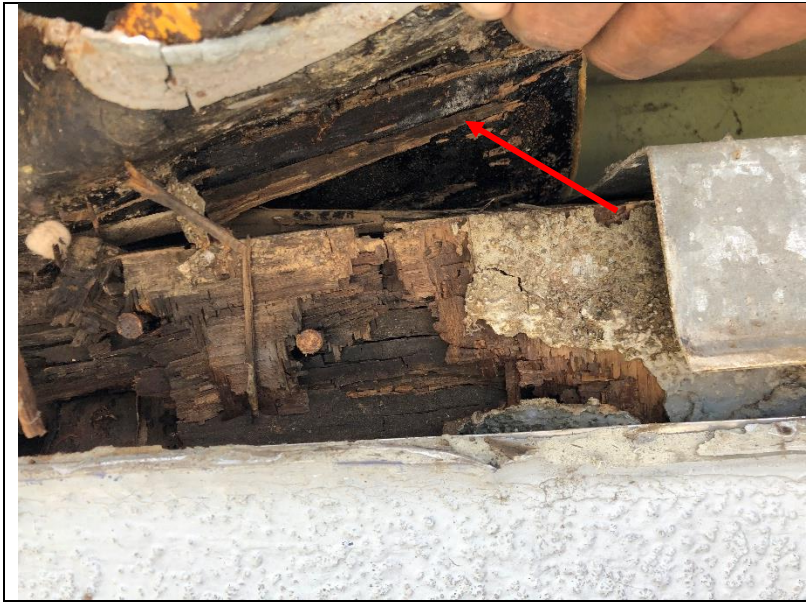
**Photo 341:**  
The self-adhered sheet membrane was not adhered to the substrate and numerous open seams were observed in the installation of the product.

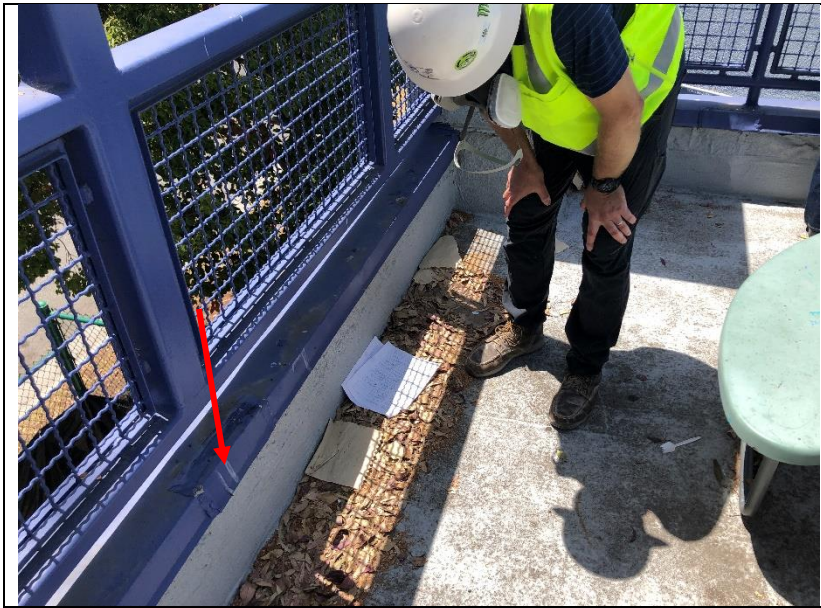
Due to the numerous locations where the guardrails penetrate the coping, Little, Martin & Associates, and DTR decided to undertake additional limited investigation at several other locations to confirm that the condition was systemic throughout the campus. Three additional locations over classroom 400 at building B were opened, a section of coping at the northwest corner of the pedestrian deck over classroom 500 at building D was opened, and a section of coping under the western guardrail above the communications classroom 205 at building A was opened. All locations that were opened had similar damage with varying severity. In some of the locations, the wood sheathing appeared to be OSB rather than plywood. OSB is not approved for use in DSA projects to DTR's knowledge. (**Photos 342 – 354**).

**Photo 342:**  
An overview of a second DT location at the handrail curb on the west side of room 400.

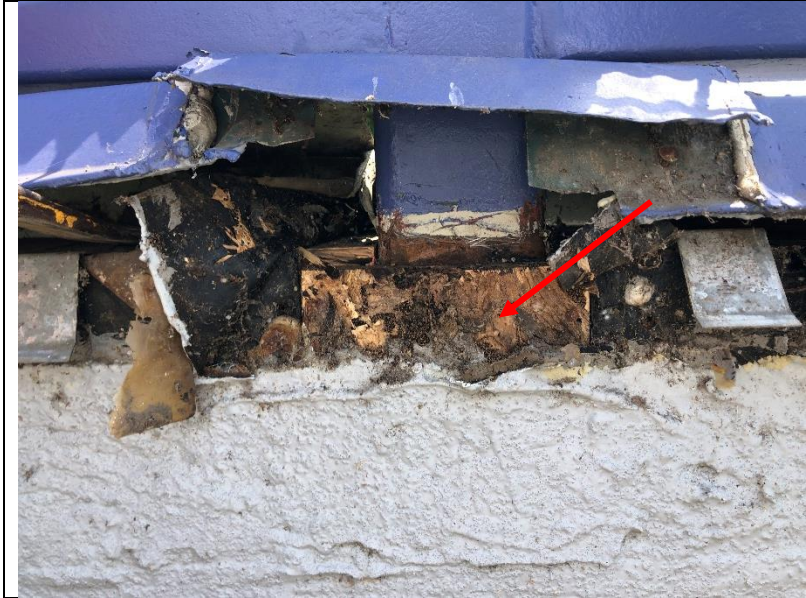
**Photo 343:**  
Wood rot and deteriorated wood materials were observed under the coping cap at the handrail curbs.
