**Santa Monica-Malibu  
Unified School District**  
John Muir - SMASH Elementary School

**Findings Report**  
**Building Envelope Investigation**

Report Date: June 30, 2022

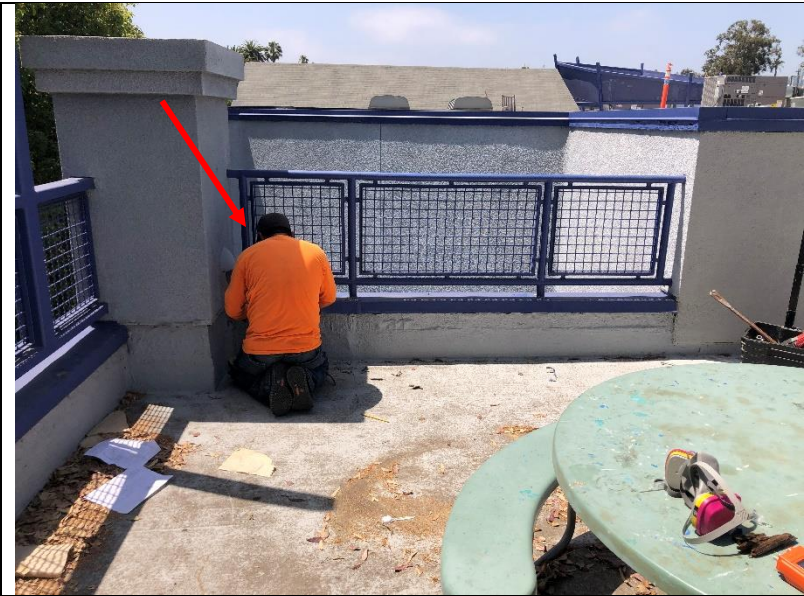
**Photo 344:**

An overview of a third DT location at the handrail curb on the north side of room 400.

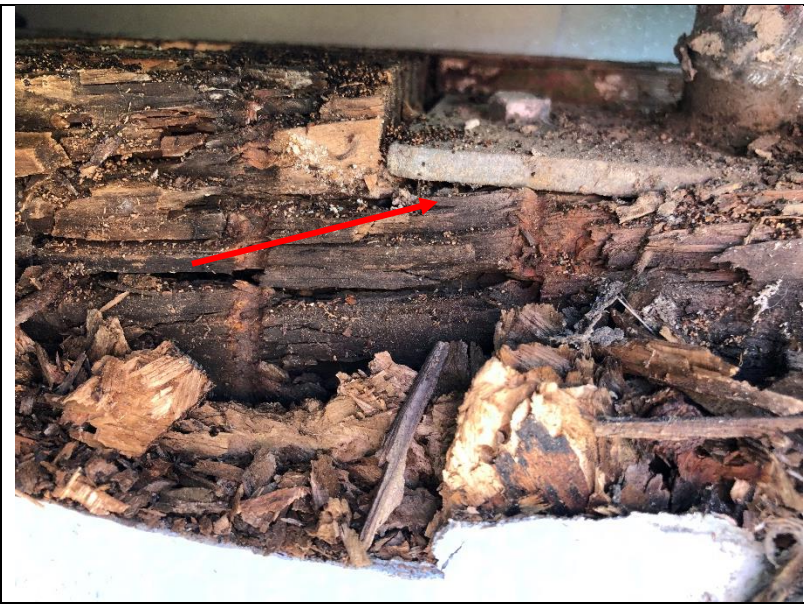
**Photo 345:**

Wood rot and deteriorated wood materials were observed under the coping cap at the handrail anchor plates on the curbs.

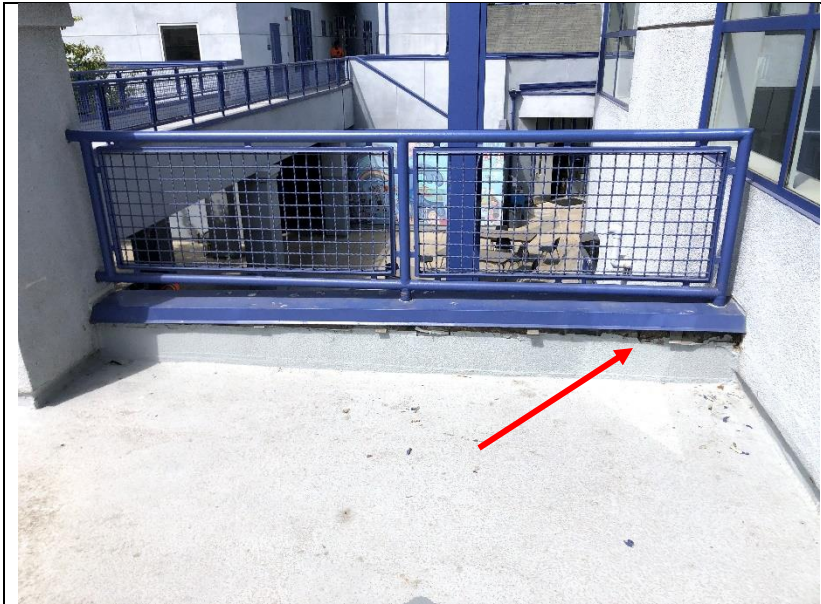
**Photo 348:**  
An overview of a fourth DT location at the handrail curb on the east side of room 400.

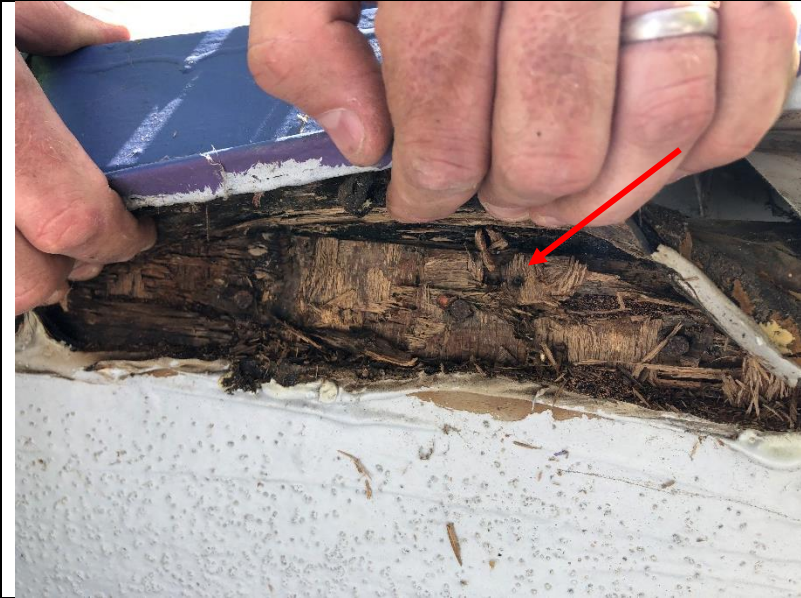
**Photo 351:**

Wood rot and deteriorated wood materials were observed under the coping cap at the handrail curb.

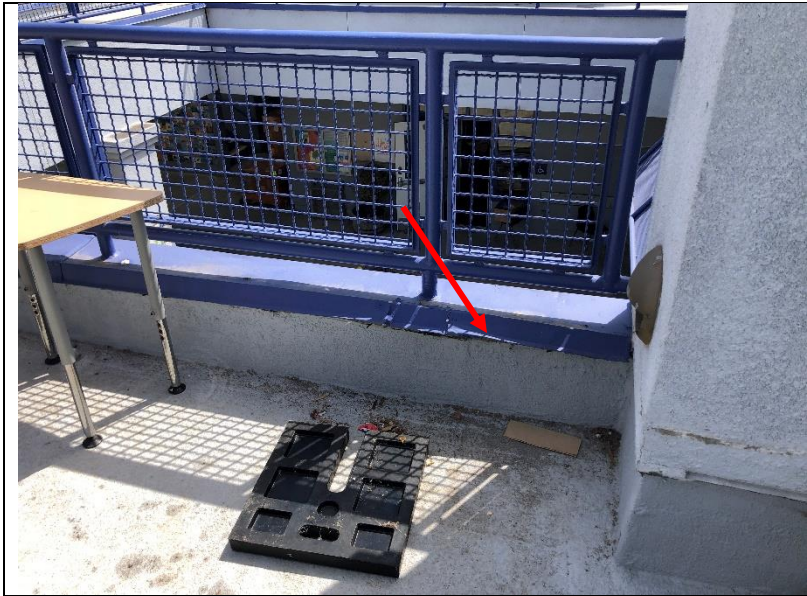
**Photo 352:**

An overview of a DT location at the handrail curb on the north side of building D classroom 500.

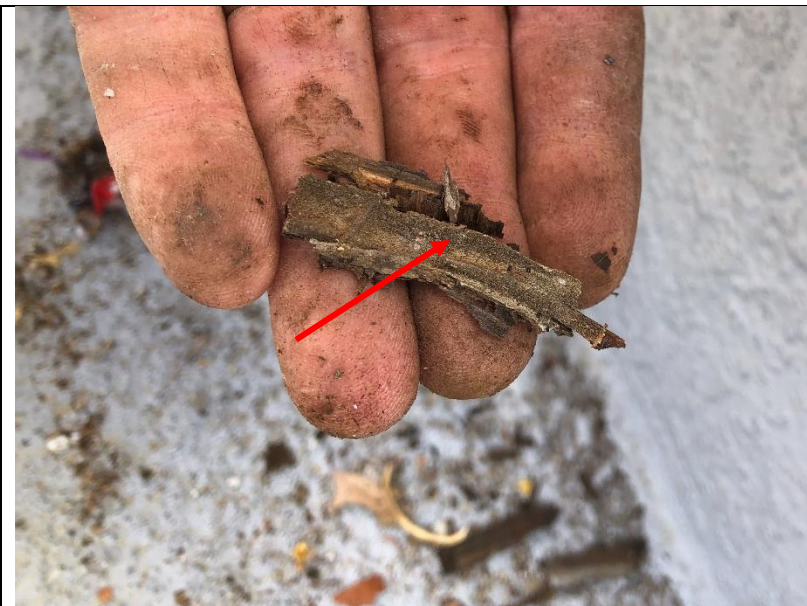
Due to the numerous locations where the guardrails penetrate the coping, Little, Martin & Associates, and DTR decided to undertake additional limited investigation at several other locations to confirm that the condition was systemic throughout the campus. Three additional locations over classroom 400 at building B were opened, a section of coping at the northwest corner of the pedestrian deck over classroom 500 at building D was opened, and a section of coping under the western guardrail above the communications classroom 205 at building A was opened. All locations that were opened had similar damage with varying severity. In some of the locations, the wood sheathing appeared to be OSB rather than plywood. OSB is not approved for use in DSA projects to DTR's knowledge. (**Photos 342 – 354**).

**Photo 354:**

Deteriorated wood material with a fastener that fell from under the coping cap at the handrail curbs during coping removal.
