# **BUILDING ASSESSMENTS**

MALIBU MIDDLE HIGH SCHOOL  
SANTA MONICA-MALIBU UNIFIED SCHOOL DISTRICT

4.0 Malibu Middle & High School Building Assessment

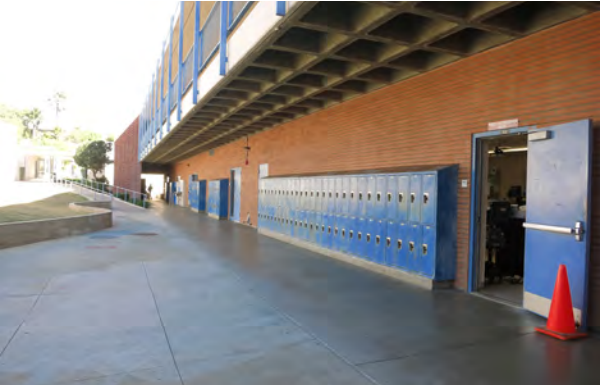
- The exterior finish is brick and in fair condition. Various areas with efflorescence and faded graffiti.
- At the enclosed stairs, the metal pan is corroding. The glue down ceiling tiles appear to be original to the building are in poor condition, are mismatched and coming unglued.
- Underside of second floor walkway is concrete coffered ceiling. This is in good condition.
- The exterior guardrail and posts are faded and need to be repainted. The metal mesh infill is bent and warped and should be replaced.
- The plaster soffit appears in acceptable condition.
- Exterior lockers need to be refinished/replaced; paint in poor condition, showing signs of corrosion. Lockers on 2nd floor have been removed, but the curbs remain.
- Exterior lights are wall mounted.

First floor exterior.

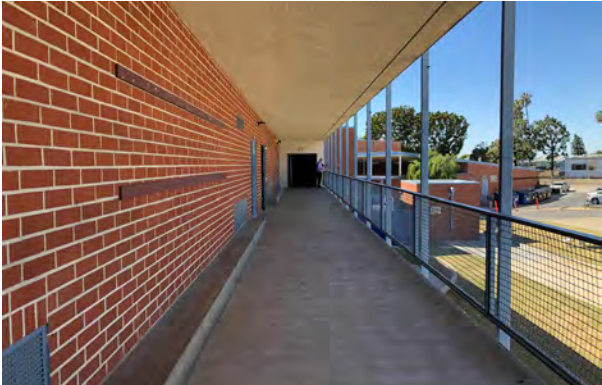
Second floor exterior.

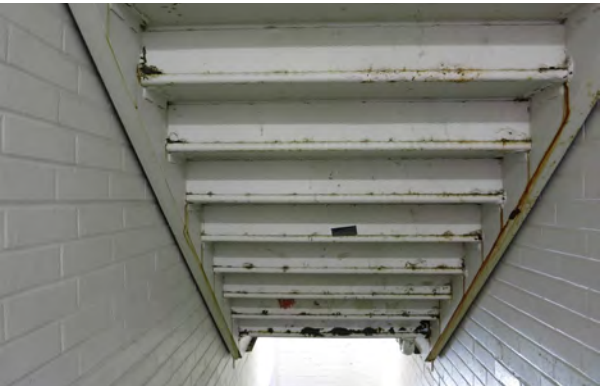
Enclosed exterior stair.

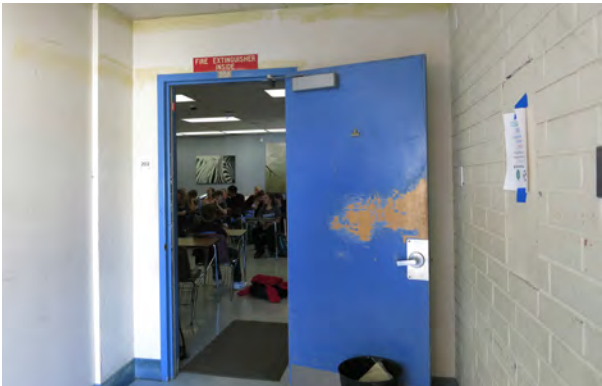
- Door frames are hollow metal and showing signs of corrosion.
- Wood doors show wear and tear, paint is badly chipped; need to be refinished and painted.
- Door louvers are corroded.
- Majority of thresholds do not appear to meet today's code and will need to be replaced if there is a modernization.

Typical classroom door.

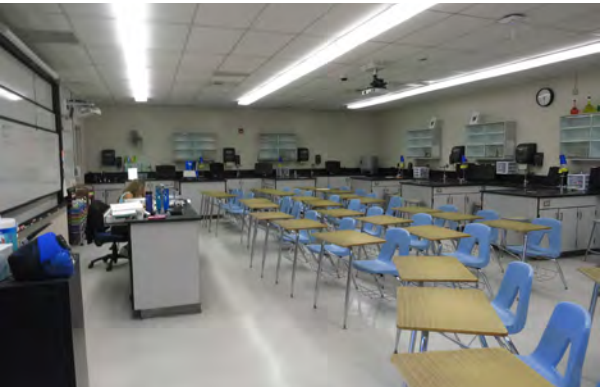
- Interior VCT Floor finish is in fair condition with various areas near lab equipment that are badly stained. VCT in hallway is in poor condition.

- Interior gypsum board painted walls are in fair to poor condition; needs to be painted.
- Rubber wall base is faded, chipped/ peeling and in poor condition.
- Acoustical ceiling is in poor condition with warping, chips and stains.
- Lab casework appears to be in good condition.

Typical science lab.

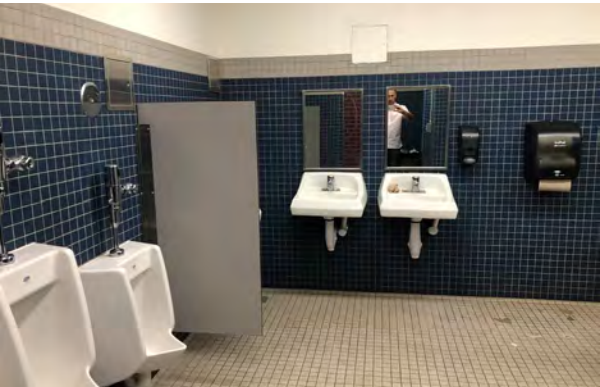
The restroom fixtures in Building D appeared to have been modernized recently and were in very good condition at time of observation.

Typical restroom, boys.

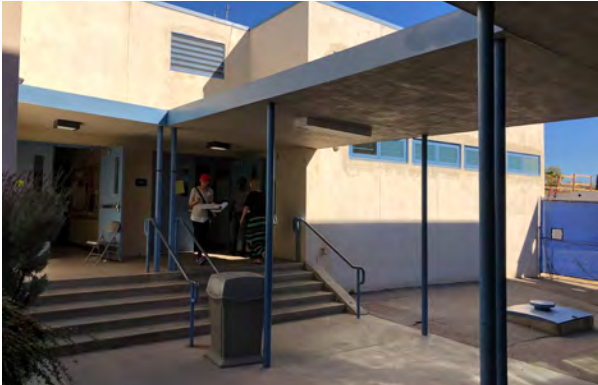
Entryway.

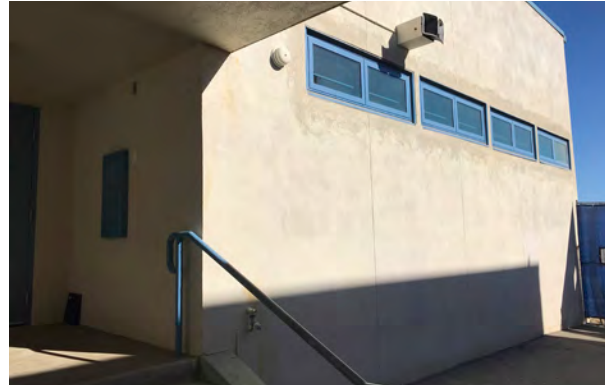
Typical clerestory windows.

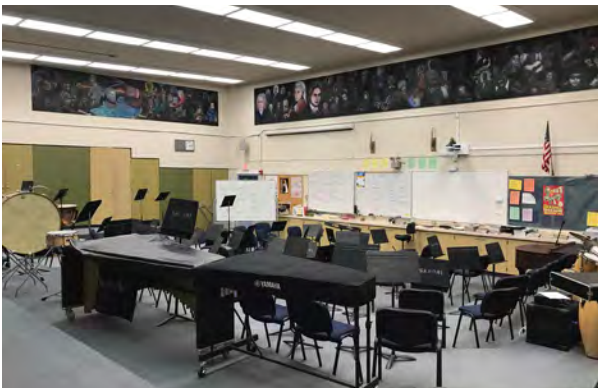
Band Classroom.

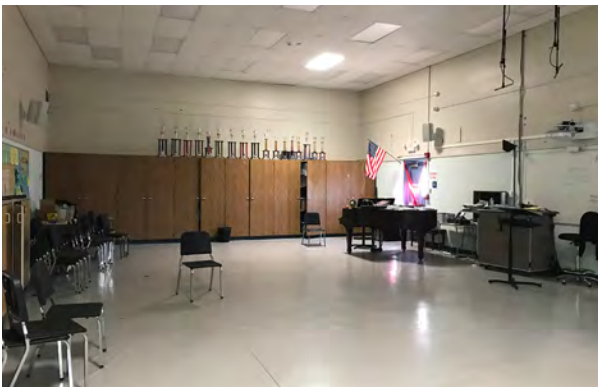
Music Classroom.

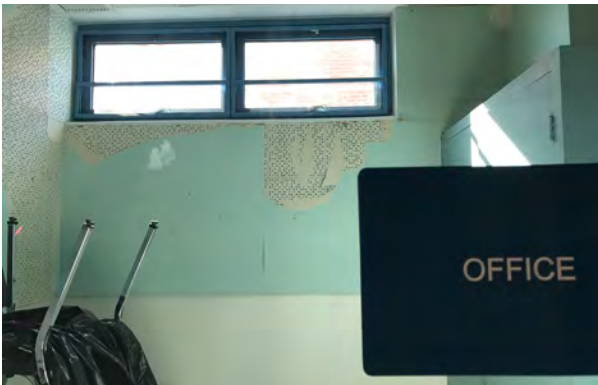
Office under renovation.

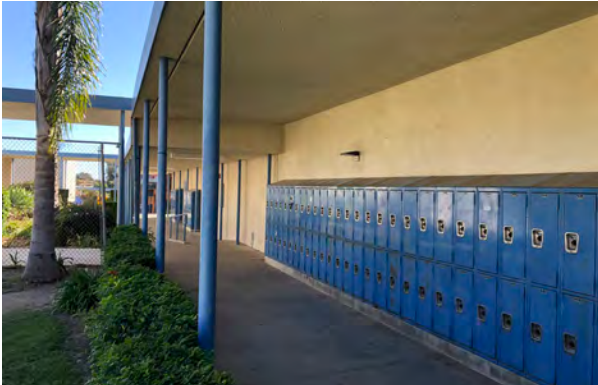
Covered walkway along building.

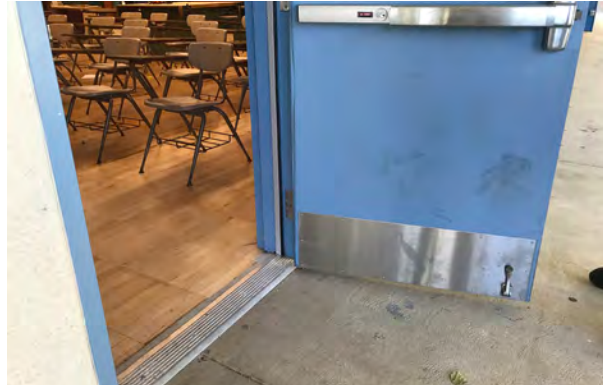
Typical classroom door.

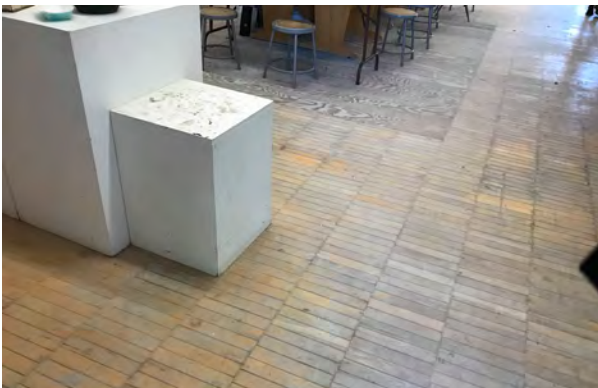
Typical original parquet flooring.

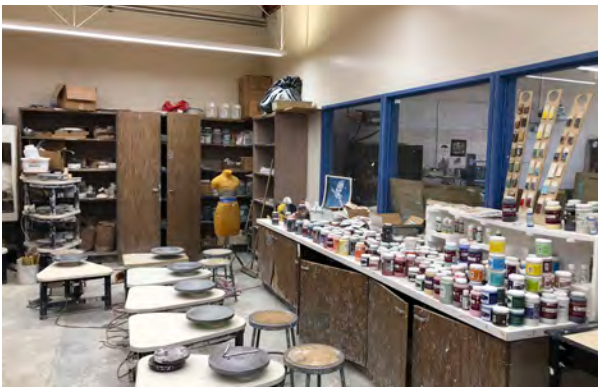
3D Art - Ceramics.

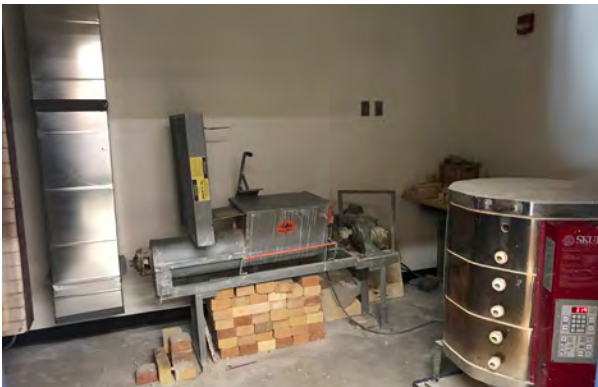
Kiln Room.

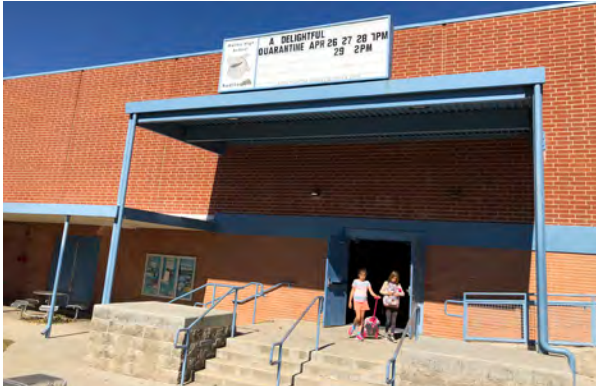
Entry.

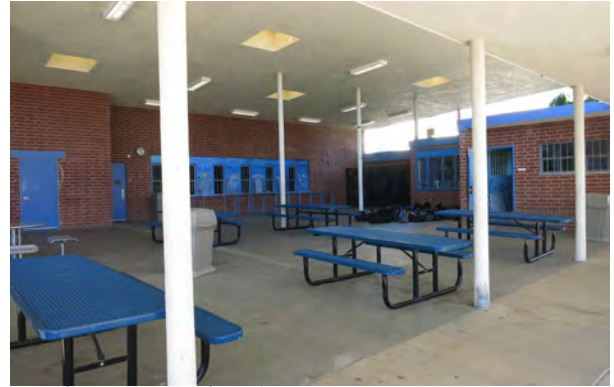
Outdoor covered eating area.

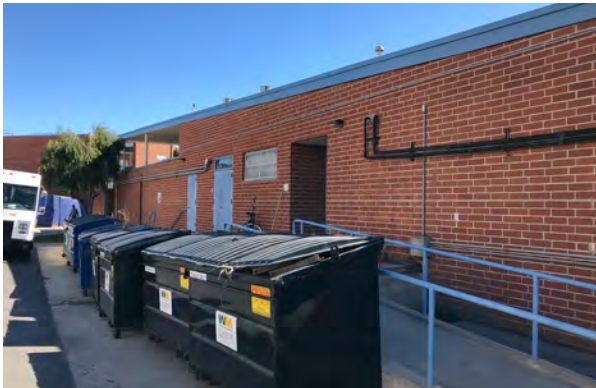
Delivery and trash area.

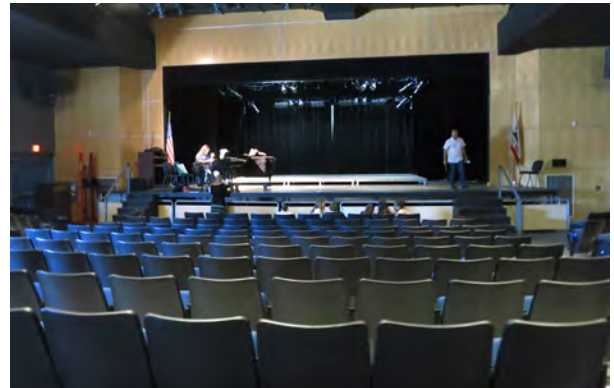
Theater and stage.

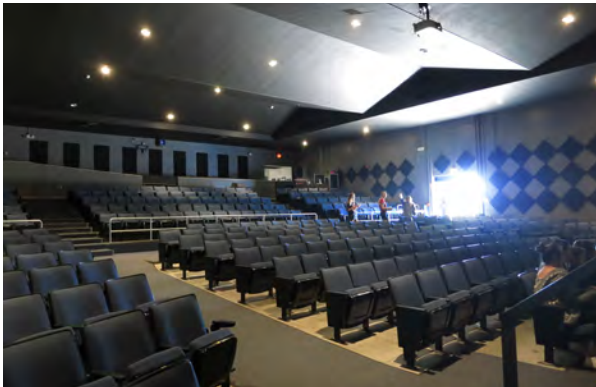
Theater.

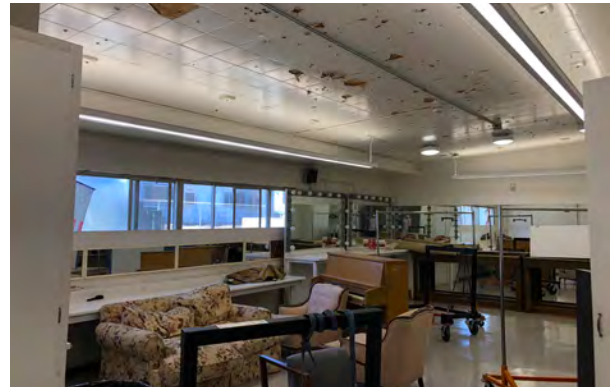
Dressing Room.

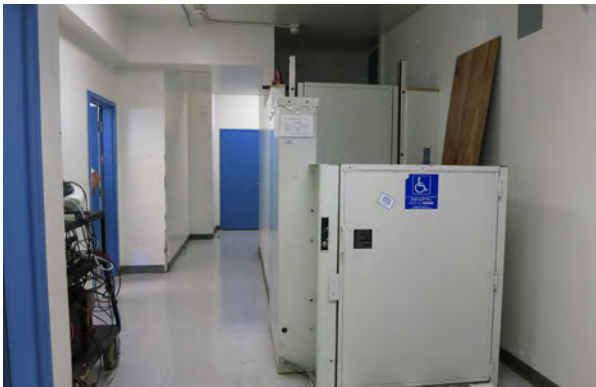
Corridor to support spaces; ADA lift to stage.

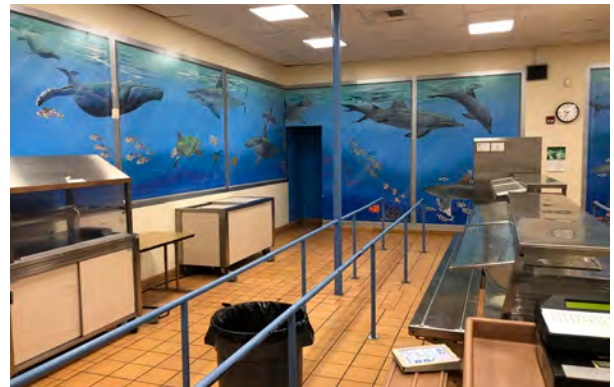
Food serving.

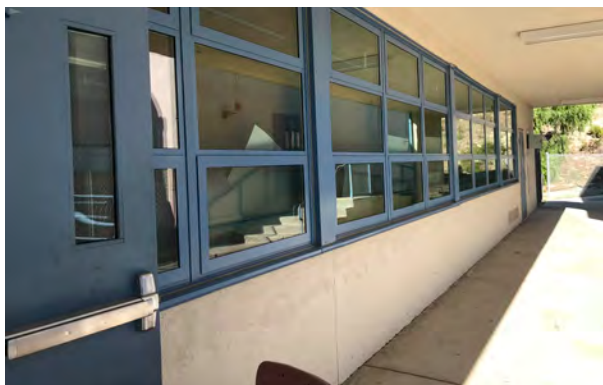
Typical door and storefront window system.

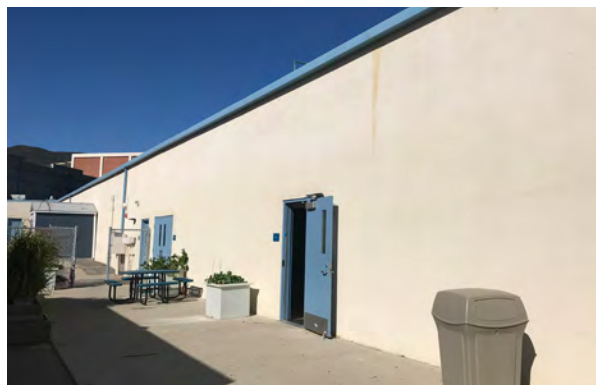
Typical exterior wall.

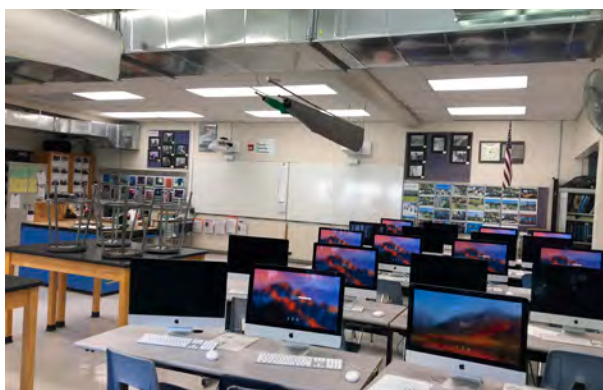
Digital photography classroom.

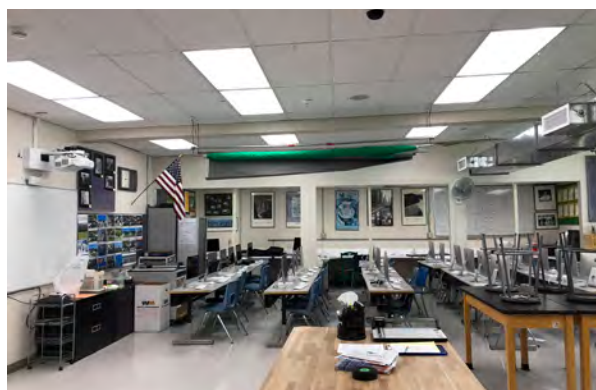
Digital photography classroom.

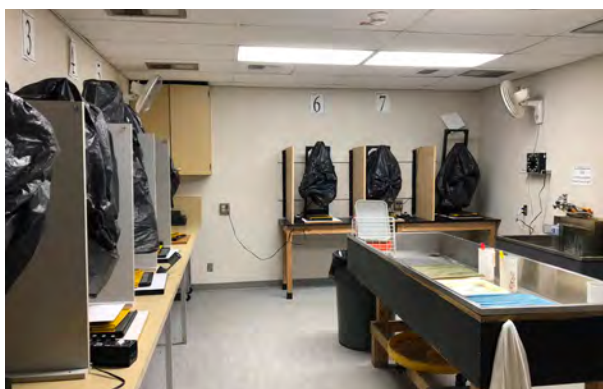
Dark room/ developing room.

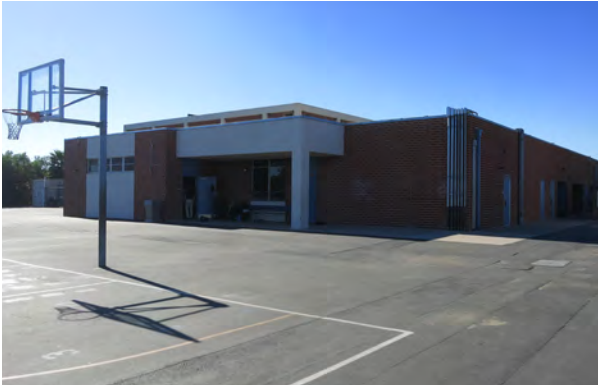
- The exterior finish is mainly brick with some areas of plaster. Overall, the exterior walls appear to be in good to fair condition with some areas of staining from removed graffiti. M&O has reported areas of cracking on the East and West sides.

Exterior elevation of Bldg. J towards hardcourts.

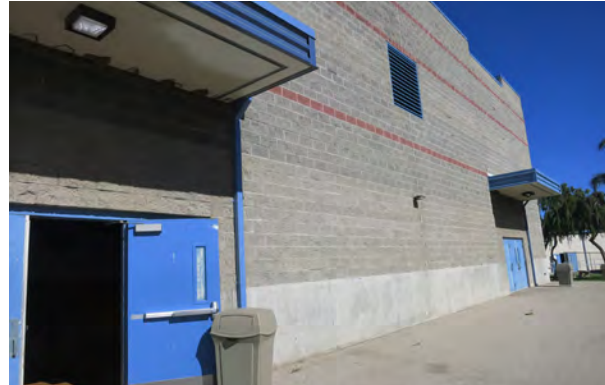
Exterior elevation of Bldg. J1.

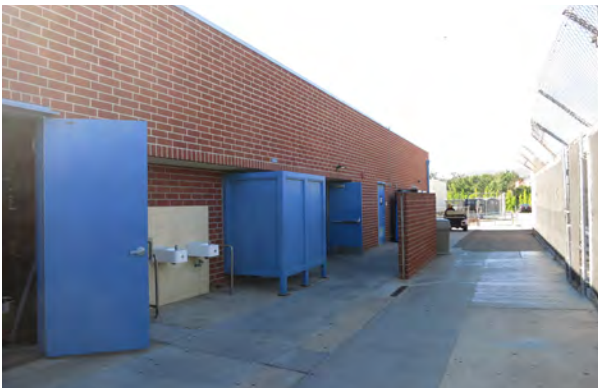
Entry to locker rooms in Bldg. J.

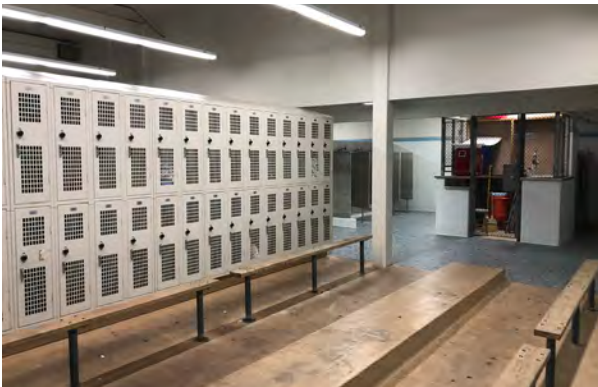
- Locker room finishes (sealed concrete flooring, painted gypsum, brick walls, ceramic tiles at showers and restrooms) are in poor condition. Lockers are in good condition. Benches are worn and aged. Rubber wall base is in poor condition.
- Wood sports floor at gym is original and well maintained. Classroom wood flooring appears original, but maintained.
- Acoustical ceiling system and tiles in Classrooms and various vestibules are in poor condition. Ceilings are mostly acoustical metal deck with perforated metal panel.

Typical Locker Room in Bldg. J.

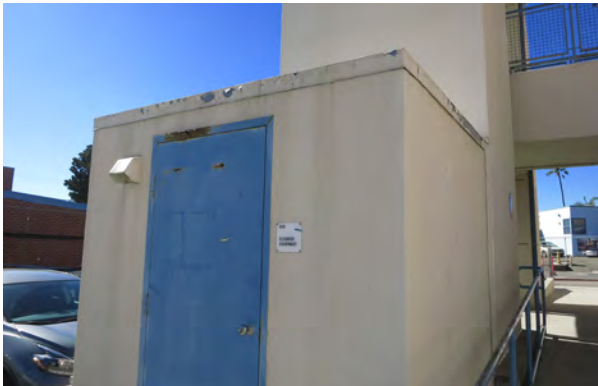
Elevator and machine room.

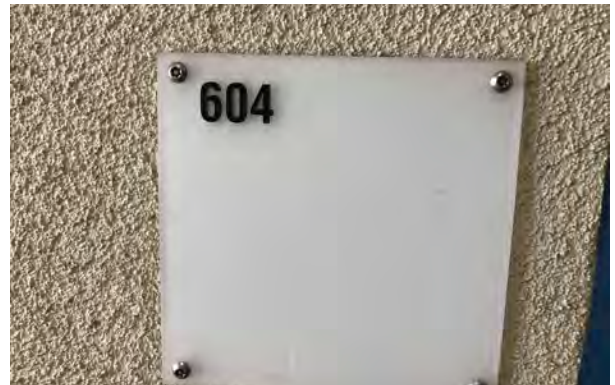
Typical signage.

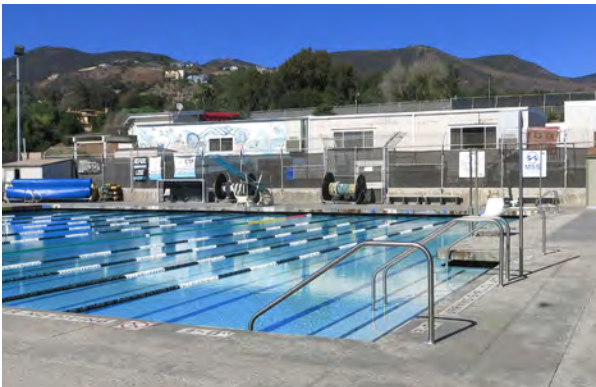
- Pool Overall Category Rating by M&O: [5]

Pool.

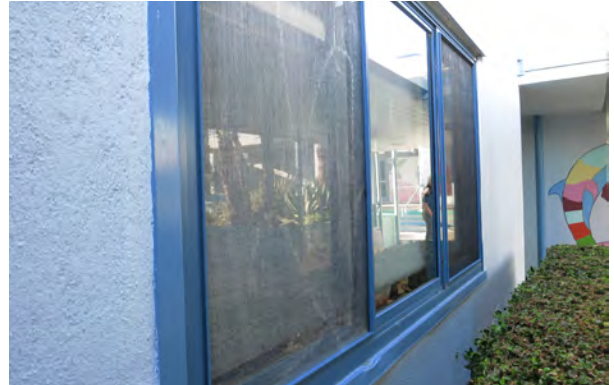
Typical glazing.

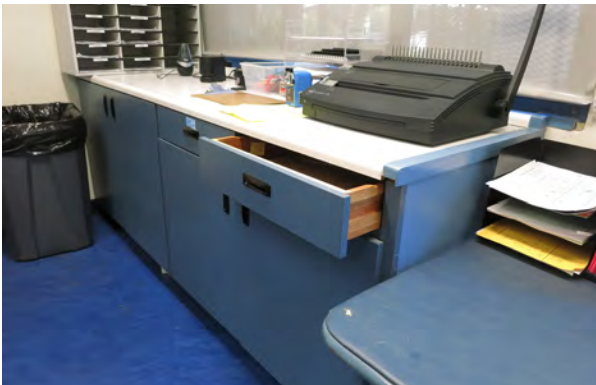
Typical refurbished casework.

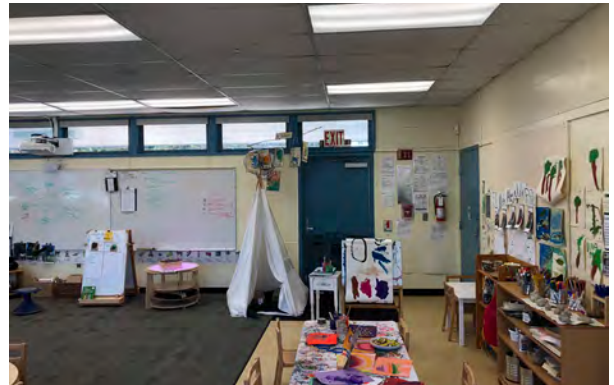
Typical Kindergarten Classroom.

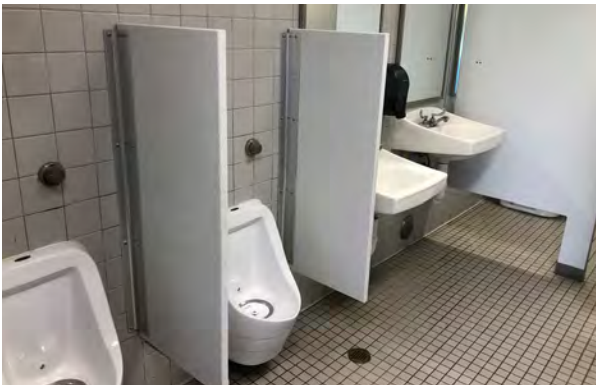
Typical student restrooms.

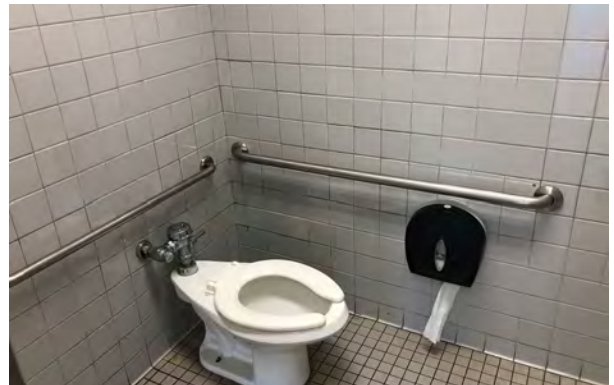
Typical Kindergarten restroom.

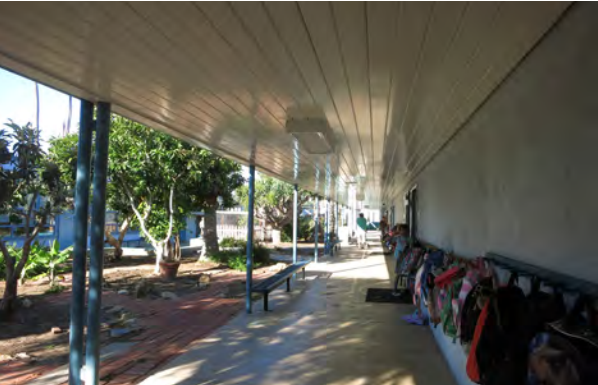
Exterior elevation along covered walkway.

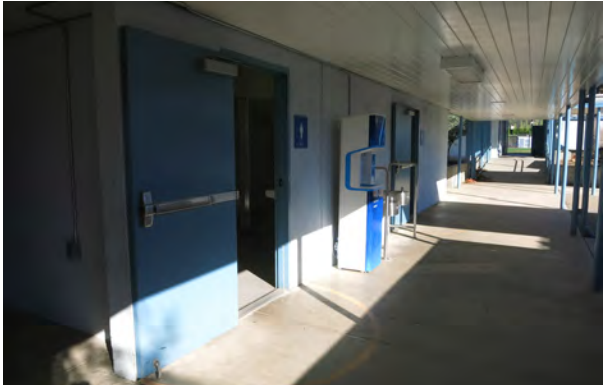
End of building elevation; entry to restrooms.

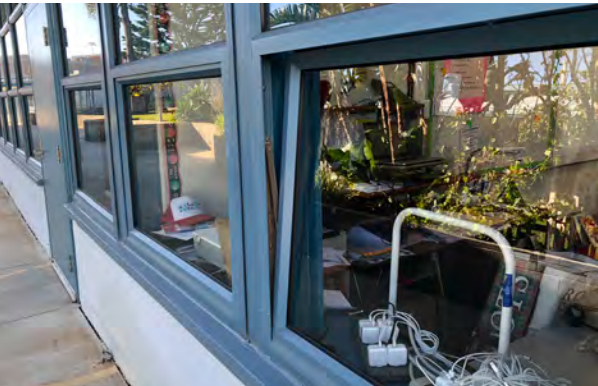
Typical storefront and operable glazing.

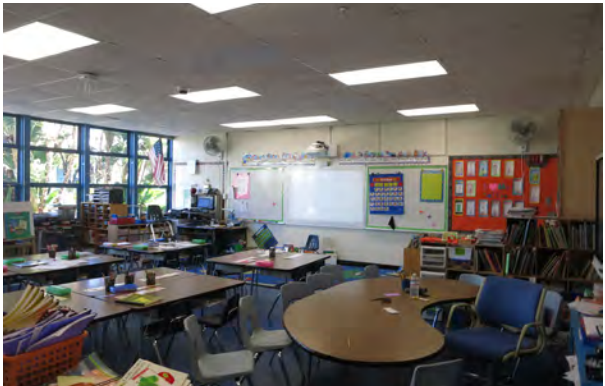
Typical classroom.

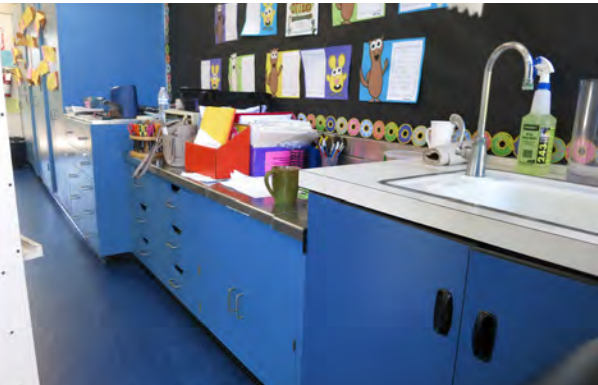
Typical casework in classroom.

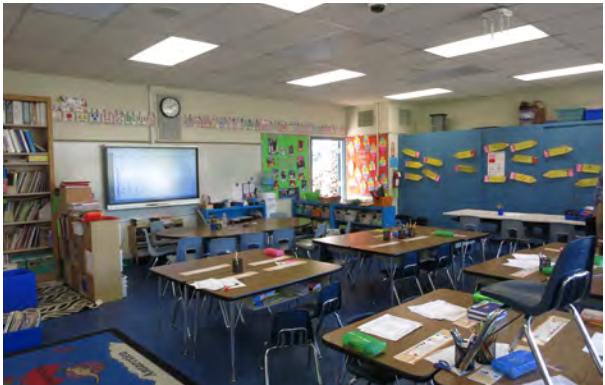
Typical classroom.

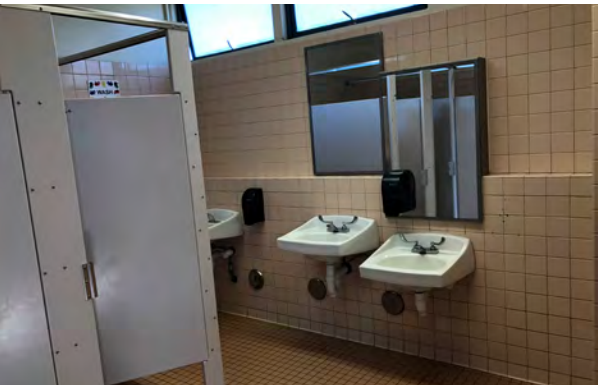
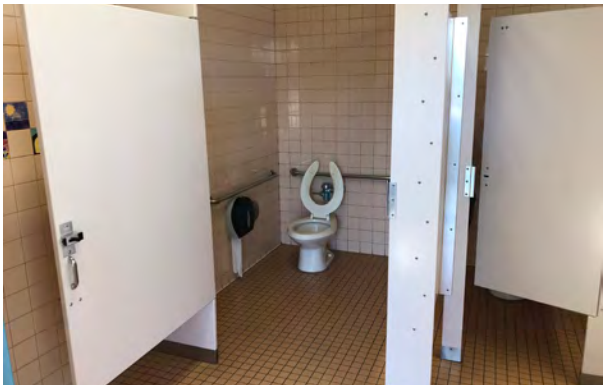
Typical Restroom - girls.

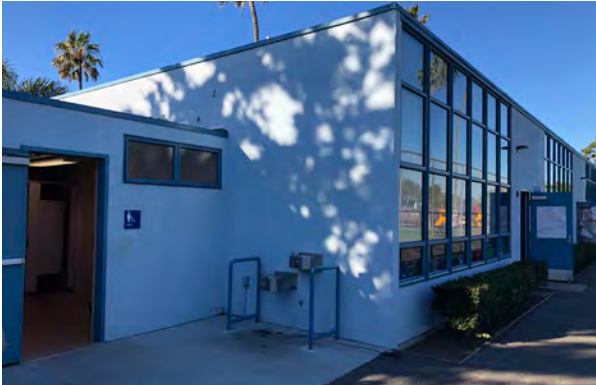
North elevation at restrooms.

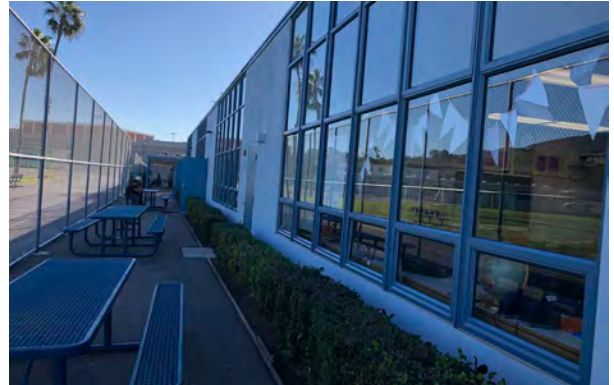
North elevation with typical window system.

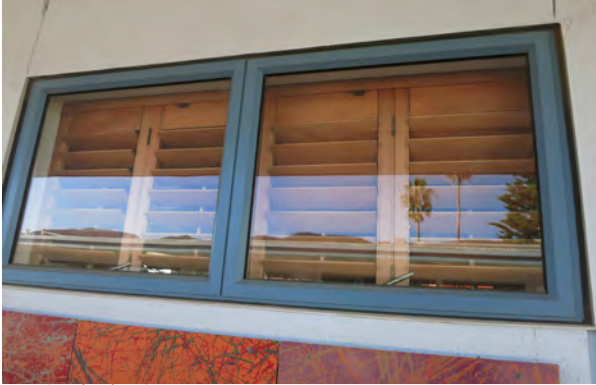
Typical glazing.

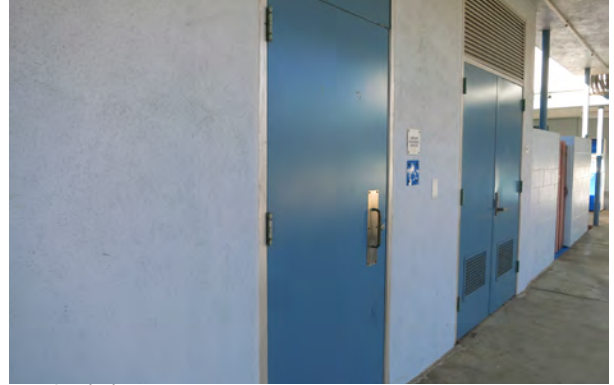
Typical doors.

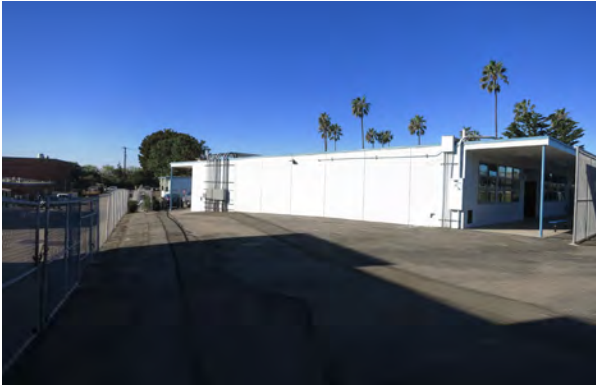
East exterior elevation.

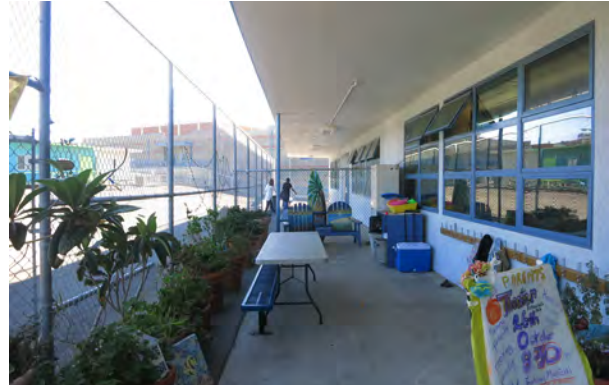
North exterior elevation.

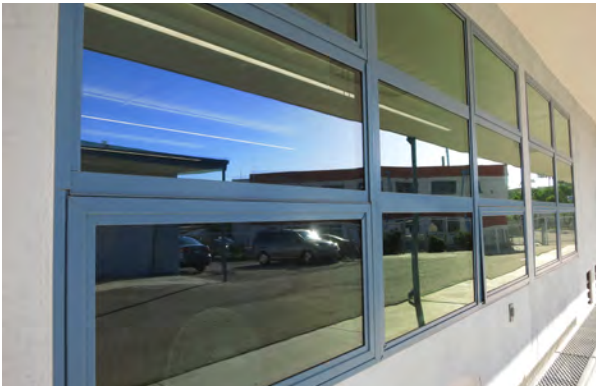
Typical storefront window system.

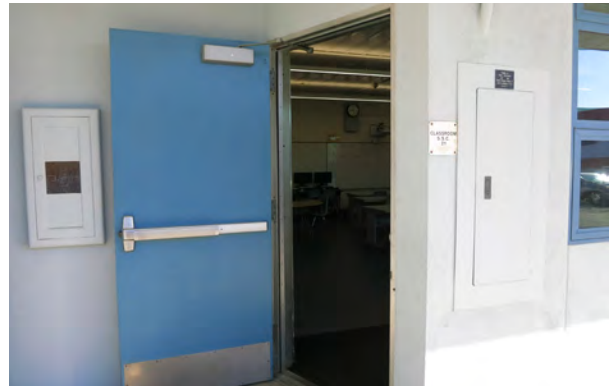
Typical door.

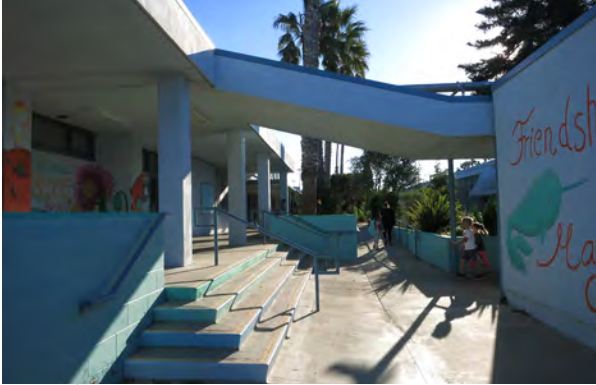
Entry into MPR.

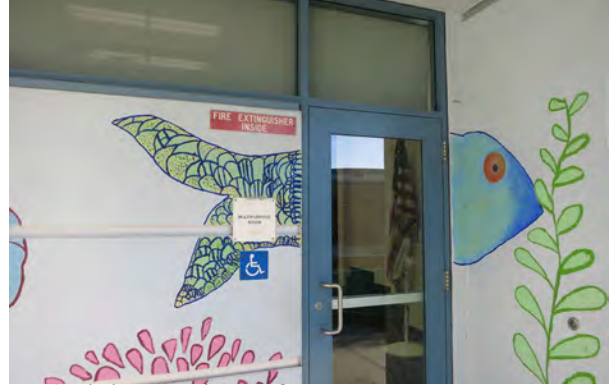
- Exterior is typically aluminum storefront system for doors and windows. These are in good condition.
- Interior wood doors and hollow metal frames are in good condition.

Typical door and storefront system.

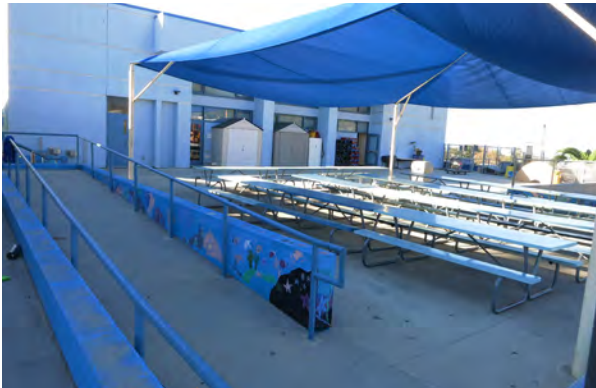
Outdoor eating/ lunch area.

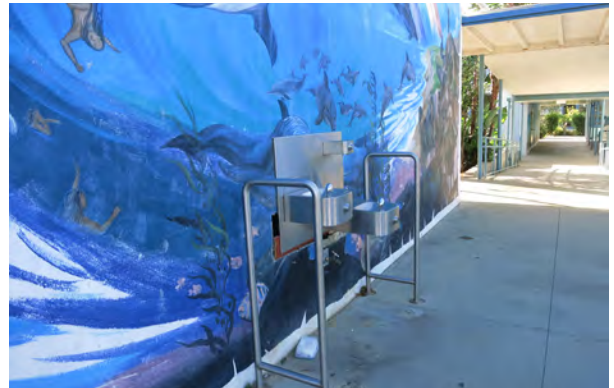
Drinking fountain.

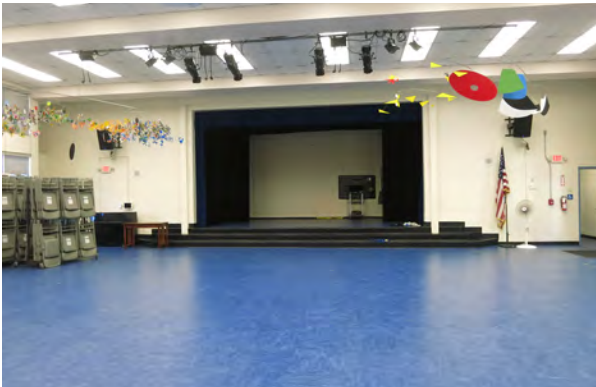
- Interior resilient floor finish (in MPR, Stage and Kitchen) is in general in good condition. Rubber at stage steps is uplifting.
- Interior gypsum board painted walls are in acceptable condition.
- Rubber wall base is in good condition.
- Acoustical ceiling system is in fair condition with areas that appear to be sagging.
- Casework is original wood type, and appears to be in fair condition. Lunch table and benches fold into wall pockets.

Multipurpose Room and stage.

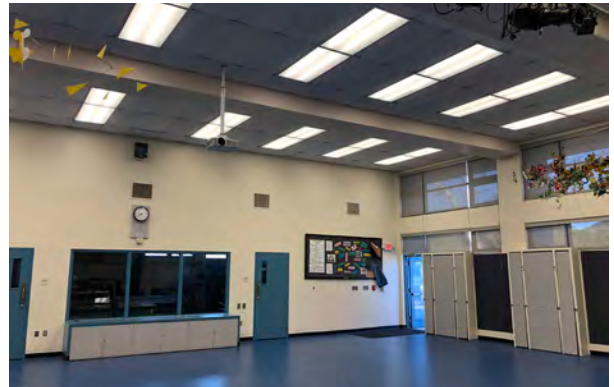
Multipurpose room.

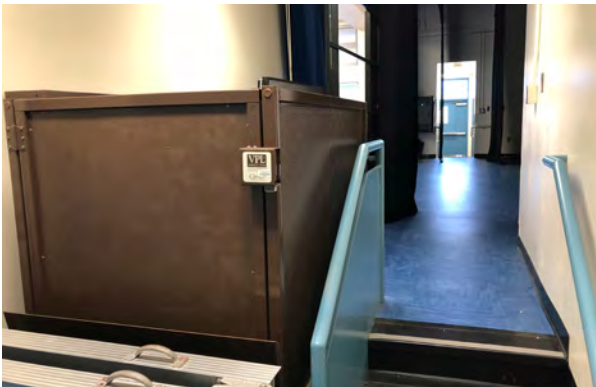
- ADA compliant door hardware.
- Door thresholds appear to be compliant.
- Signage appears to be compliant; but many are worn.
- There is an ADA lift to the stage.
- A more detailed assessment and survey will need to be performed as projects come online.

ADA lift at stage.

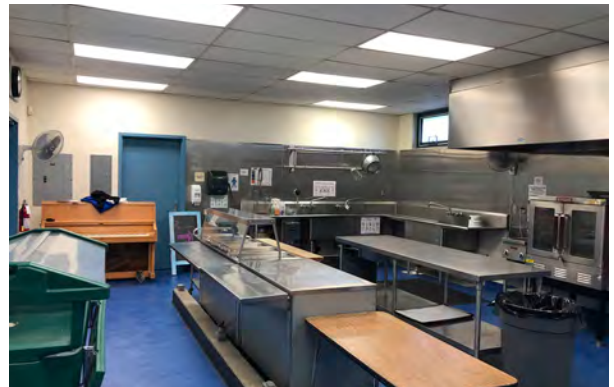
Food service/ kitchen.

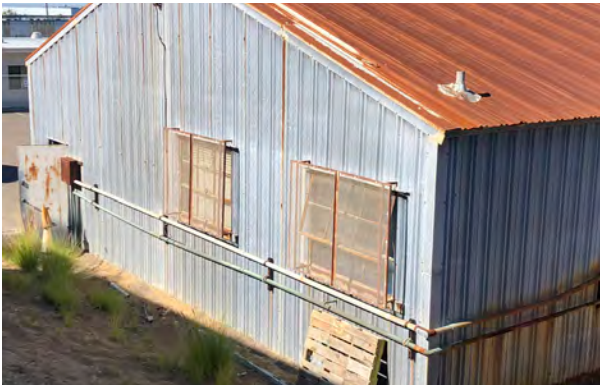
Bus depot.

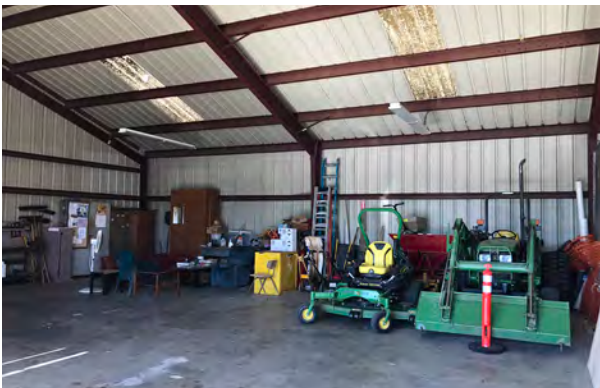
M&O Storage.

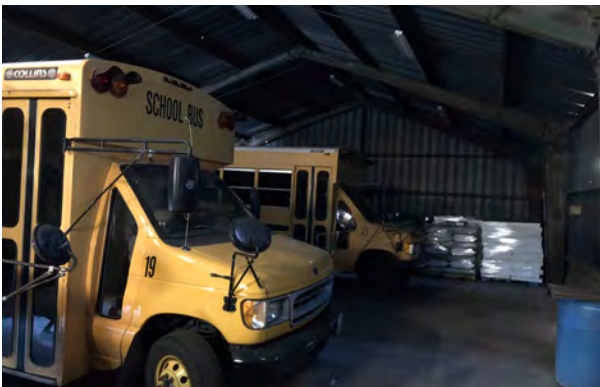
Bus depot.

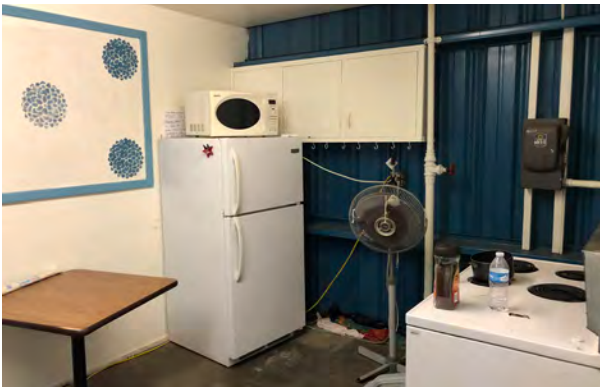
Transportation/ M&O staff lounge.
