**Santa Monica-Malibu
Unified School District**
John Muir - SMASH Elementary School

Findings Report
Building Envelope Investigation

April 05 – 06, 2022

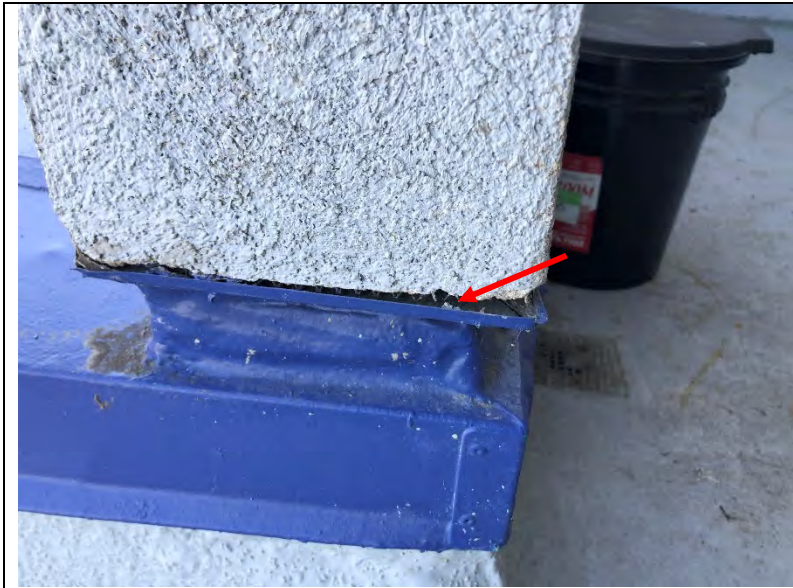
The buildings are in heavy use by the student body and show much of the wear and tear associated with school campuses with young students. Impact and abrasion damage was present in the lower areas of the walls and was more prevalent at corners and entry points (**Photos 01 – 05**).

Photo 05:
Abrasion and impact damage at the bottom of a plastered column.

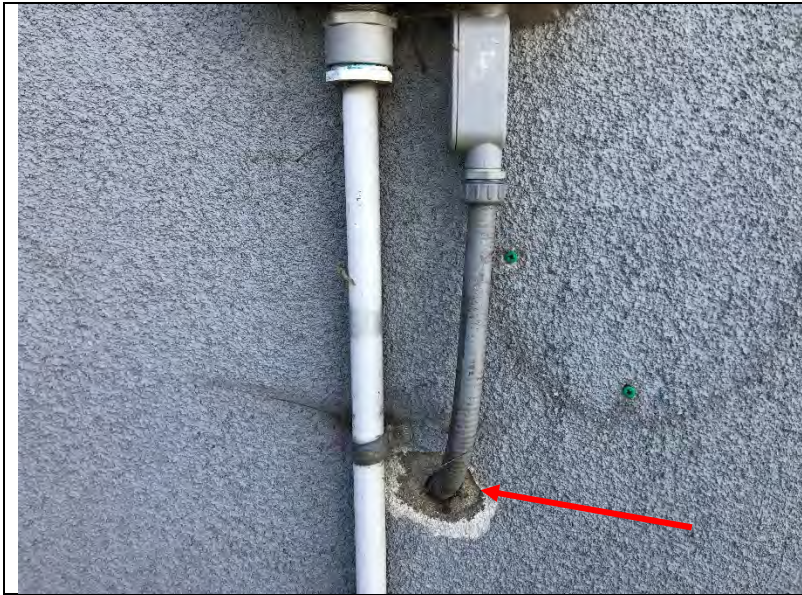
Photo 08:

Penetrations in the cement plaster assembly with no visible sealant.

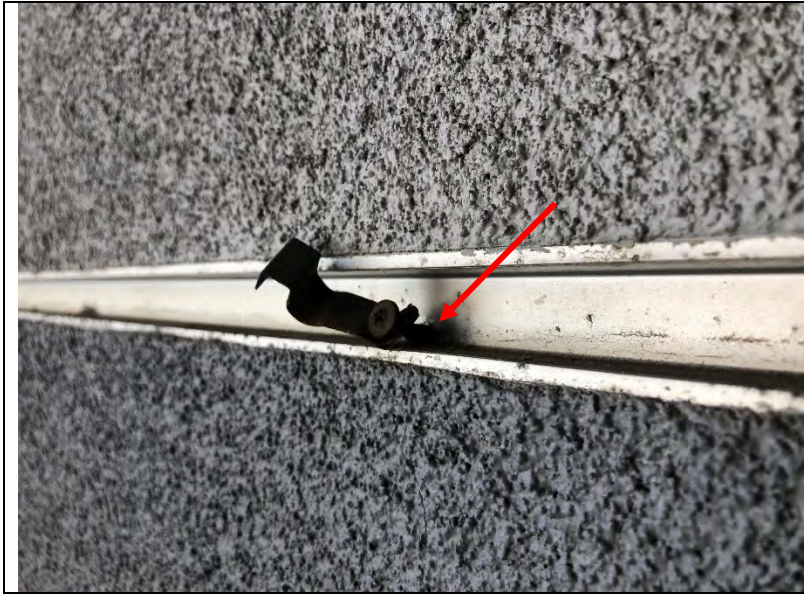
Photo 09:
An un-sealed penetration in a cement plaster control joint.

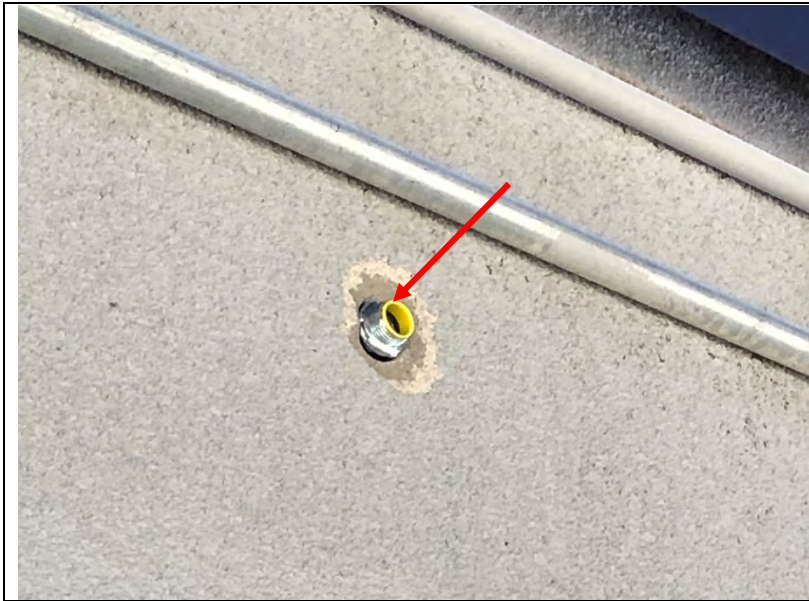
Photo 10:
An open penetration in the cement plaster assembly with no visible sealant.

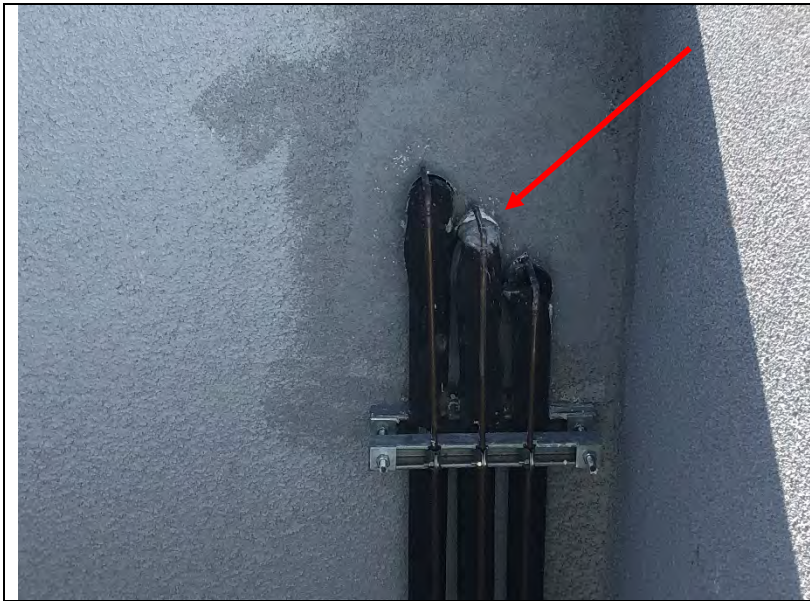
Photo 11:

Penetrations in the cement plaster assembly.

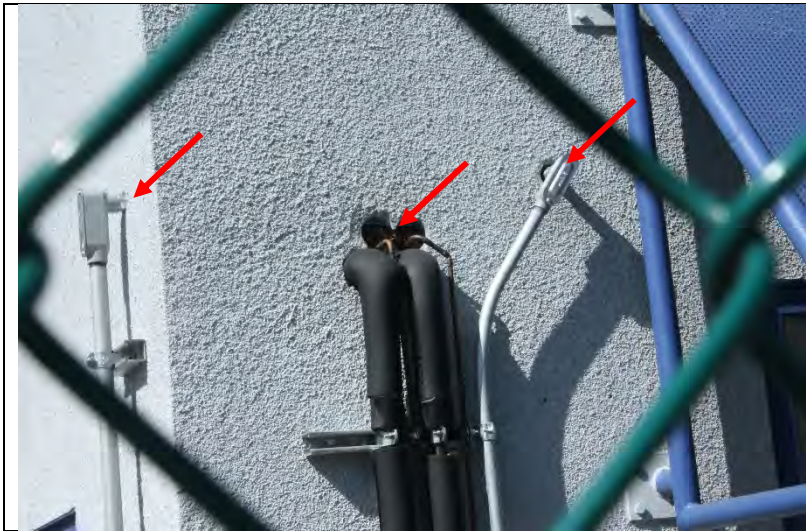
Photo 12:

Penetrations in the cement plaster assembly with no visible sealant.

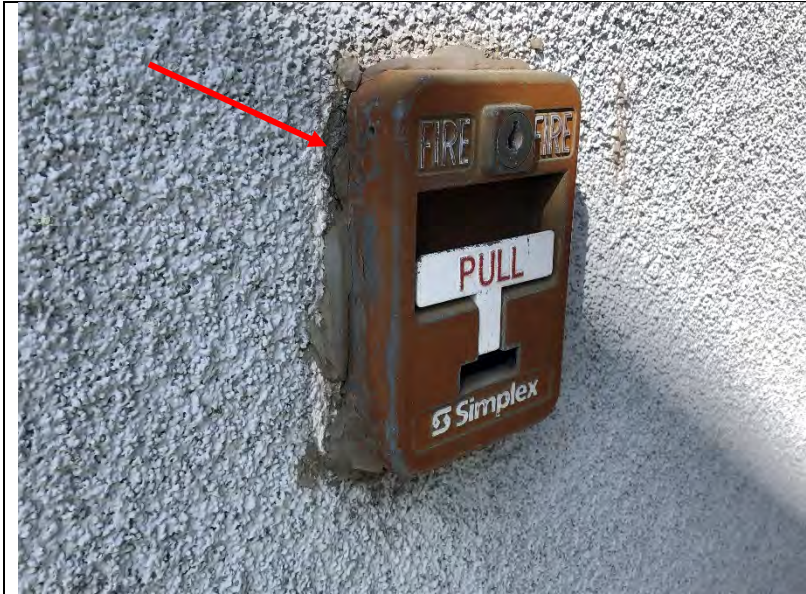
The exterior walls have numerous penetrations including electrical conduits, canopy mounting brackets, and HVAC and plumbing pipes. Many of the penetrations were not part of the original construction. In some locations (e.g. fire pull stations) sealant had been added to the perimeter of the penetrations. It is unclear if the sealant was applied due to water leaks or to aesthetically close the openings around the penetrations. In other locations, penetrations appeared to have been abandoned and not properly sealed (**Photos 06 – 15**). Some of the penetrations in the cement plaster assembly have been made for mounting items on the walls including hook and eyelet anchors, drywall fastener attachments, and coat racks attached to the walls with screws. Some of the penetrations appear to be part of the installation of new HVAC equipment and had not been connected to any equipment at the time of DTR's observations (**Photos 16 – 24**).

Photo 13:
A fire alarm pull penetration in the cement plaster assembly with a failed sealant application.

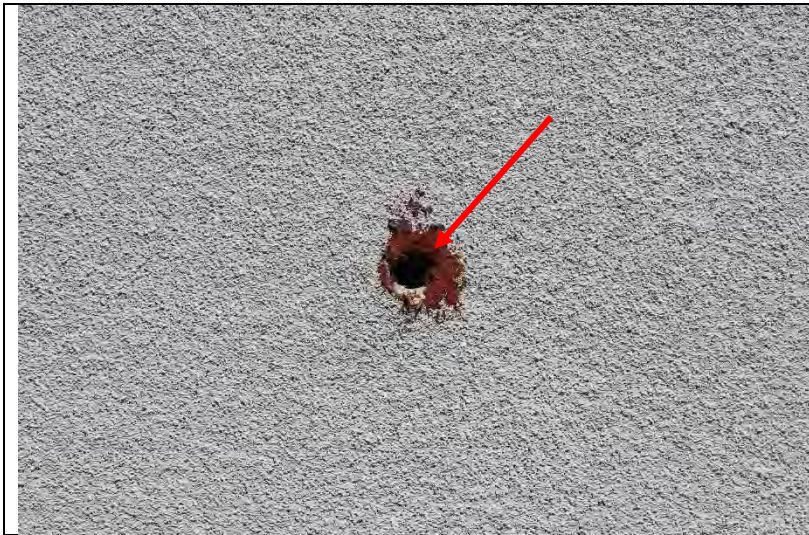
Photo 16:
An abandoned penetration in the cement plaster assembly with what appears to be fire caulk (rather than a weather sealant) applied.

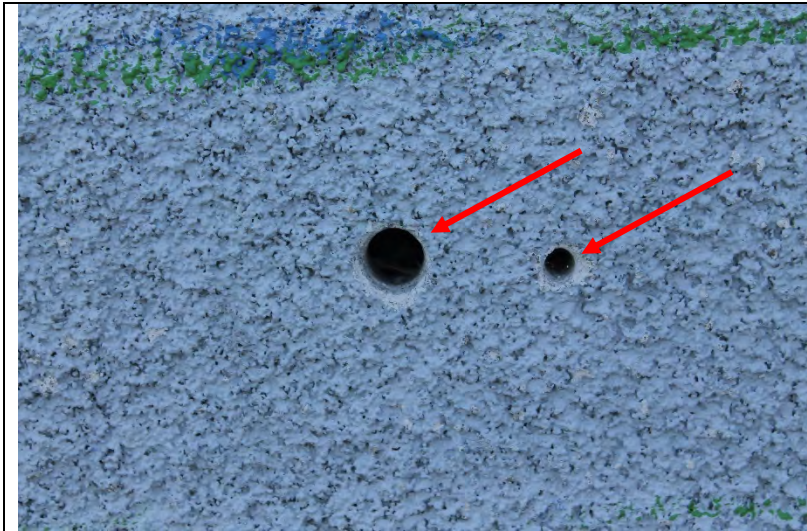
Photo 17:
Abandoned penetrations in the cement plaster assembly

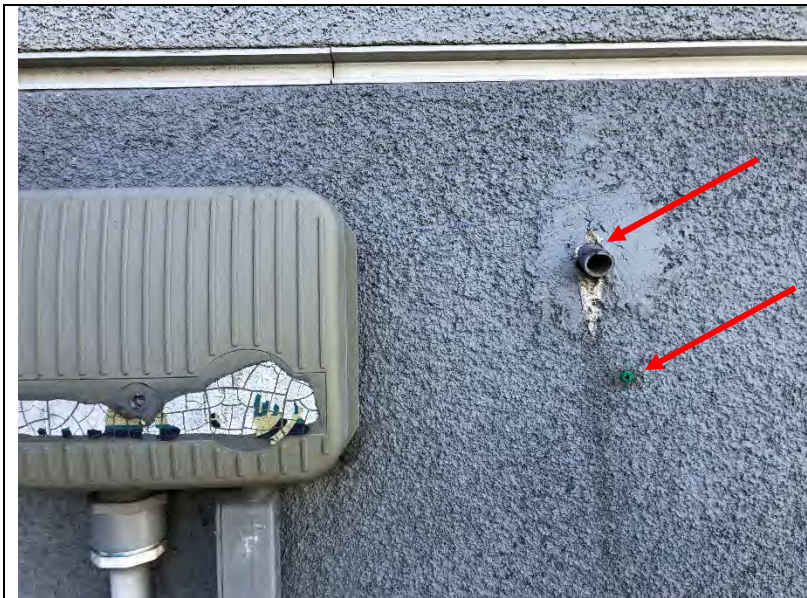
Photo 18:
An abandoned penetration in the cement plaster assembly

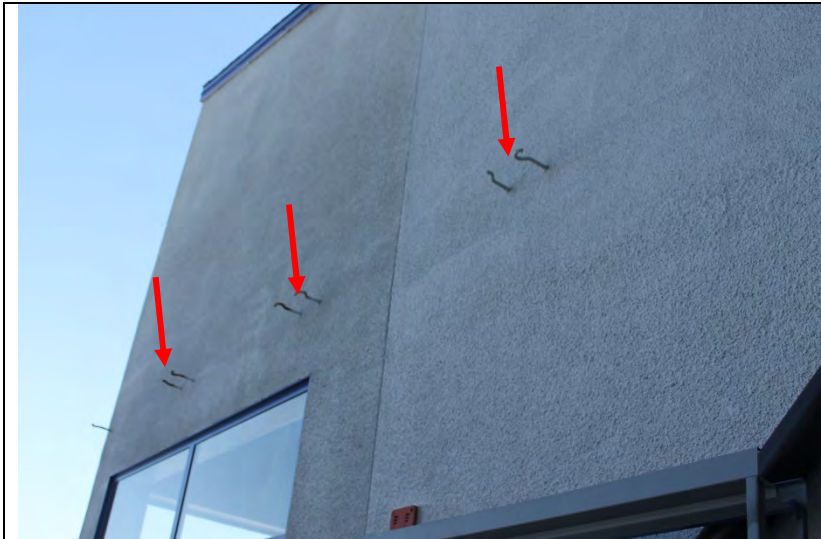
Photo 21:
Hook anchor penetration in the
cement plaster assembly

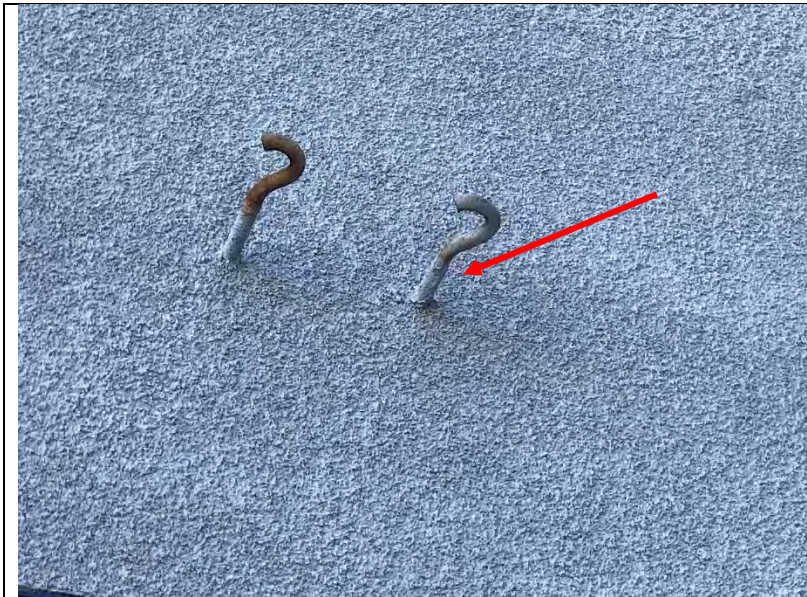
Photo 22:
Hook anchor penetration in the
cement plaster assembly

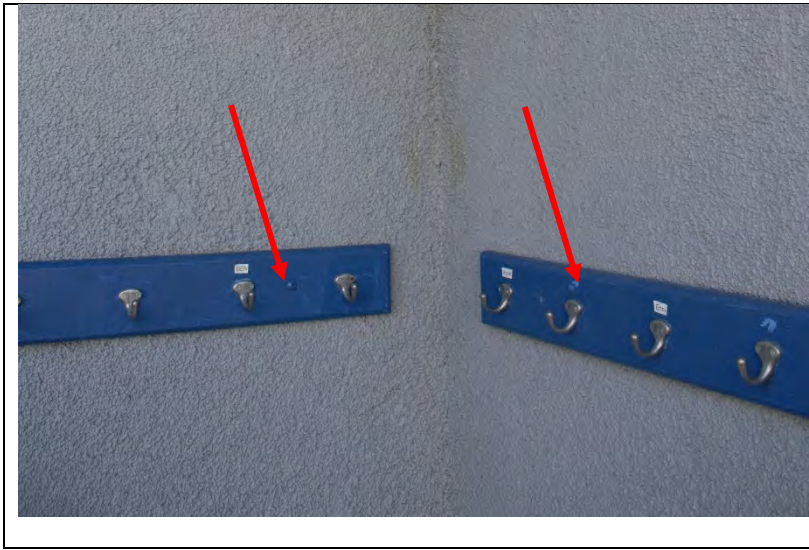
Photo 24:

Coat racks were mounted to the cement plaster walls.

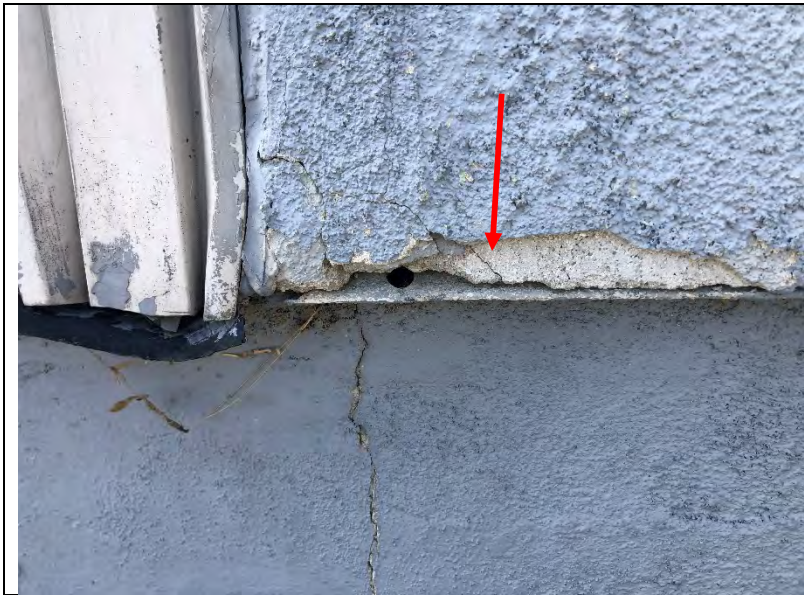
Photo 25:

Cracks, spalling, and chipping were observed in several locations. While deficiencies were observed on every elevation, they were more prevalent along the metal control joint trim, at the base of the walls, and at other transitions (**Photos 25 – 31**).

Deficiencies in the cement plaster were observed at the base of the walls

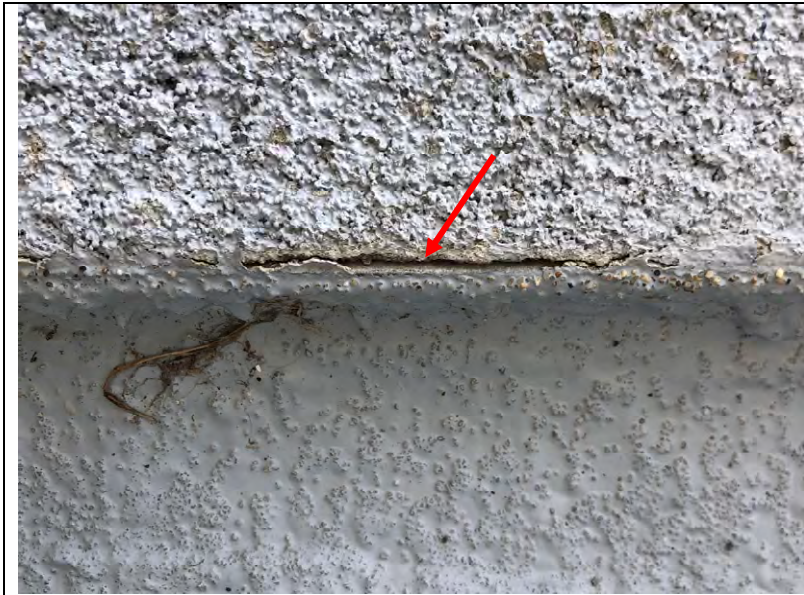
Photo 26:

Deficiencies in the cement plaster were observed at the base of the walls

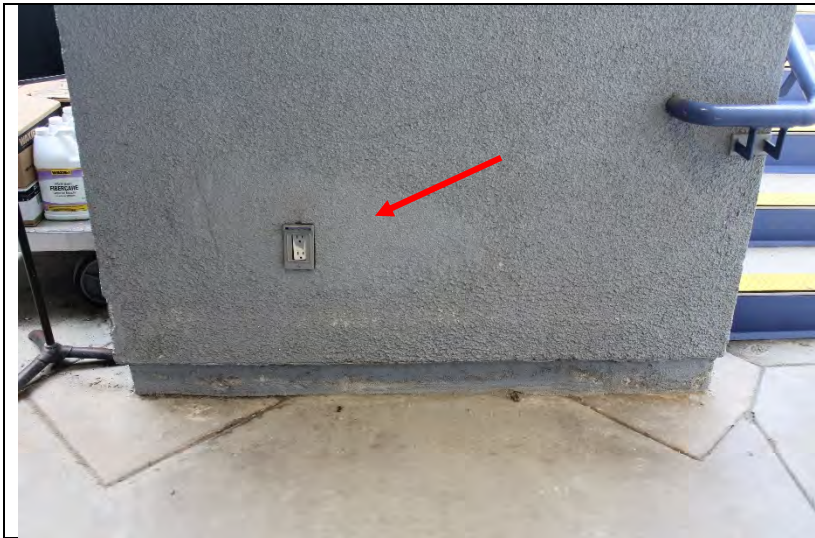
In several locations, new paint had been applied over the cement plaster. The new application of paint did not match the old finish in color or texture. It was unclear if this was done to cover previously repaired damage, to cover graffiti, or for other reasons (**Photo 32 – 36**).

Photo 33:
New paint had been applied over repairs to the cement plaster

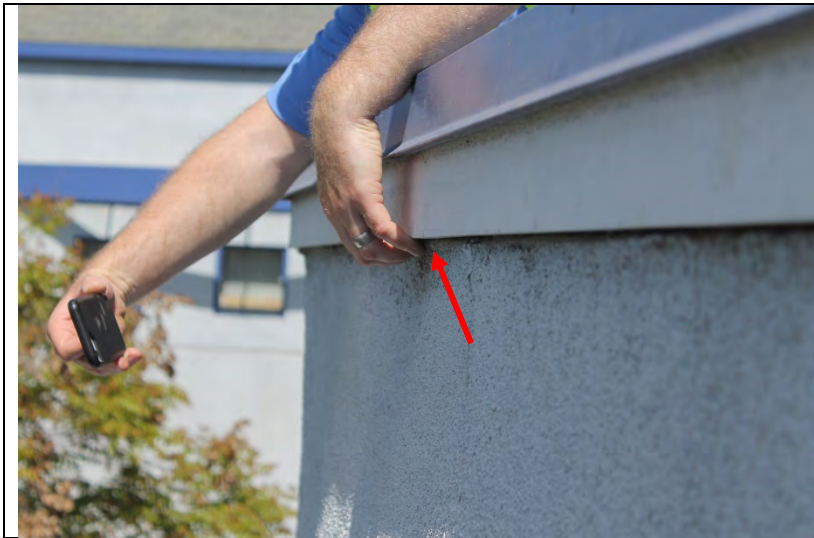
DTR observed openings along the juncture of cement plaster and roof edge and at the juncture of cement plaster and structural elements. Openings were also observed at expansion joints between buildings and between the raised walkways and the buildings. At some locations, the foam joint covers were loose or had fallen out (**Photo 37 – 40**).

Photo 37:
An opening between metal flashing and the top of the cement plaster assembly.

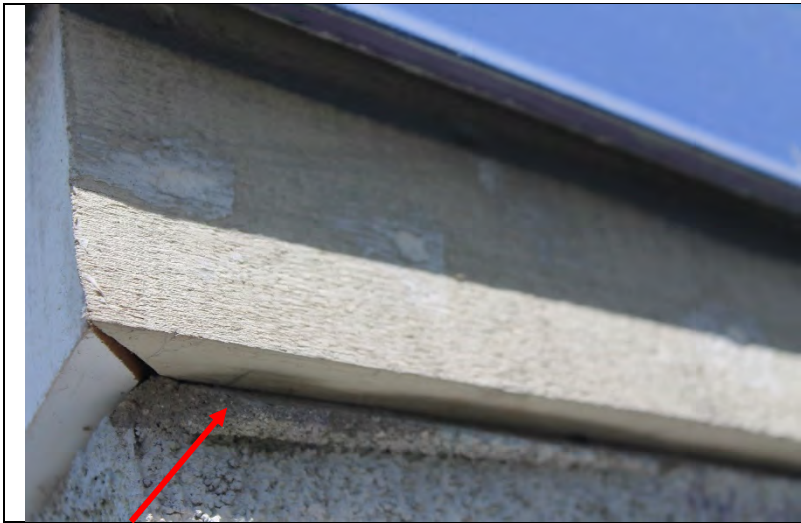
Photo 38:
An opening at the top of the cement plaster assembly.

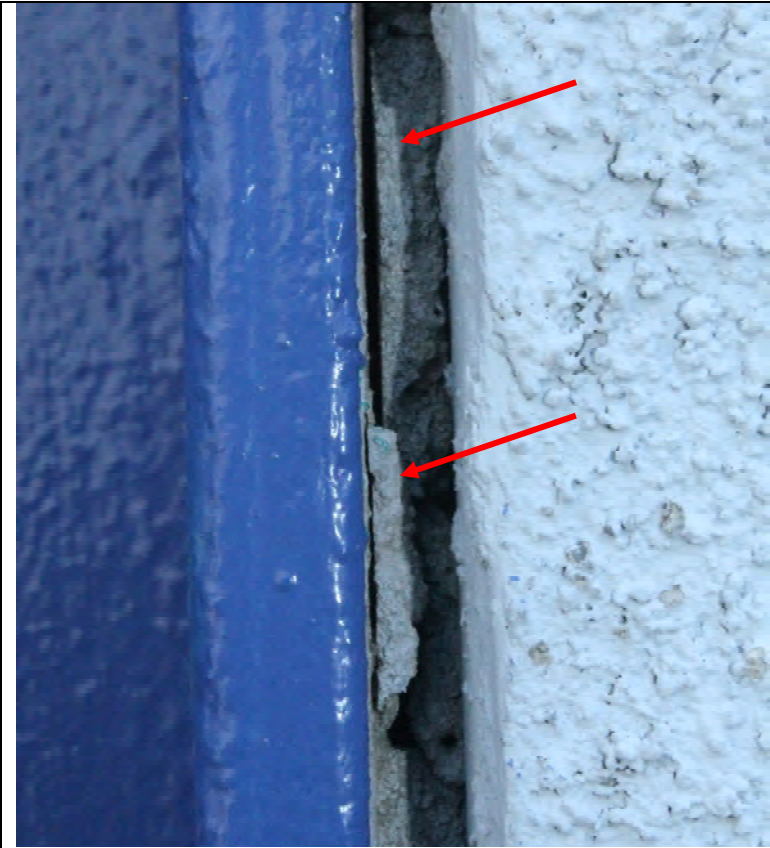
Photo 43:
An un-sealed opening in the cladding system where the cement plaster assembly intersects a structural beam.

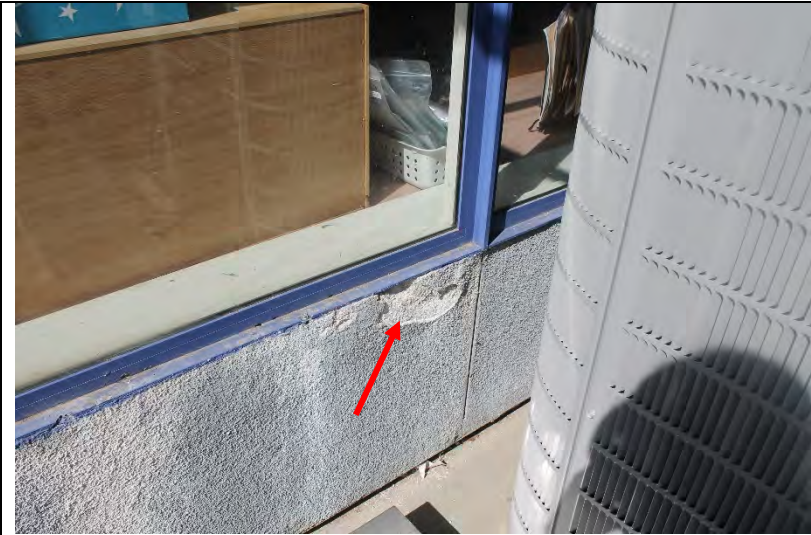
Photo 44:
What appears to be salt corrosion of the cement plaster cladding under a window frame on the east side of building D.

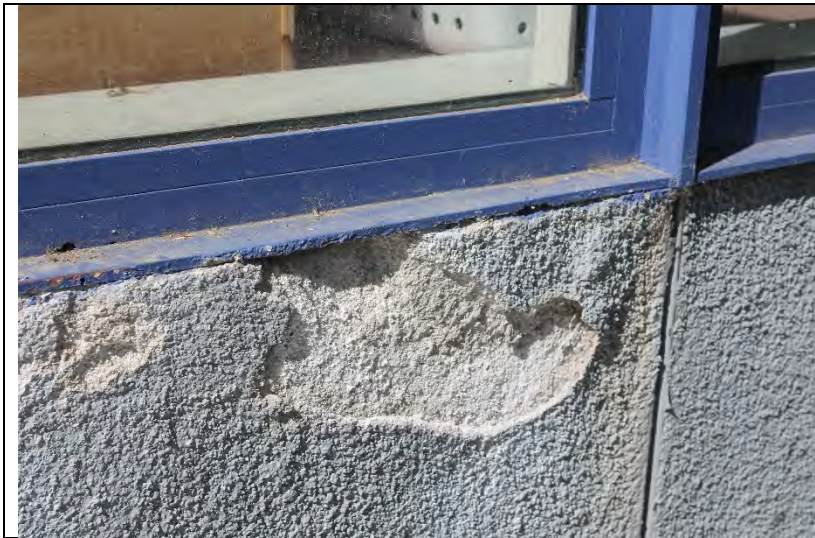
Photo 45:
What appears to be salt corrosion of the cement plaster cladding under a window frame on the east side of building D.

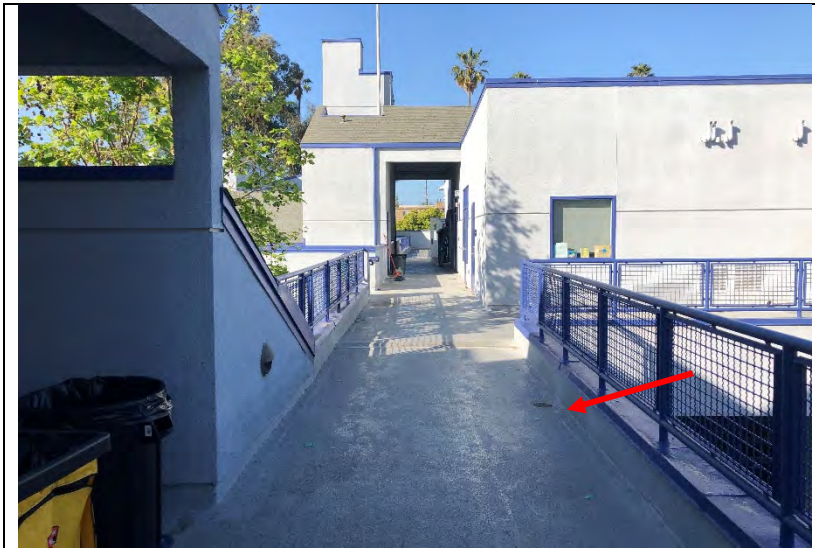
Many of the elevated pedestrian walkways and exterior stairs were built as part of the 2001 modernization project. Approximately 5 years ago, the elevated walkways were resurfaced with a Tremco traffic coating with embedded granules. The traffic coating was flashed up onto the walls below the cement plaster. Nearly all of the plaster system base of wall drainage system weep screeds were blocked or obstructed by the coating directing water behind the traffic coating upturn and into the wall system (**Photos 46 – 49**).

Photo 46:
Overview of the traffic coating on an elevated walkway.

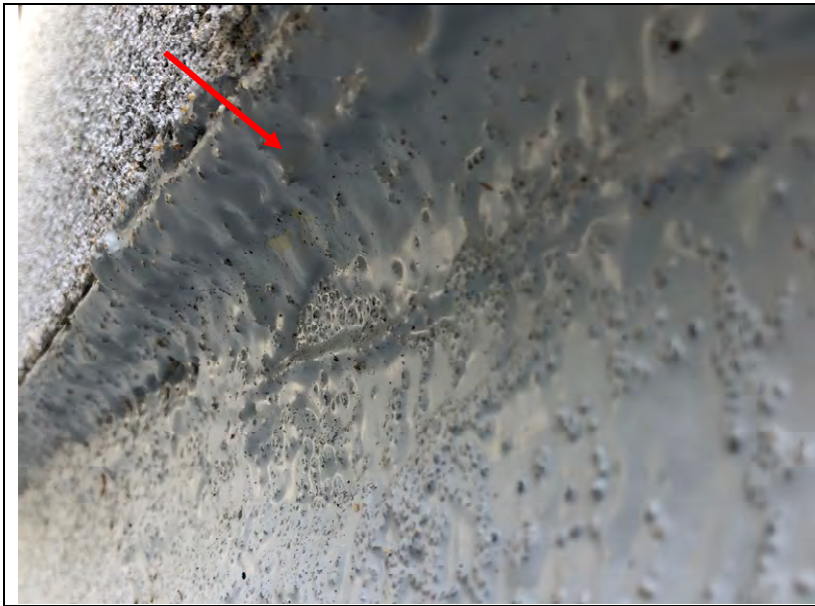
Photo 49:
The traffic coating lapped up onto the weep screed. No weep holes were visible at this location.

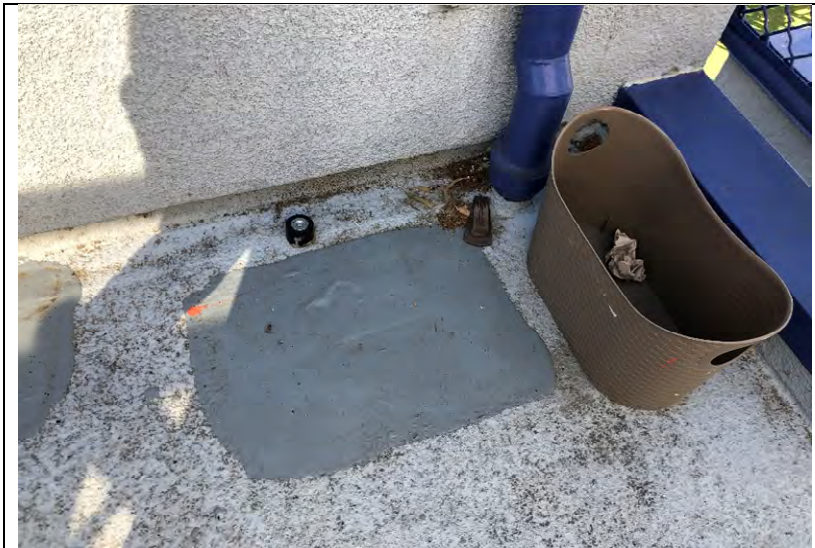
In general, the traffic coating is well adhered to the substrate and in good condition. Several patches were observed around the campus. Blistering and pinholes were observed at several of the traffic coating patches (**Photos 50 – 52**).

Photo 50:
A patch in the traffic coating.

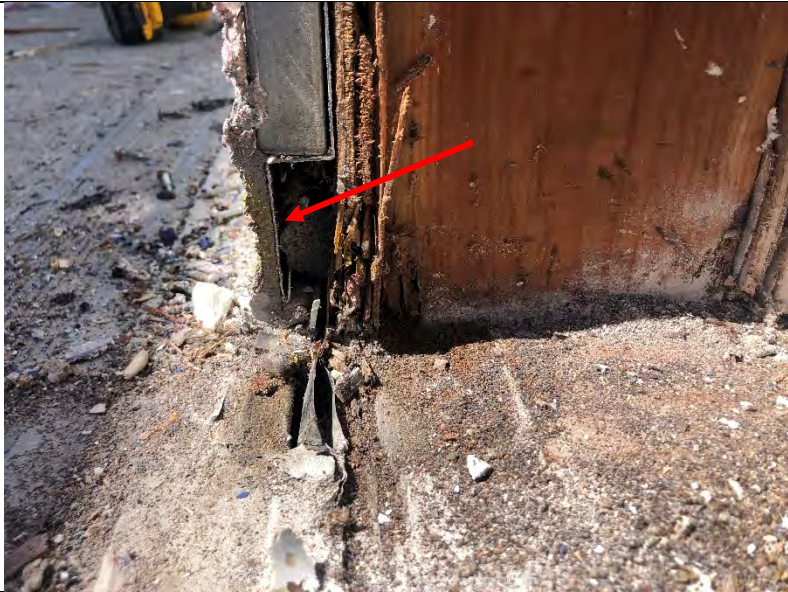
At the walkway outside classroom 480, the cement plaster did not have a visible weep screed. The traffic coating on the deck appeared to terminate flush with the cement plaster. After the hollow metal door frame had been removed at that location, DTR observed that a Z-flashing had been installed below the cement plaster. A backer rod had been placed behind the Z-flashing (**Photos 53 – 54**).

<p>Photo 54:</p> <p>Z-flashing had been installed below the cement plaster instead of a weep screed.</p>
--	---

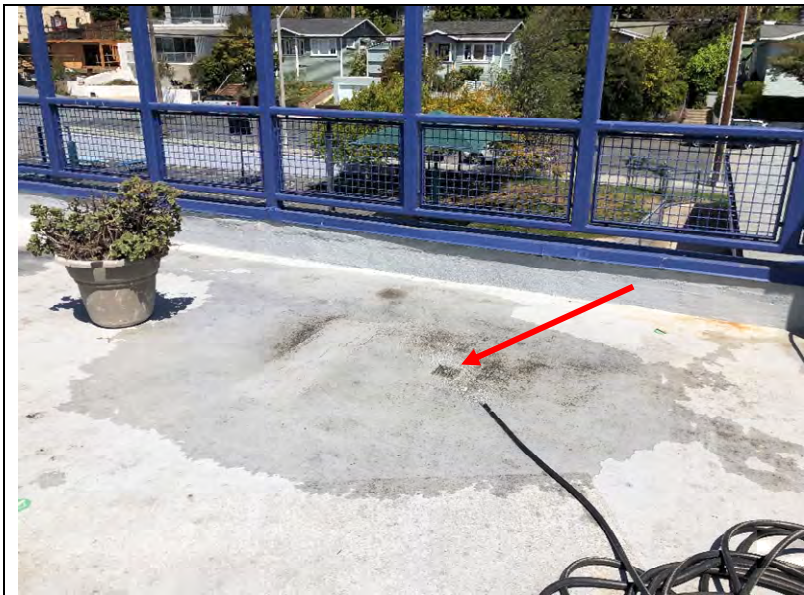
Per request of the school district, several of the surface drains were tested outside Classroom 555, on the walkway above Communications room 205, and Kindergarten Classroom 600. Staining was observed under several of the drain assemblies but DTR was not able to recreate a leak when the drains were flooded. In some locations, it appeared that new drain assemblies and plumbing had been installed. Above Kindergarten Classroom 600 there was evidence that the drains had been relocated at some point during the life of the building. Current drains appear to have a 2" opening while the pipes under the deck are larger. Various drain covers were used in different locations, some were round and some were square (**Photos 55 – 62**).

Photo 55:
Flood testing of a square traffic coating drain over Communications room 205.

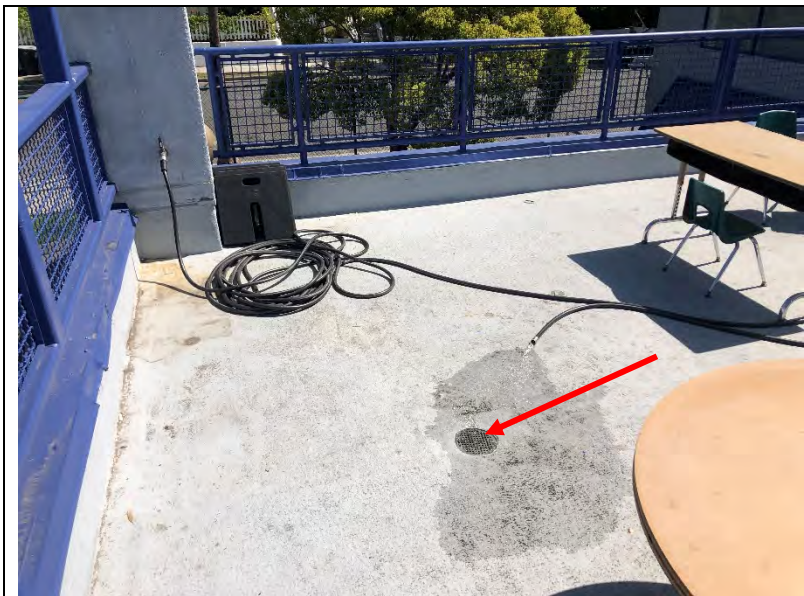
Photo 56:
Flood testing at a drain outside of classroom 555.

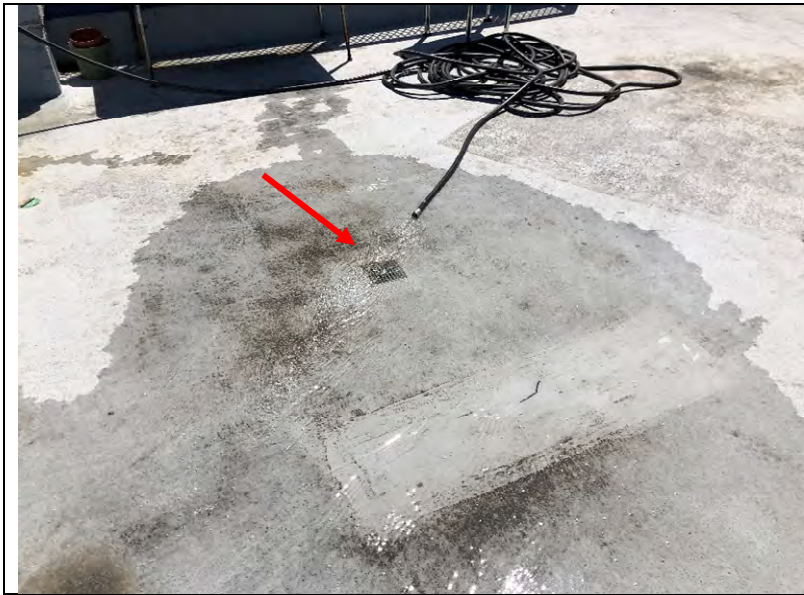
Photo 57:
Flood testing outside classroom 555.

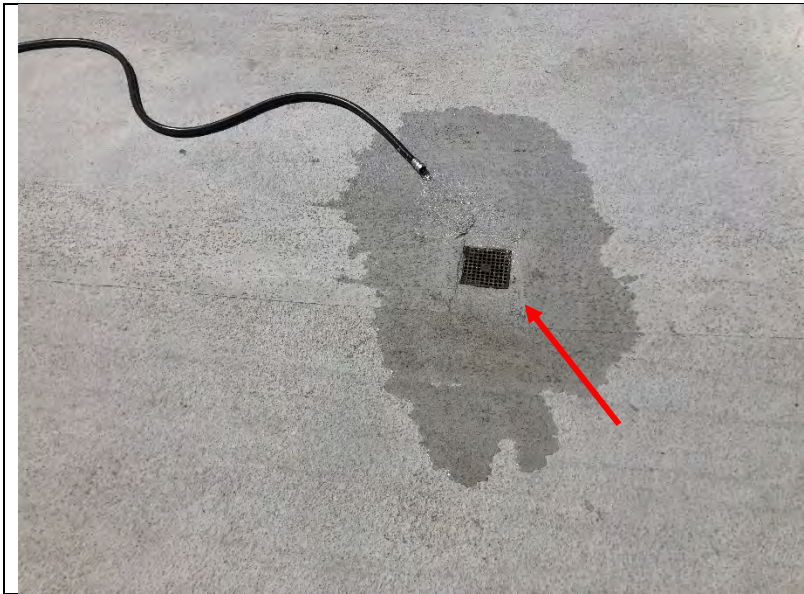
Photo 58:
Flood testing a drain on the elevated walkway.

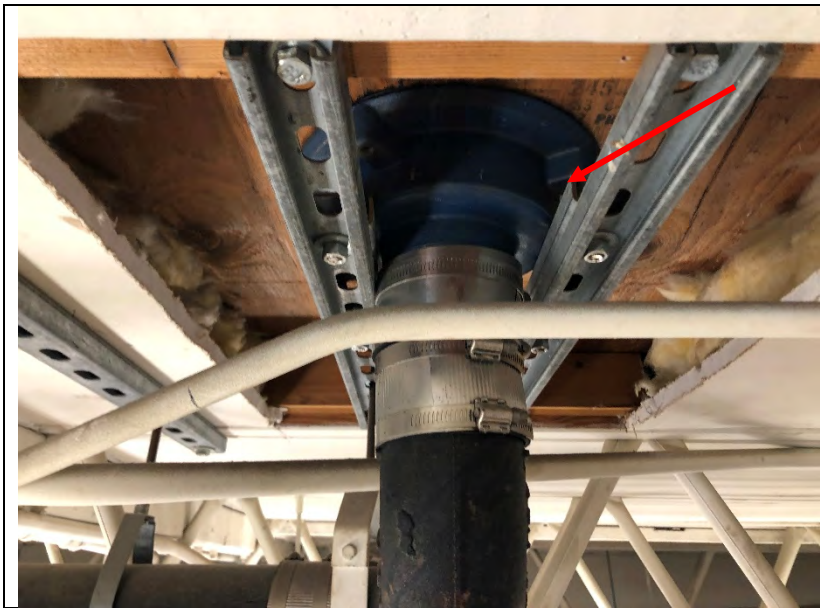
Photo 62:
A drain assembly was attached to the bottom of the deck with uni-strut. No anchor bolts were holding the assembly to the deck.

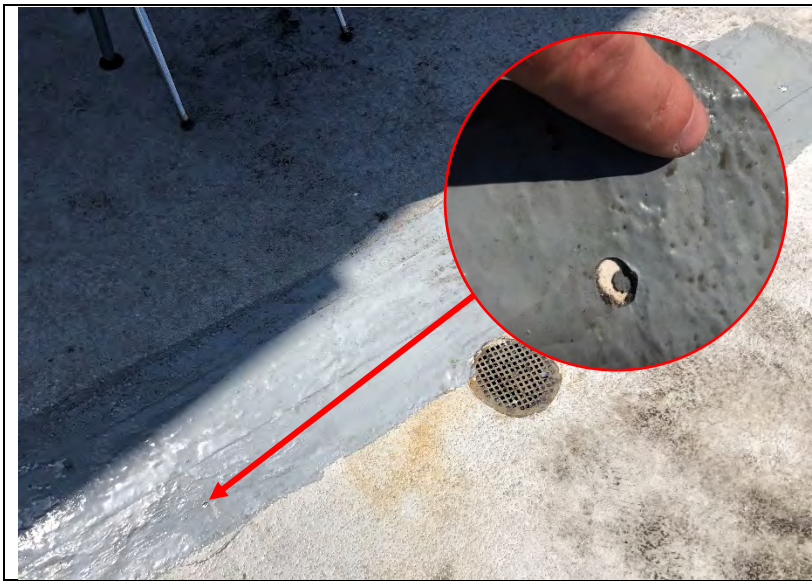
During the flood testing, one of the traffic coating patches outside classroom 555 became saturated. DTR observed that a deficient location on the surface of the patch was allowing water to enter under the waterproofing. No water was observed inside the building during the test (**Photos 63 – 64**).

Photo 63:
A failure in a traffic coating patch adjacent to a drain test.

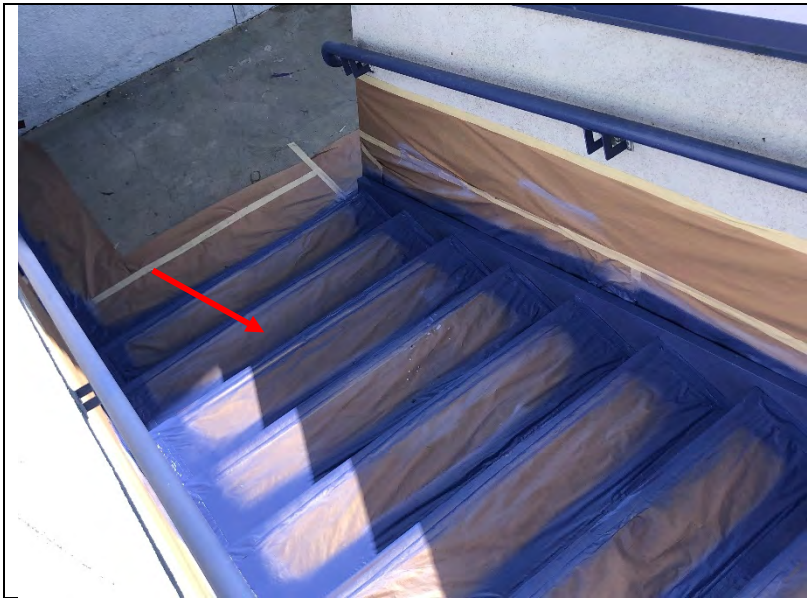
Photo 67:

The stairs were masked off during painting.

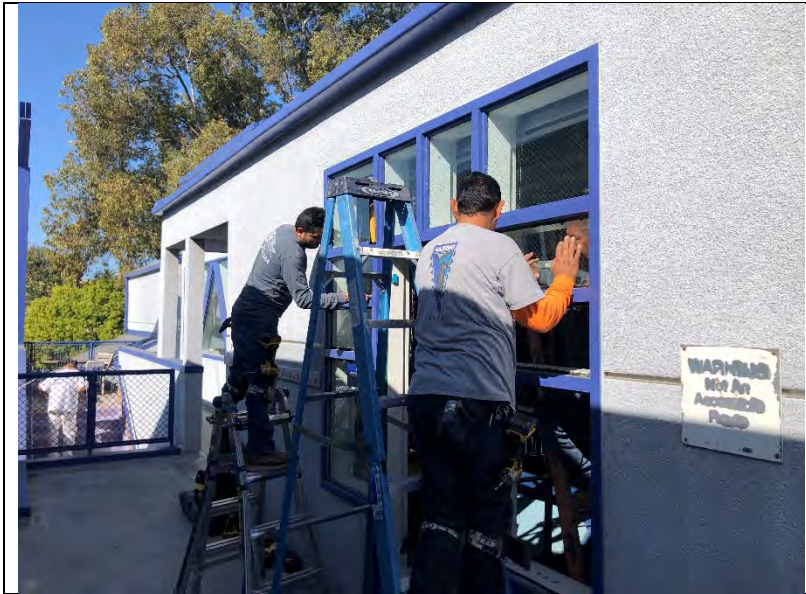
Photo 69:
The hollow metal frame was being removed at Classroom 480.

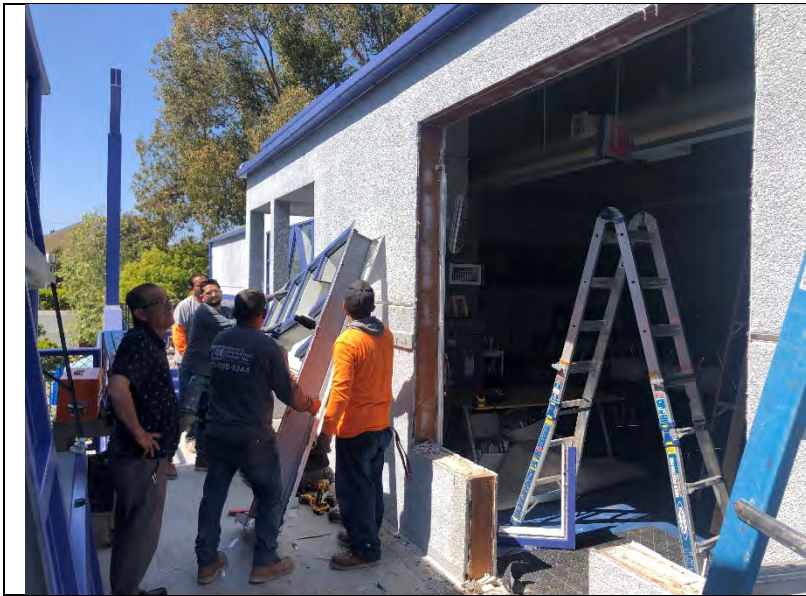
Photo 70:
The hollow metal frame after it was fully removed at classroom 480.

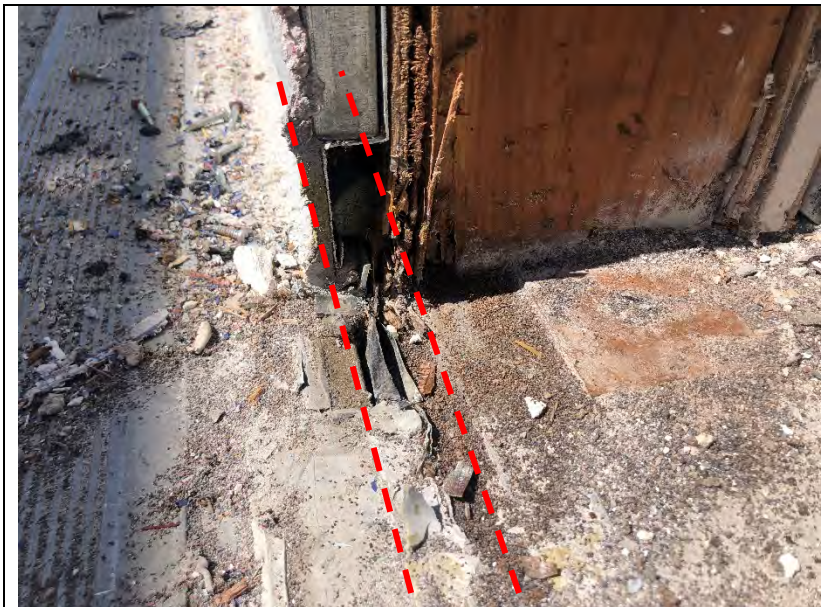
Photo 71:

The neoprene water stop at the expansion joint drainage was level with the interior of the cement plaster assembly.

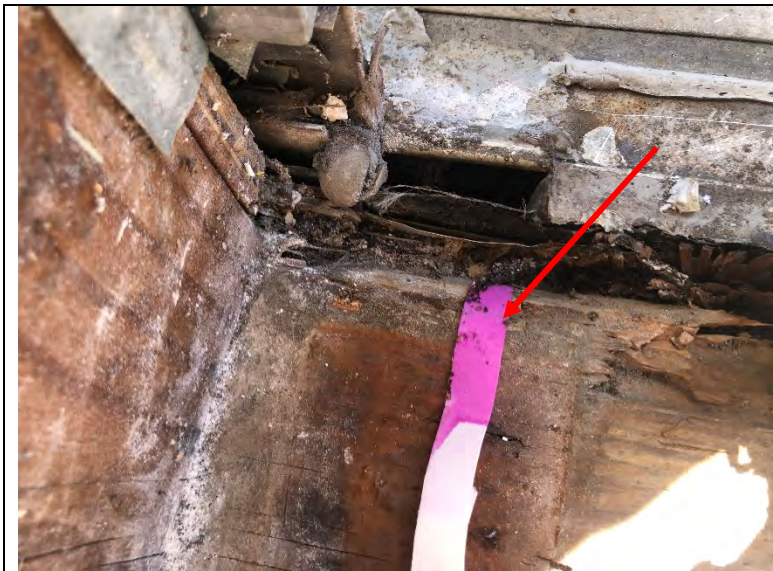
Photo 74:
A water activation strip shows a positive result for water at the deck to wall expansion joint at the threshold of classroom 480.

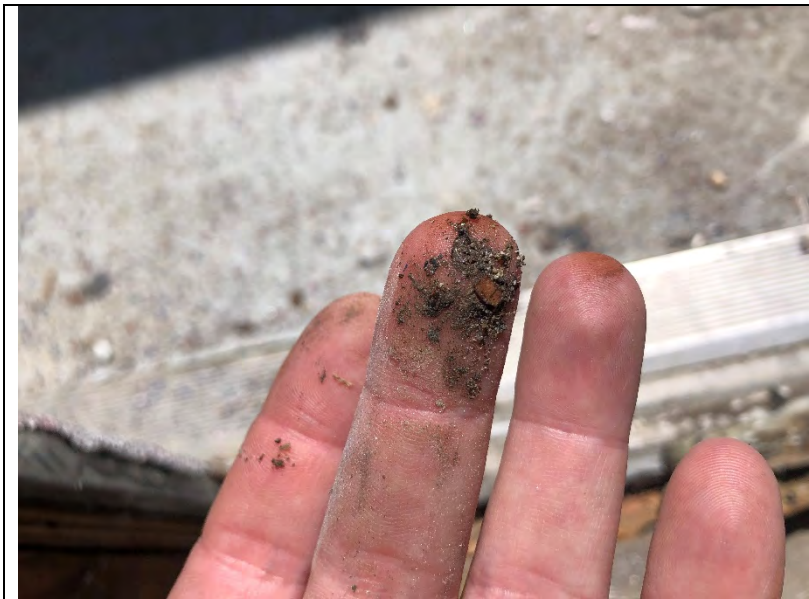
Photo 75:

Wood surfaces at the threshold were damp to the touch.

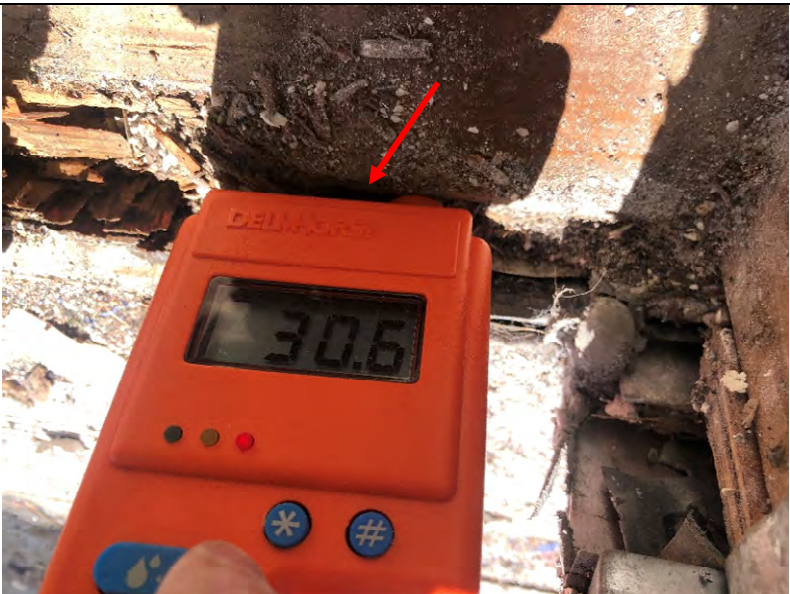
<p>Photo 77:</p> <p>Moisture reading of the wood at the threshold.</p> <p>30.6 %</p>
--	---

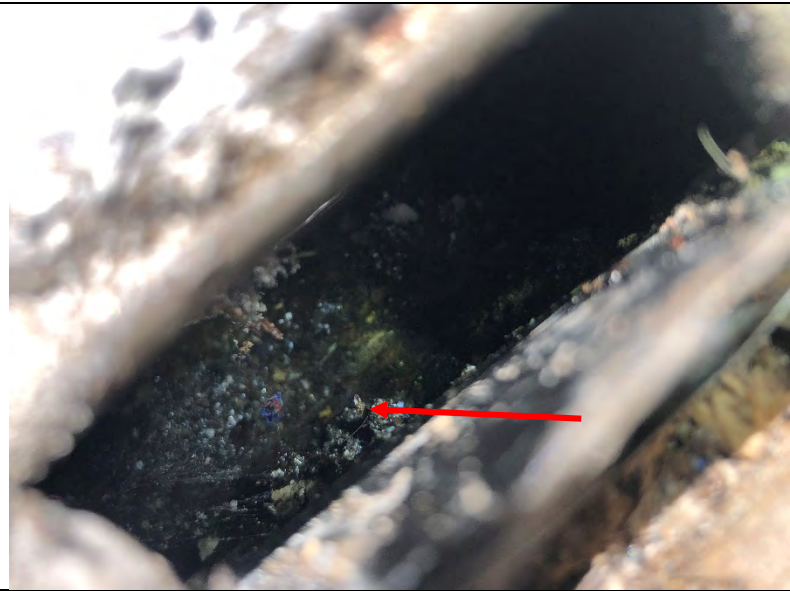
<p>Photo 78:</p> <p>Standing water in the neoprene water stop at the expansion joint.</p>
--	--

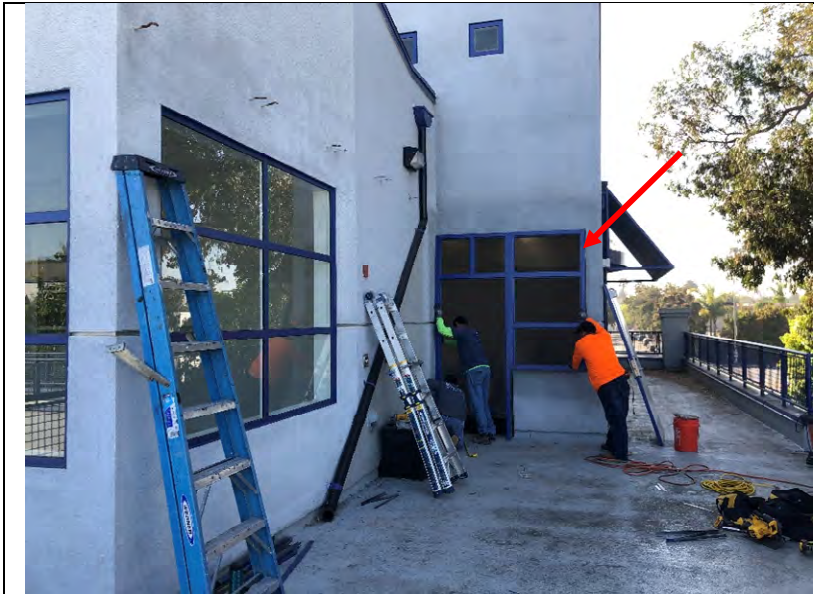
Photo 80:
Hollow metal frame were being removed from the west side of building B.

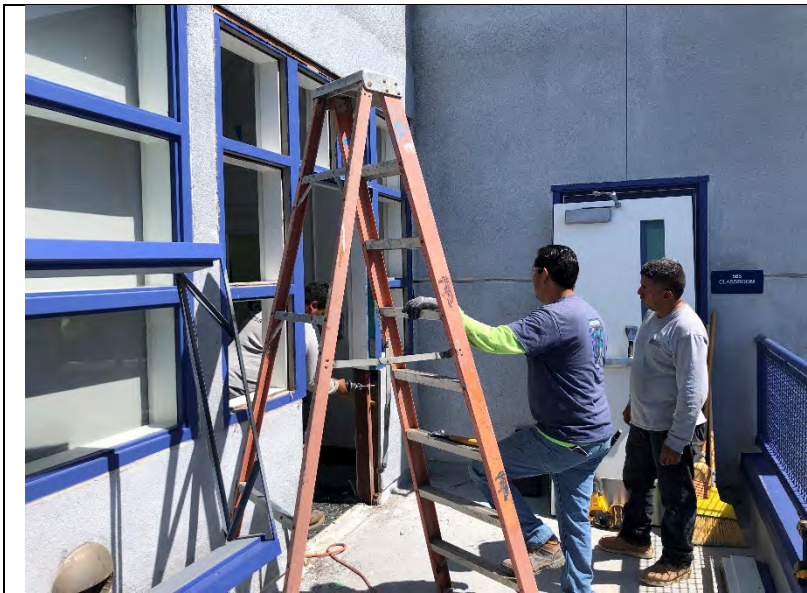
As each hollow metal frame was removed, DTR was able to observe the wall assemblies at each location. At the entry to technical room 570, adjacent to the door, the exterior plywood was partially visible below the window. The exterior surface of the plywood was delaminated and rough indicating repeated wetting. Fasteners at the window sill were corroded and easily removed from the framing wood indicating reduced fastening strength. No flashing was observed at the sill or jambs of the rough opening (**Photos 89 - 94**).

Photo 89:
A hollow metal frame being removed at building D.

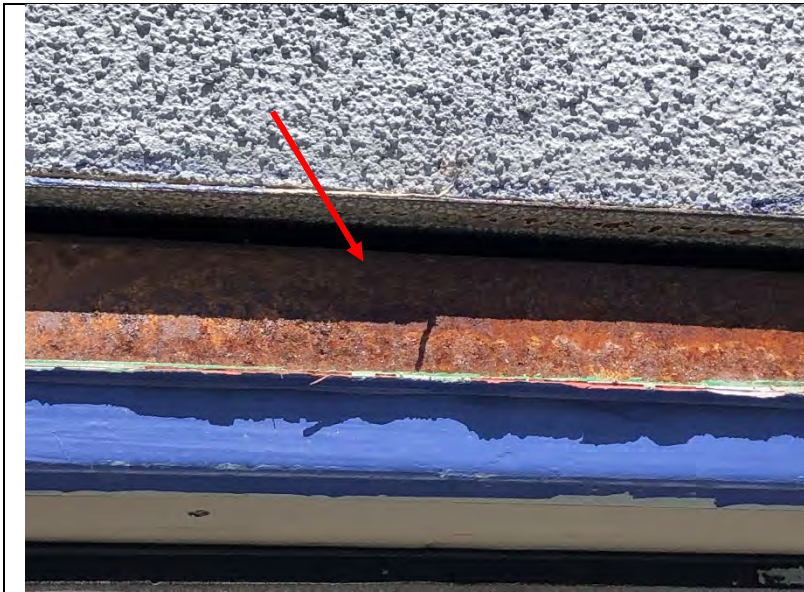
DTR observed that some of the hollow metal-framed doors had head flashing such as Technical Room 570, while others did not such as Classroom 480. When the head flashing above the door was removed at Technical Room 570, corrosion was observed along the head of the hollow metal frame. No weep screed was observed in the plaster stop at that location (**Photos 95 – 96**).

Photo 96:
Corrosion was observed behind a head flashing at one of the hollow metal framed doors.

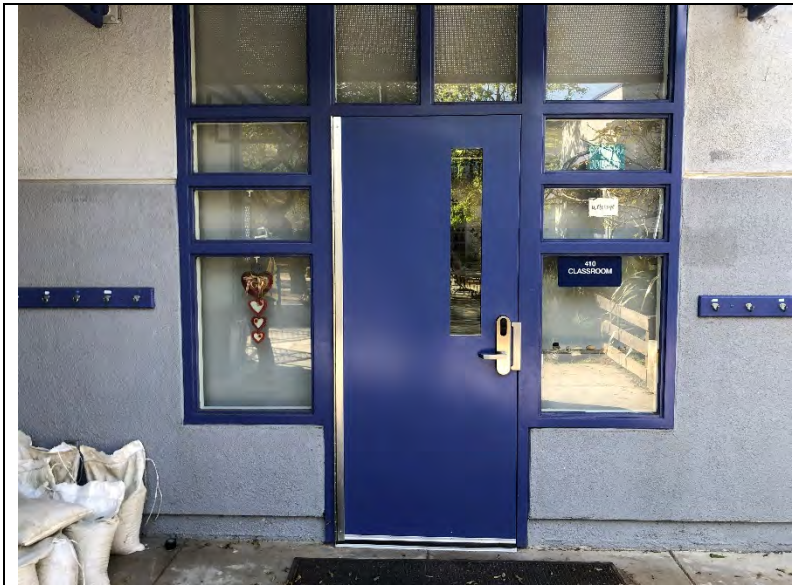
There were a variety of window types and sizes on the campus. The hollow-metal framed windows were, for the most part, combined door/window systems that were being removed. However, some of the upper clerestory windows on the saw-tooth roofs were also hollow-metal framed. Windows on the second floor of the light wells also had hollow-metal frames in some locations (**Photos 97 - 100**).

Photo 97:
A hollow metal frame door/window assembly.
