**Santa Monica-Malibu
Unified School District**
John Muir - SMASH Elementary School

Findings Report
Building Envelope Investigation

April 05 – 06, 2022

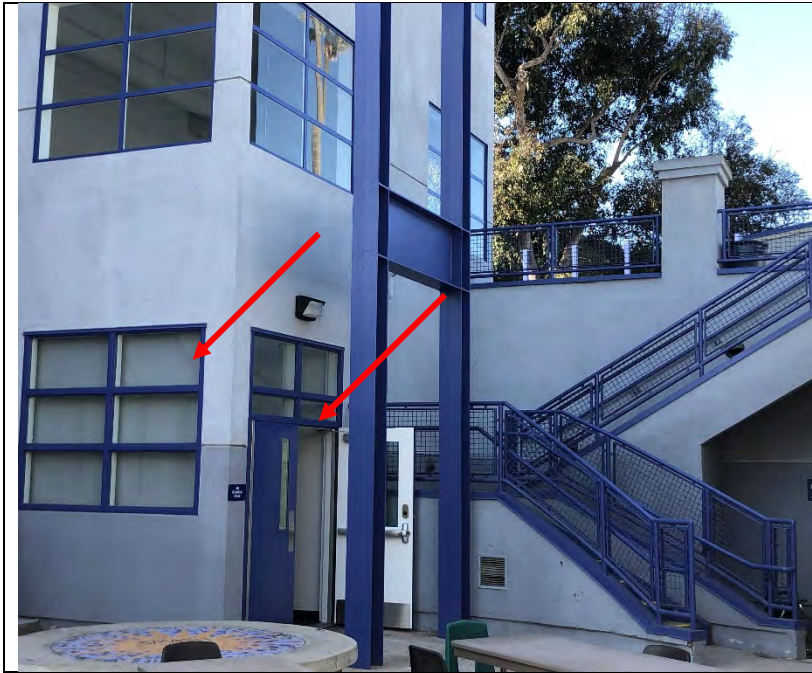
There were a variety of window types and sizes on the campus. The hollow-metal framed windows were, for the most part, combined door/window systems that were being removed. However, some of the upper clerestory windows on the saw-tooth roofs were also hollow-metal framed. Windows on the second floor of the light wells also had hollow-metal frames in some locations (**Photos 97 - 100**).

Photo 98:
Hollow metal frame assemblies.

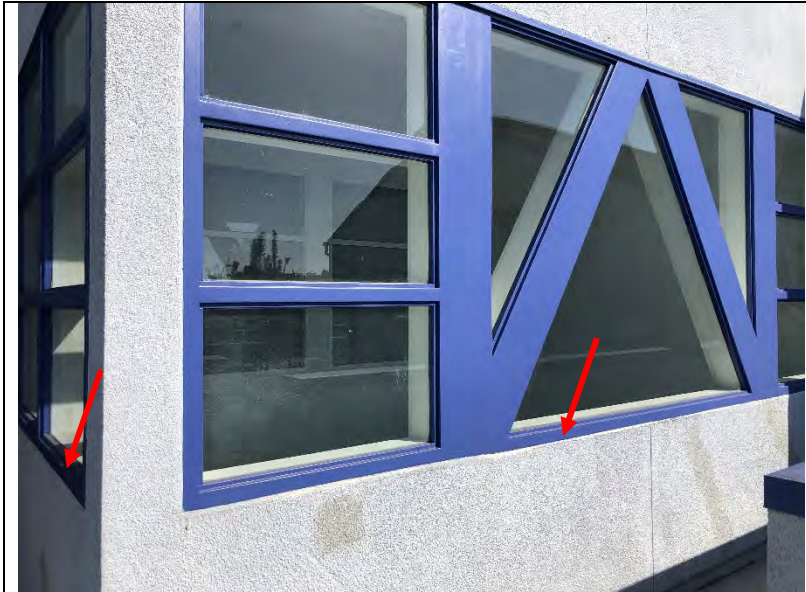
Photo 99:
Hollow metal frame assemblies.

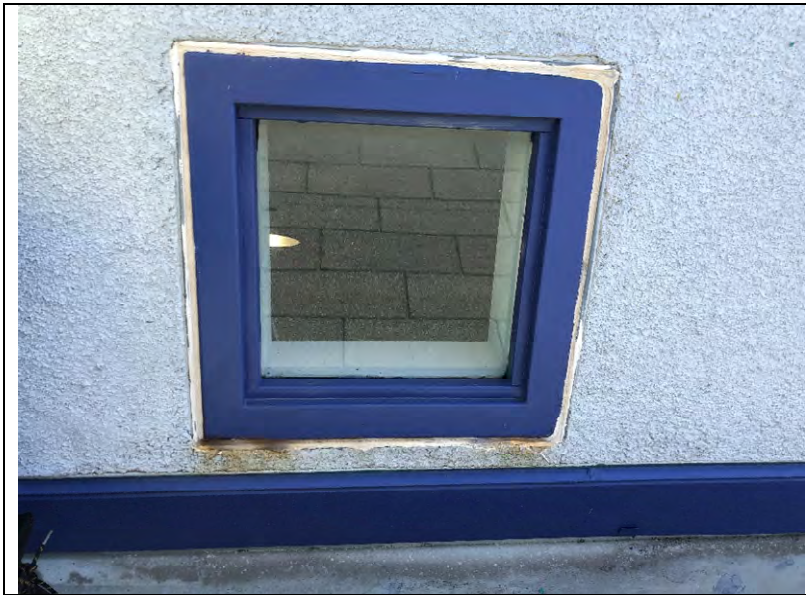
Photo 100:
A hollow metal frame window at the saw-tooth roof.

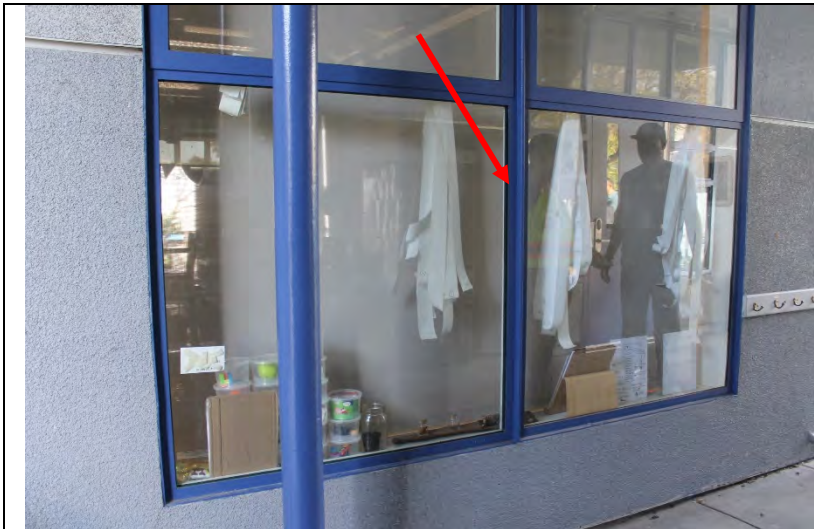
The remaining windows appear to be aluminum framed windows. Some of the aluminum-framed windows were operable and others are fixed. Some of the aluminum windows were inset whereas others were not. Some had weeps while others did not. There was no clear reasoning for the different types of windows or installation methods (**Photos 101 - 104**).

Photo 101:
Aluminum framed windows under one of the covered walkways.

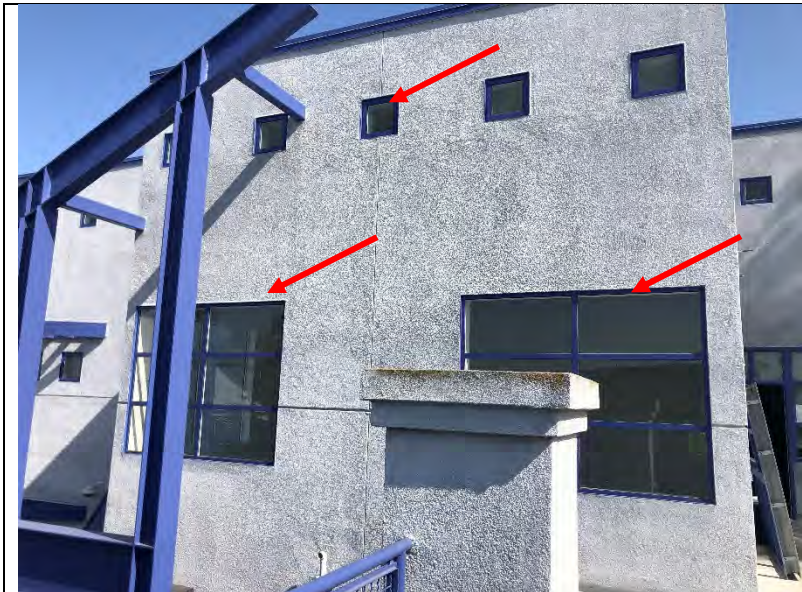
Photo 102:
Aluminum framed windows on the north side of building B.

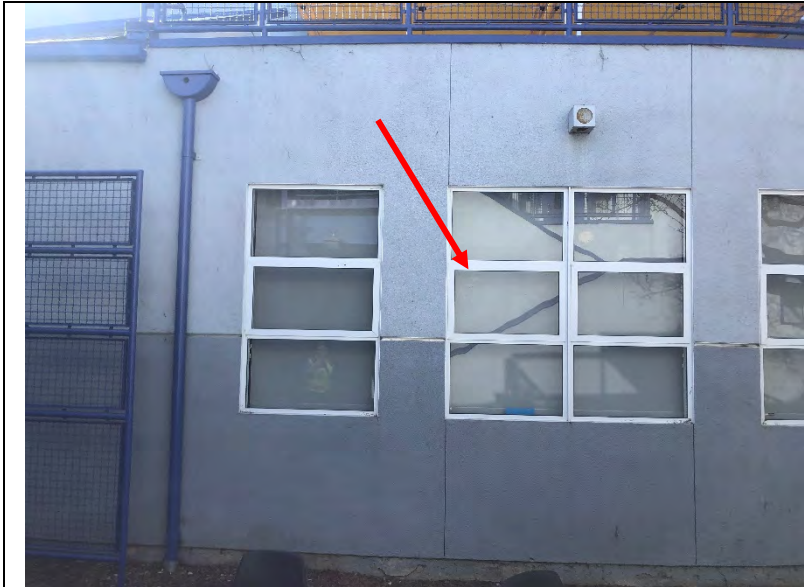
Photo 103:
Aluminum framed windows on the north side of building A.

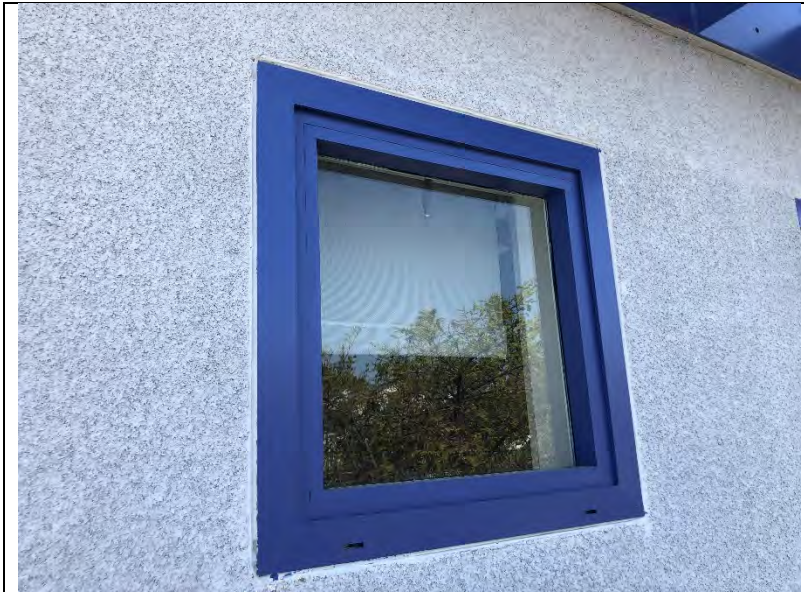
Photo 104:
An aluminum-framed window.

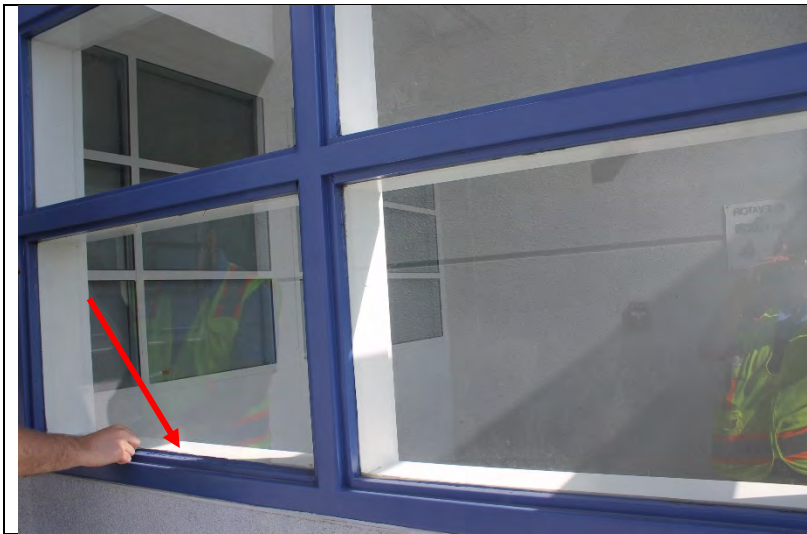
Photo 114:

Silicone sealant was applied at the glazing of this hollow-metal framed window.

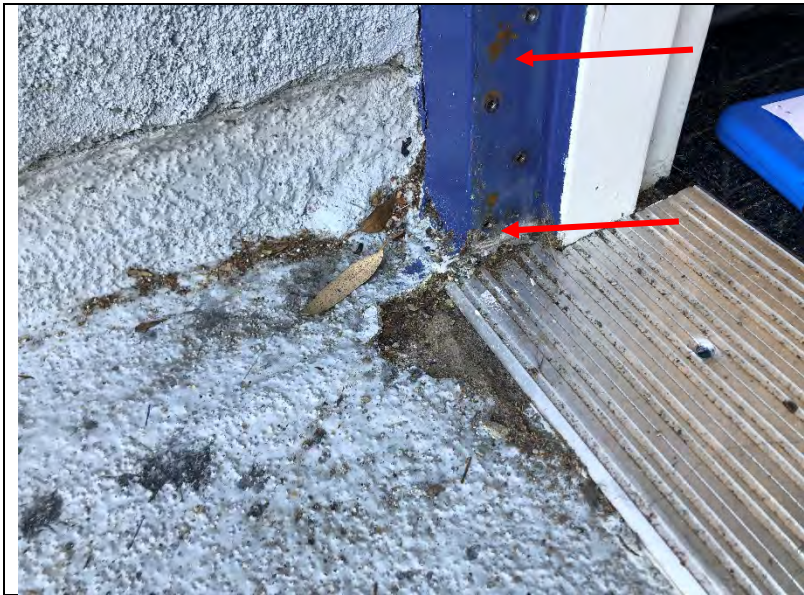
Photo 121:
Corrosion damage at the bottom of a door jamb.

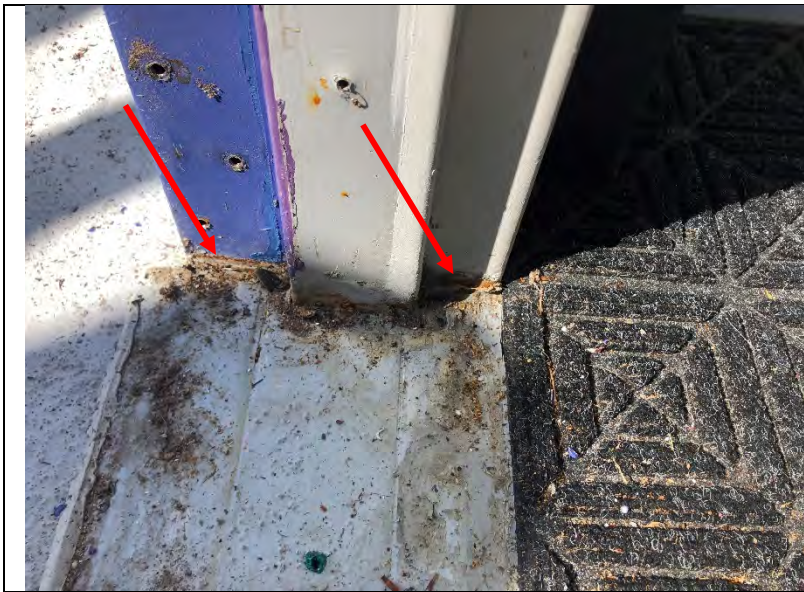
Photo 122:
Corrosion damage at the bottom of a door jamb.

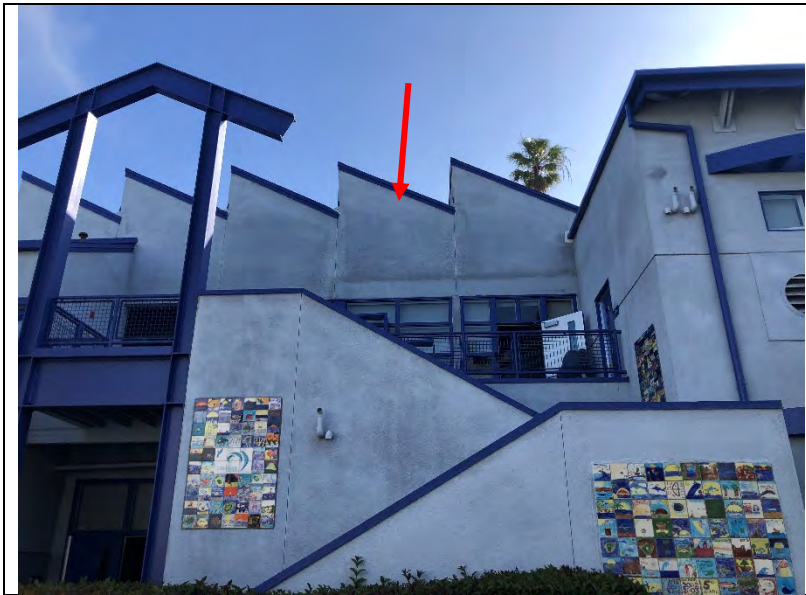
Photo 125:
The saw-tooth roof over building D.

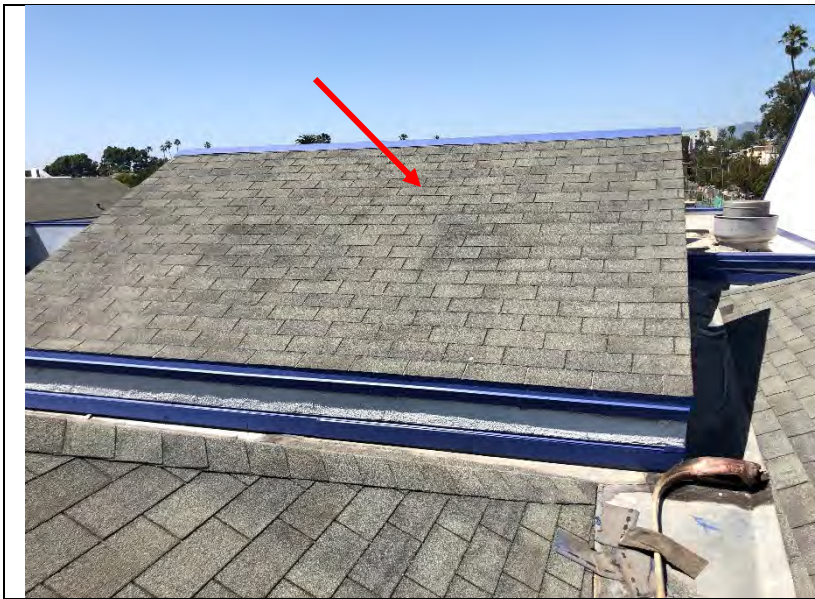
Photo 126:
The shingle assembly on the roof of building D.

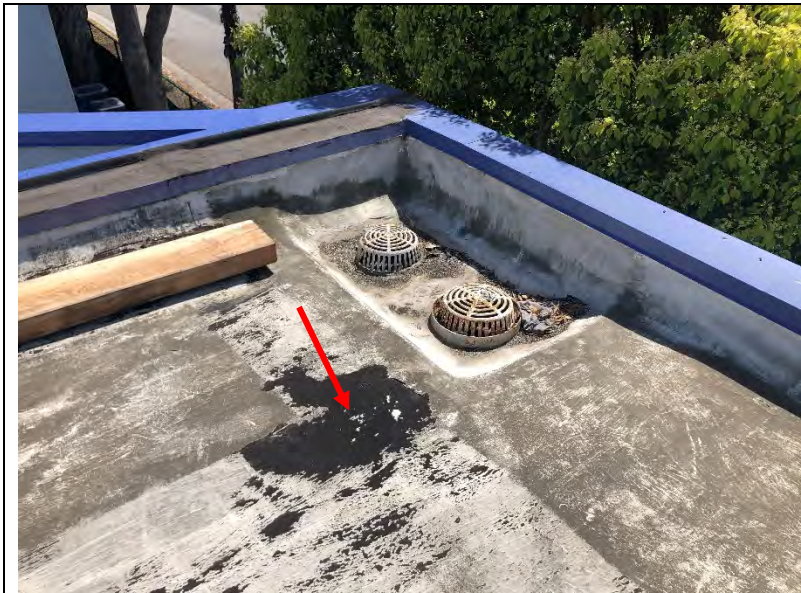
Photo 129:
A coating failure at the BUR roof over the multipurpose room.

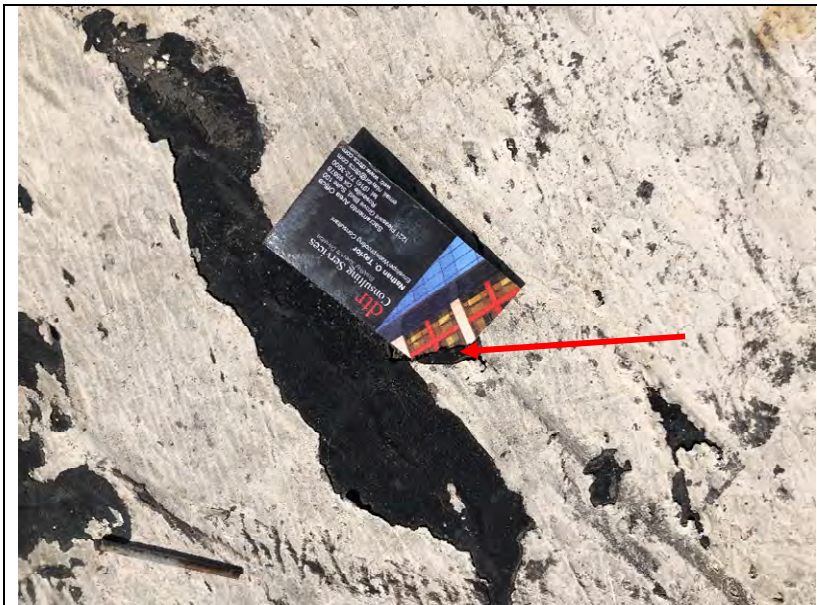
The horizontal building enclosure systems are failing at the material level as well as at transitions, accessories, and drainage systems. Roofing materials (at both steep-slope and low-slope roofs) are mostly at or beyond the end of their useful life (e.g. photo 131). Pedestrian traffic coatings are installed in a manner that is leading to water intrusion and damage (e.g. photo 53). Doors lack sill pans and expansion joints are collecting water and leaking.

Photo 131:
A hole in the BUR roof over the multipurpose room.

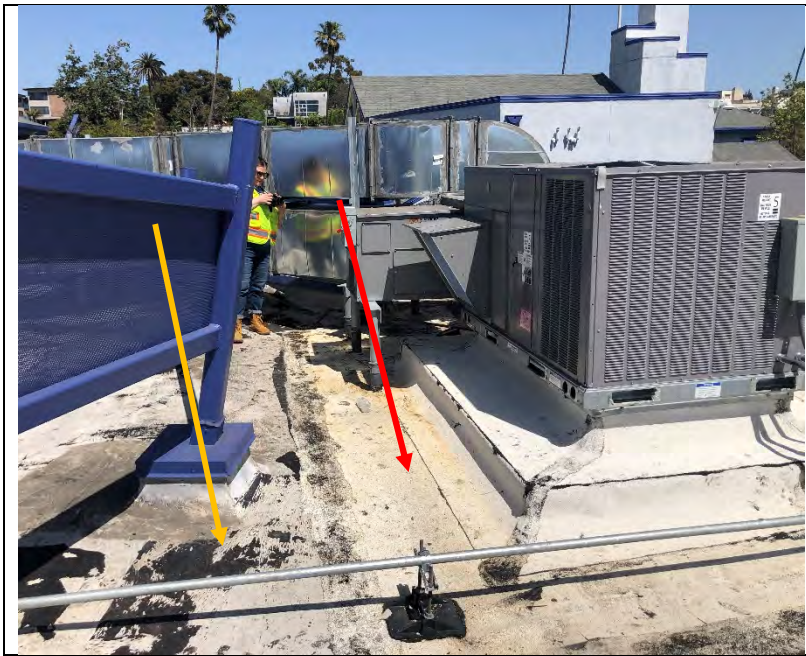
During the recent installation of HVAC systems over the multipurpose room, new mechanical curbs were built on several of the low slope roofs. DTR observed that a granulated cap sheet was installed over the new curbs and lapped onto the existing roof membrane. DTR was not present during this work. It is unclear if the coating was removed before the new granulated cap sheet was installed. There is concern that, given its condition, if the coating was not removed, the coating would not allow for proper adhesion of the new granulated cap sheet to the waterproofing layers of the BUR. It is also probable that the existing BUR membrane was too deteriorated to lap a new cap membrane into it (**Photos 132 – 134**).

Photo 132:
The existing BUR with a coating (yellow arrow) and the new granulated cap sheet (red arrow) were installed at the new mechanical curbs.

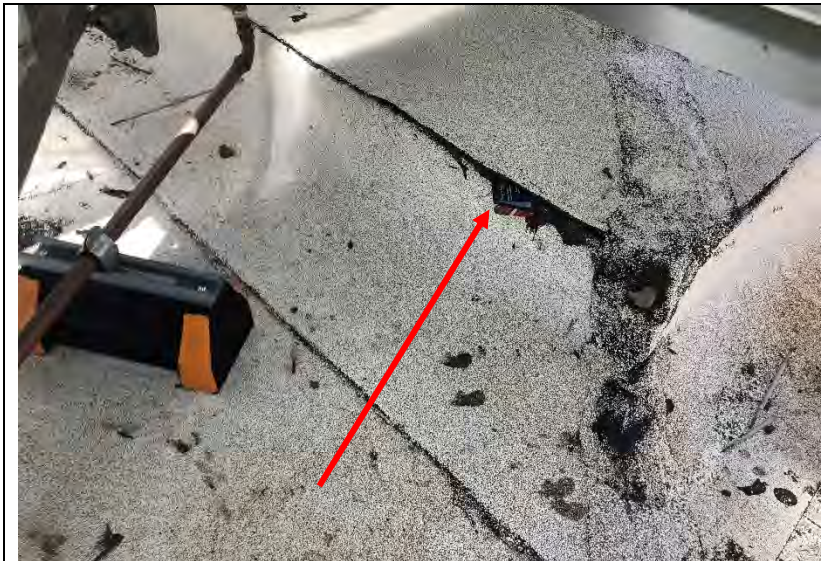
Photo 133:
A business card was inserted into a gap in the new granulated cap sheet installed at the new mechanical curbs.

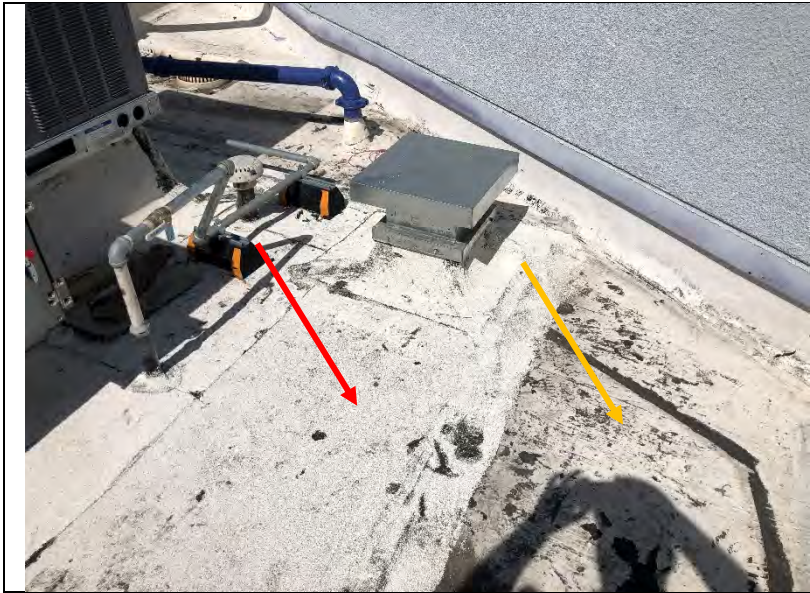
Photo 134:
The existing BUR with a coating (yellow arrow) and the new granulated cap sheet (red) were installed at the new mechanical curbs.

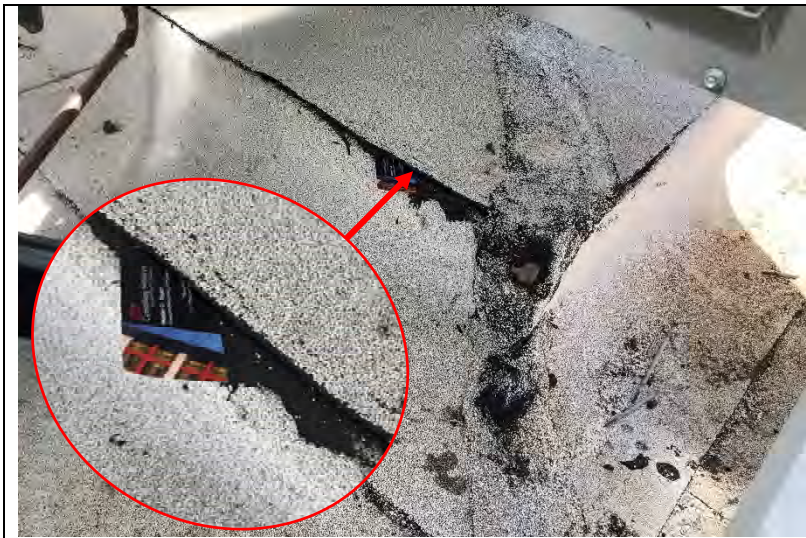
Open seams were observed in the newly installed granulated cap sheet at the mechanical curbs. Spent tig welding rods were scattered around the roof as well as slag from the welding process. In some locations, small burn marks were also observed on the membrane. DTR suspects that these burn marks were caused by welding over the unprotected roof membrane by the HVAC installers (**Photos 135 – 137**).

Photo 135:
An open seam at the newly installed granulated cap sheet at a mechanical curb.

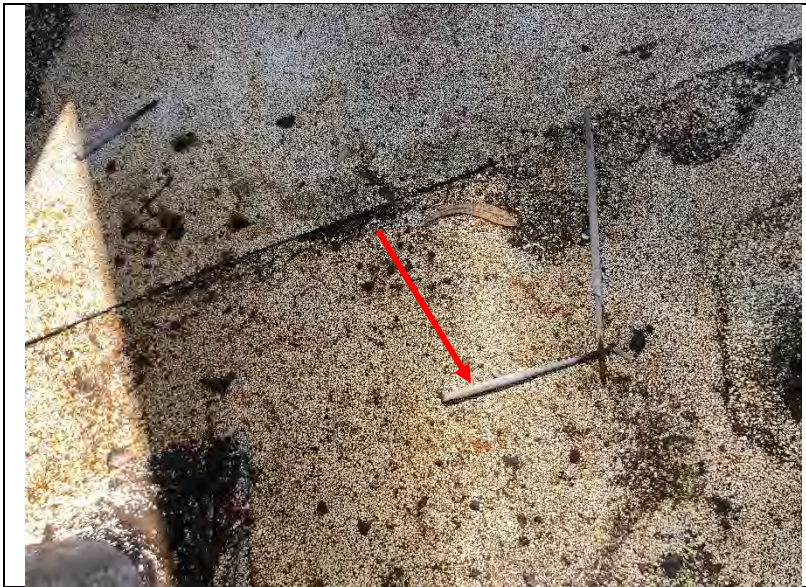
Photo 136:
Tig welding rods left on the roof.

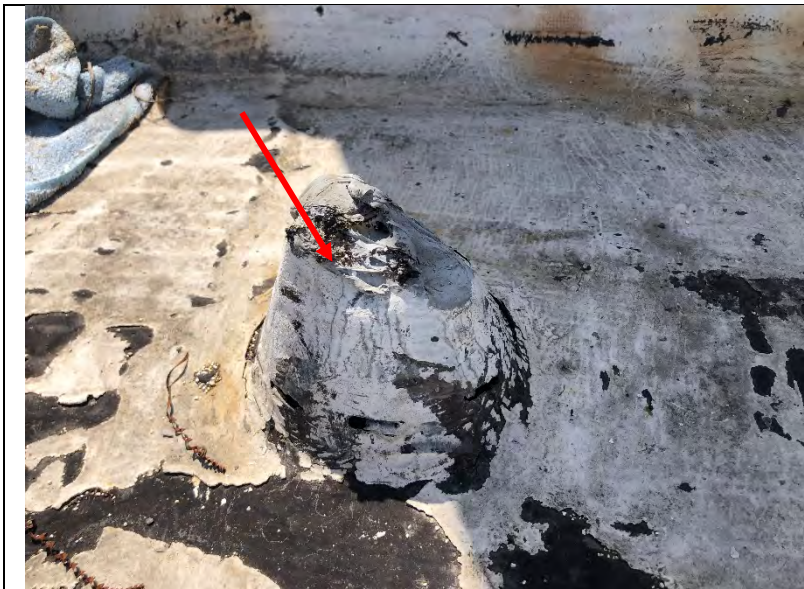
Photo 138:

Numerous deficiencies were observed in the BUR roofing system. A variety of penetration flashings had been installed including lead flashings capped with sealant joints, abandoned conical flashings, and coating flashings with drip guards. Some of the penetration flashings appeared to be new and part of the HVAC project, while other penetration flashings were aged and appeared to have been part of previous project work (**Photos 138 – 146**).

An abandoned cone-flashing on the roof of the multipurpose room.

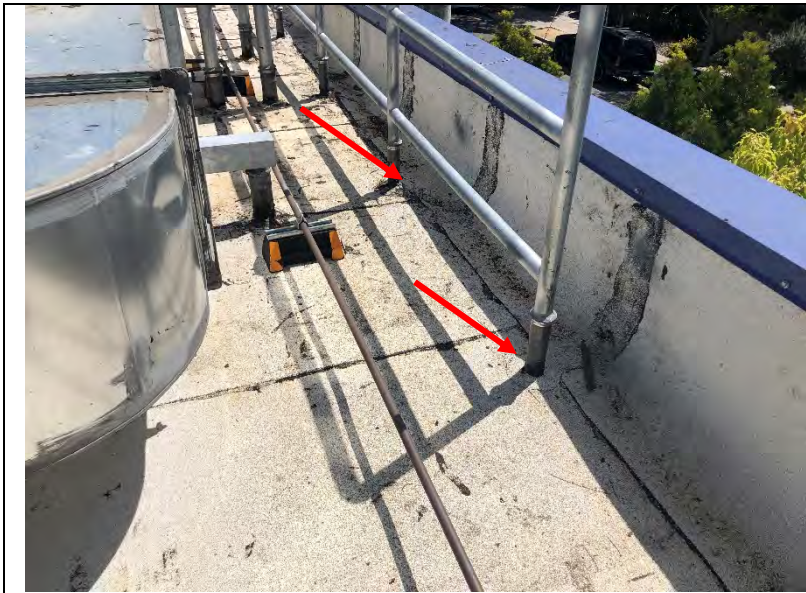
Photo 141:
Lead flashings were installed at the fall protection rail at the newly installed granulated cap sheet on the roof of the multipurpose room.

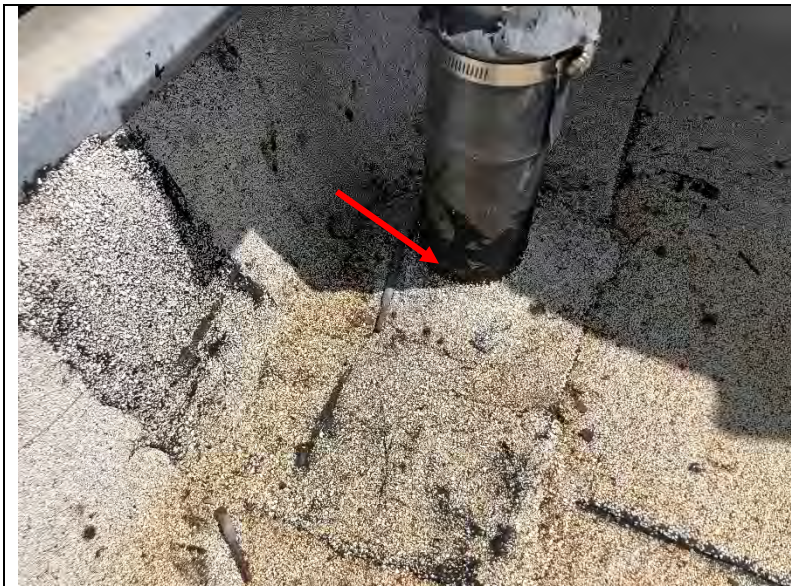
Photo 142:
Lead flashings were installed in the newly installed granulated cap sheet on the roof of the multipurpose room.

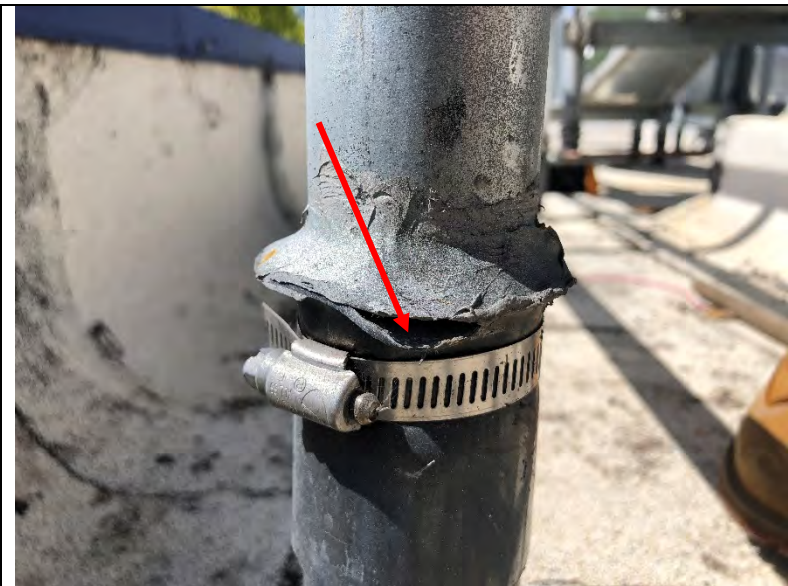
Photo 143:
An opening at a lead flashing was installed in the newly installed granulated cap sheet on the roof of the multipurpose room.

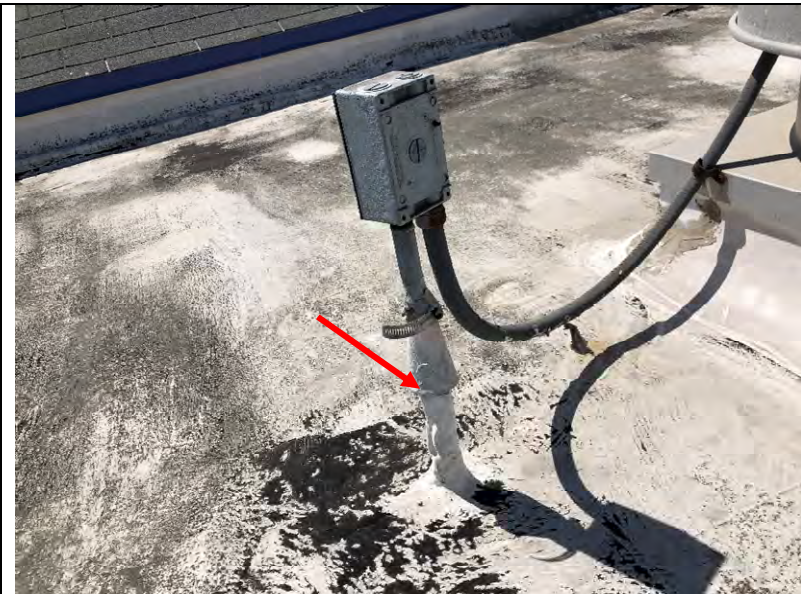
Photo 144:
An electrical conduit flashing with a drip guard on the roof of the multipurpose room.

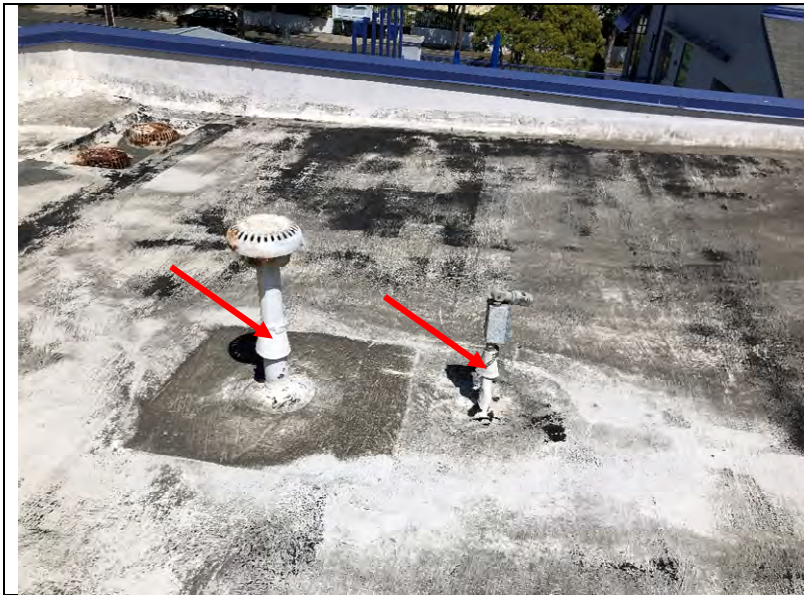
Photo 145:

Penetrations with drip guards on the roof of the multipurpose room.

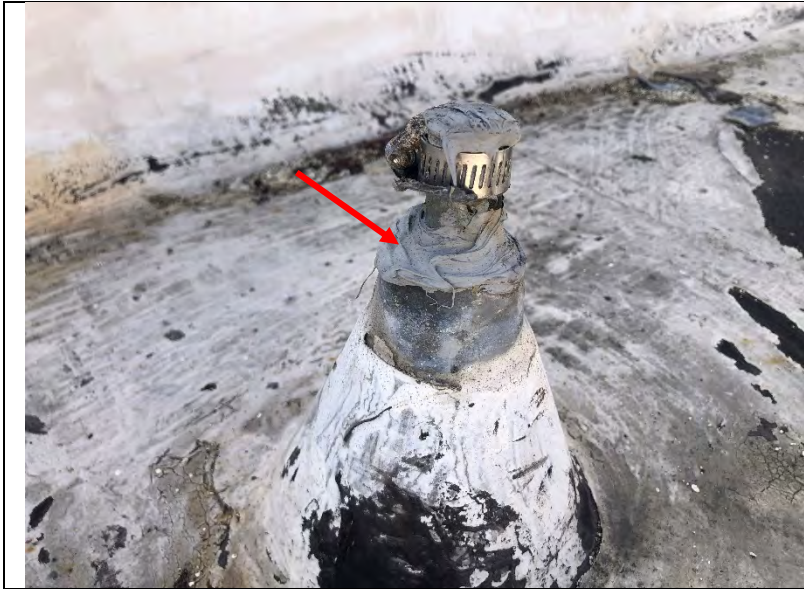
Photo 146:

An abandoned conical penetration flashing on the roof of the multipurpose room.

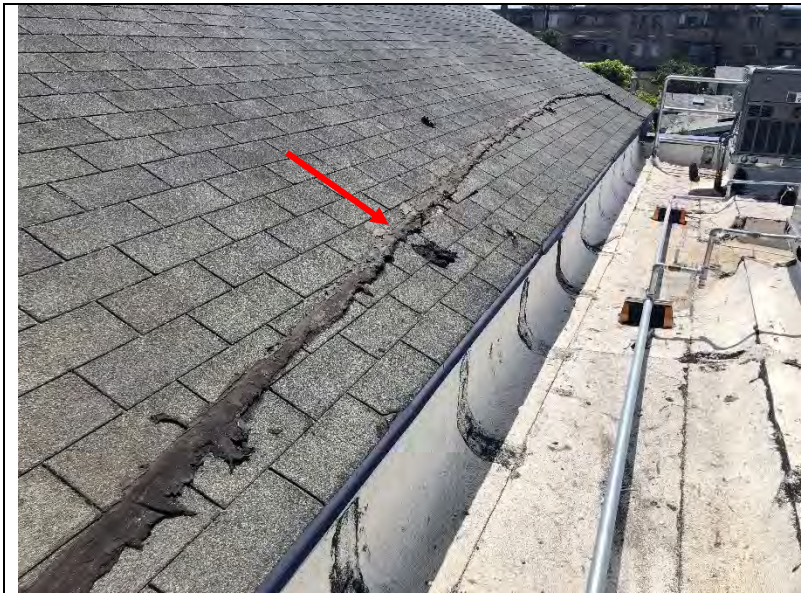
Photo 149:

A swath of mastic was observed at the asphalt shingle roofs.

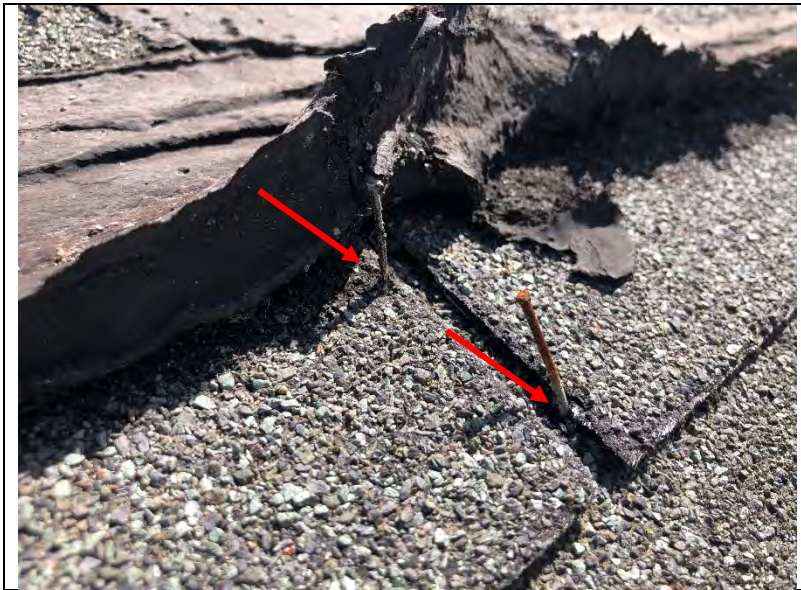
Photo 150:

Staples and nails were observed at the mastic swath.

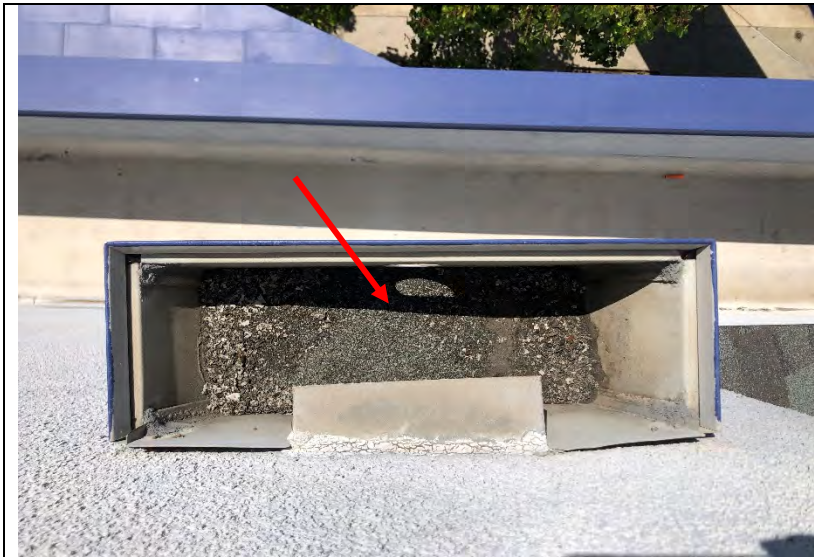
Photo 153:

Granules had filled and blocked a scupper downspout.

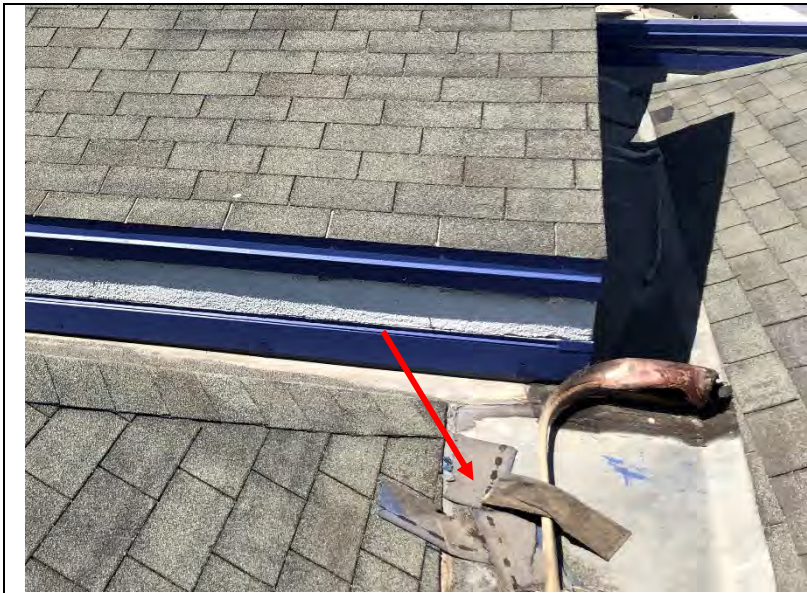
Photo 161:

In several locations, shingle tabs were observed on the roof deck or were missing altogether. Vent pipe penetrations on the shingle roofs were corroded. At one location at building C, a leak was reported under one of these vents. The vent is adjacent to other deficiencies on the roof and the location of water ingress could have more than one contributing factor. Similar corroded vents at other buildings had a self-adhered membrane flashing it to the roof in a nonstandard installation (**Photos 159 – 162**).

Shingle tabs were observed on the roof deck, at damaged areas on the roof, or were missing altogether.

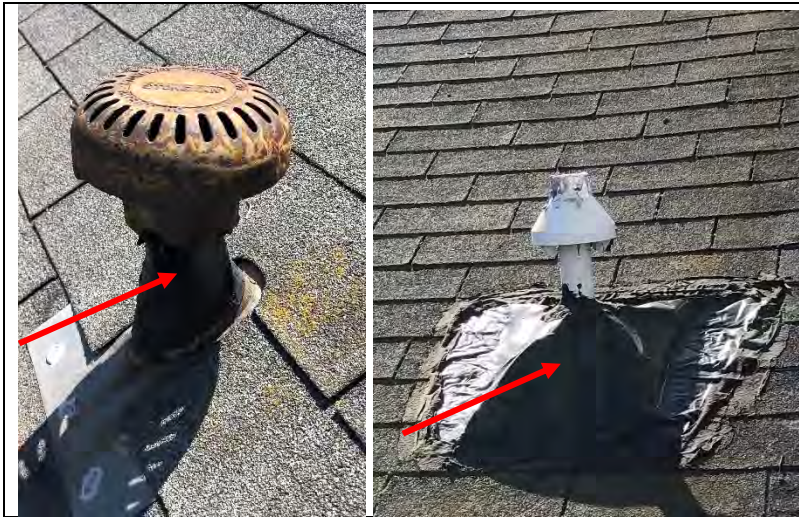
Photo 162:

Corroded vent stacks with deficient flashing were observed in several locations.

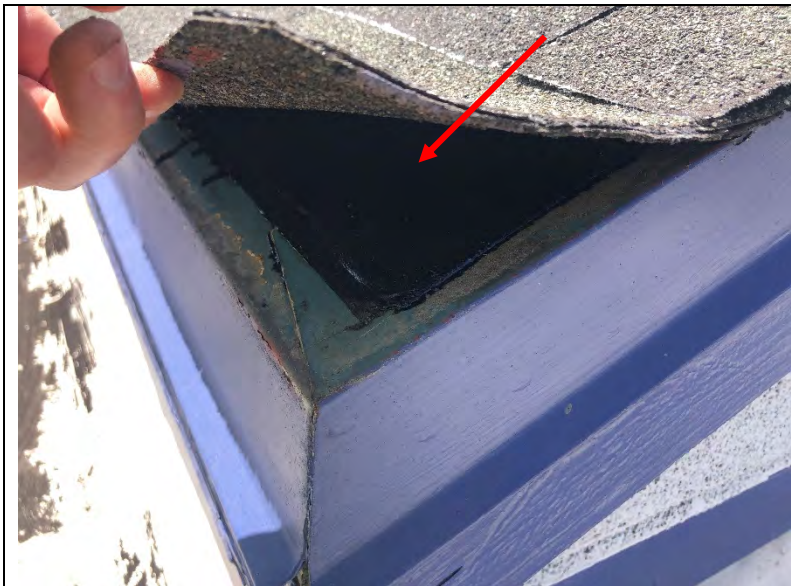
A black self-adhered underlayment was present under the asphalt shingles. In many locations, the shingles could be lifted to view the underlayment. In some locations, the underlayment was not fully adhered to the edge-of-roof metal (**Photos 163 - 164**).

Photo 163:
A black peel-and-stick underlayment was present under the asphalt shingle.

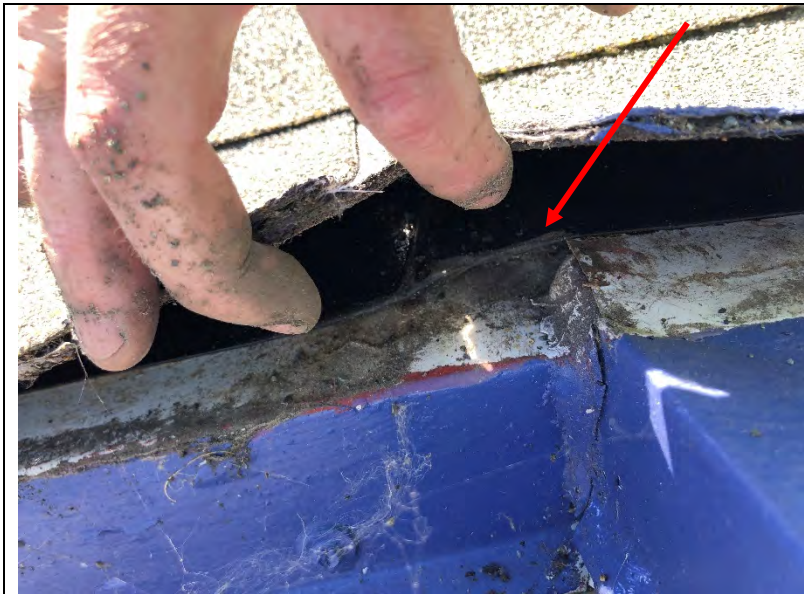
Photo 164:
The black peel-and-stick underlayment was not fully adhered at some locations.

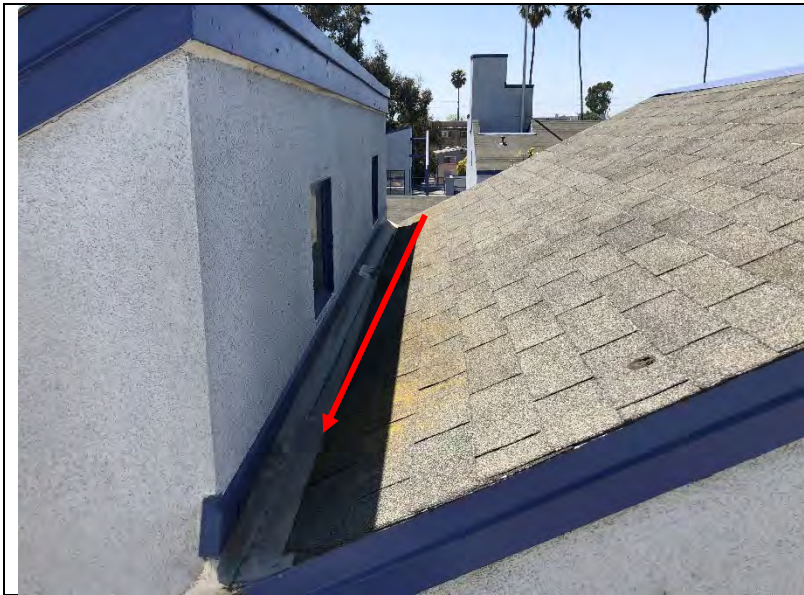
Photo 165:

Sheet metal flashing on the asphalt shingle roofs showed various signs of age degradation. In some locations, the sheet metal was corroded. A black mastic had been applied to the sheet metal along a roof-to-wall valley. It was unclear if the mastic had been applied as a patch or for some other reason. The mastic was not allowing proper drainage in the valley, granules had built up against the mastic. The mastic was also cracked and had failed (**Photos 165 – 167**).

Sheet metal flashing on the asphalt shingle roofs showed various signs of age degradation.

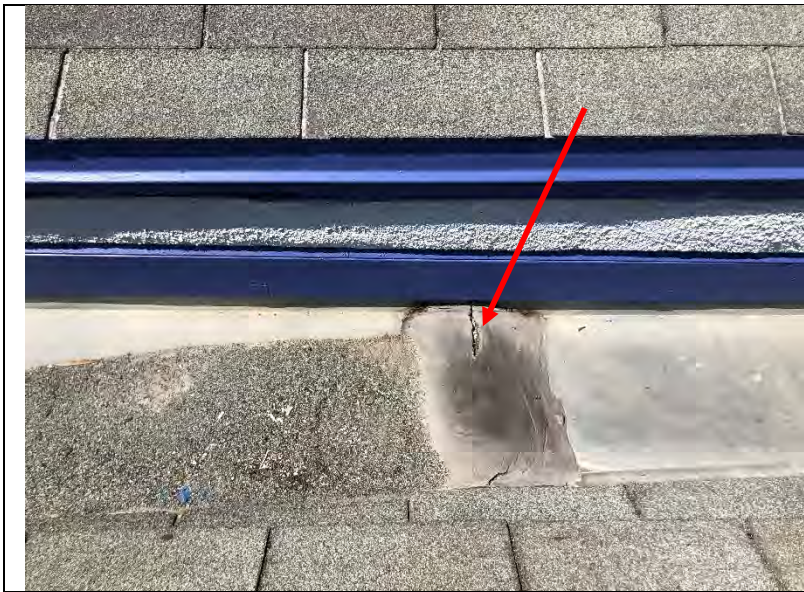
Photo 166:

A black mastic had been applied to the sheet metal along a roof-to-wall valley.

The mastic was cracked and had failed.

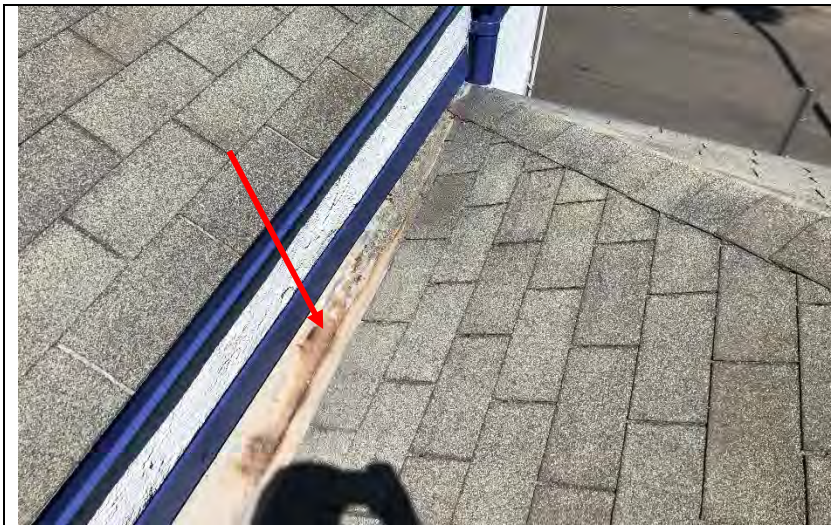
Photo 167:
Sheet metal flashing on the asphalt shingle roofs showed various signs of age degradation.

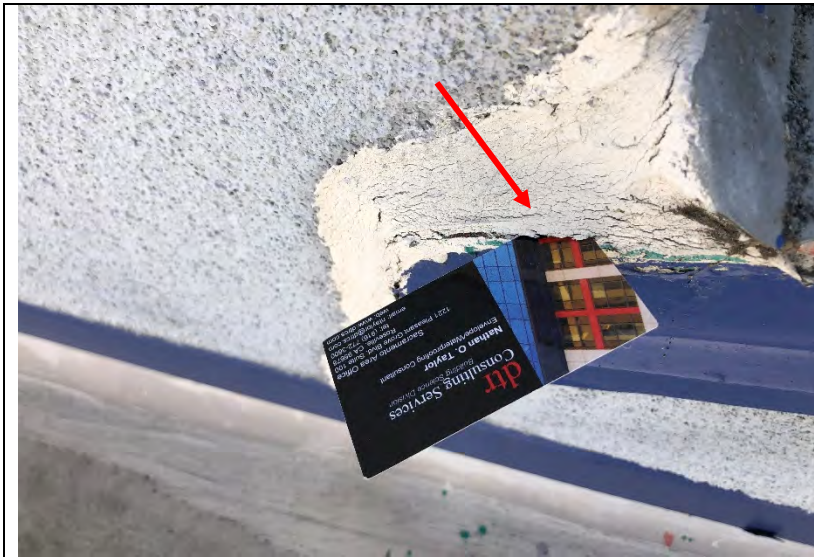
Photo 169:

Sealant was observed at the ends of the sheet metal valley, at the downturn onto the wall. The sealant was cracked and openings were visible. This condition was systemic in many of the sawtooth valleys (**Photos 168 – 169**).

Sealant at the ends of the sheet metal valleys was cracked and had failed in many locations.

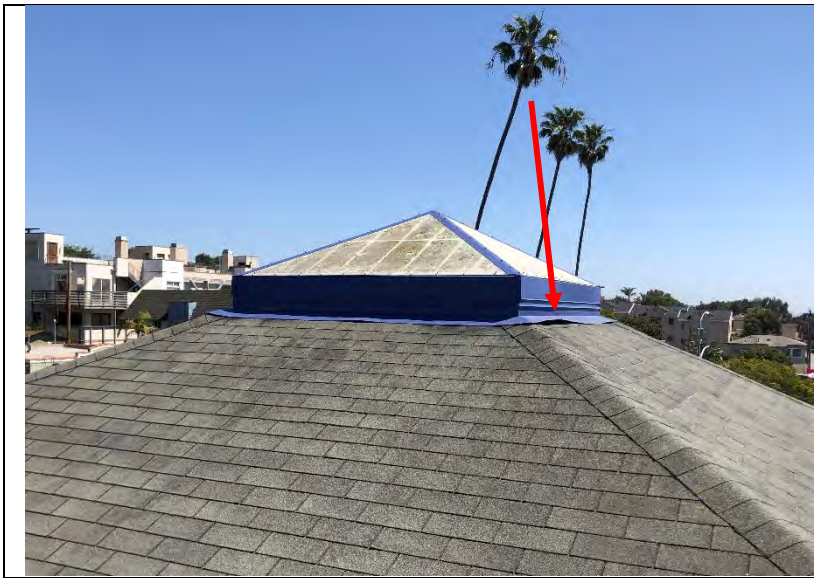
Photo 170:

Sheet metal skirt flashing at the skylights was not flat and flush to the roof. In many locations, the fasteners had been pulled loose and were no longer holding the flashing to the roof. The sheet metal has likely been raised by wind over time. Openings left by loose penetrations are possible leak locations and the raised flashings make it easier for wind-driven rain to penetrate the roofing system (**Photos 170 – 172**).

Sheet metal skirt flashing at the skylights was not flat and flush to the roof.

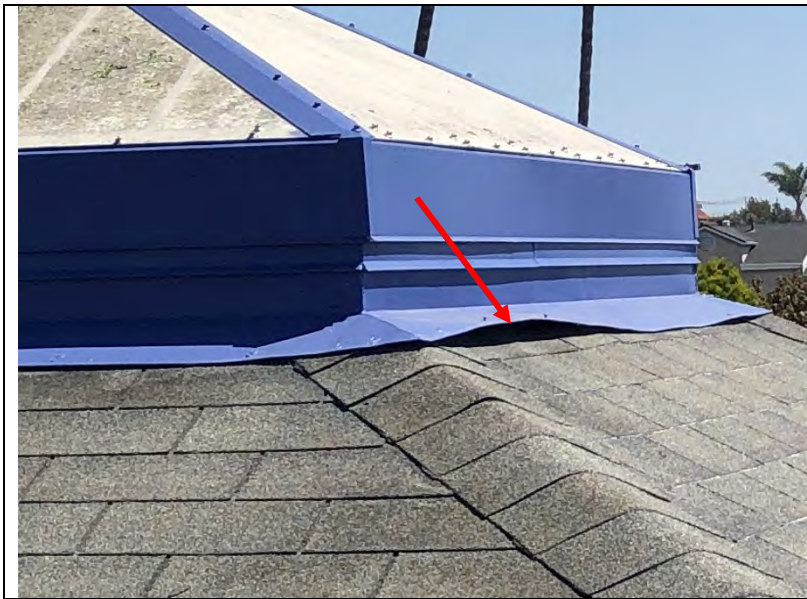
Photo 171:
Sheet metal skirt flashing at the skylights was not flat and flush to the roof.

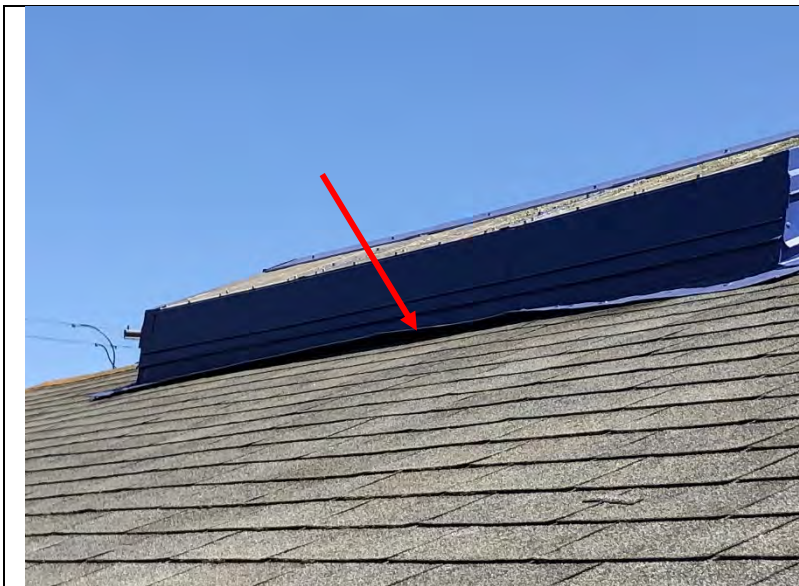
Photo 172:
Sheet metal skirt flashing at the skylights was not flat and flush to the roof.

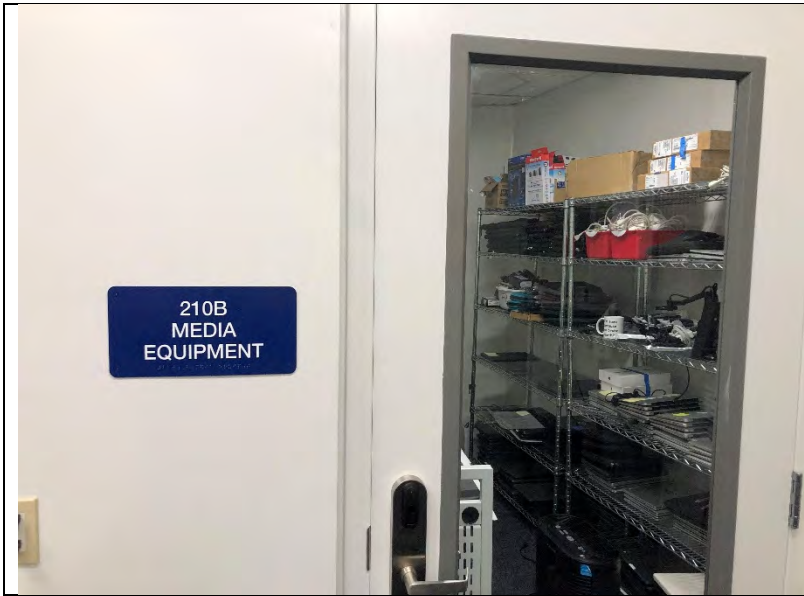
Water stains, corrosion, and staining were visible at numerous interior locations of building A. Staining was visible on the ceiling tiles along the outside wall in Room 210B Media Equipment. A hollow metal-framed door and blocked cement plaster weep screeds are located above the Media Equipment Room leak location. (**Photos 179 – 180**).

Photo 179:
Staining was visible on the ceiling tiles in room 210B Media Equipment

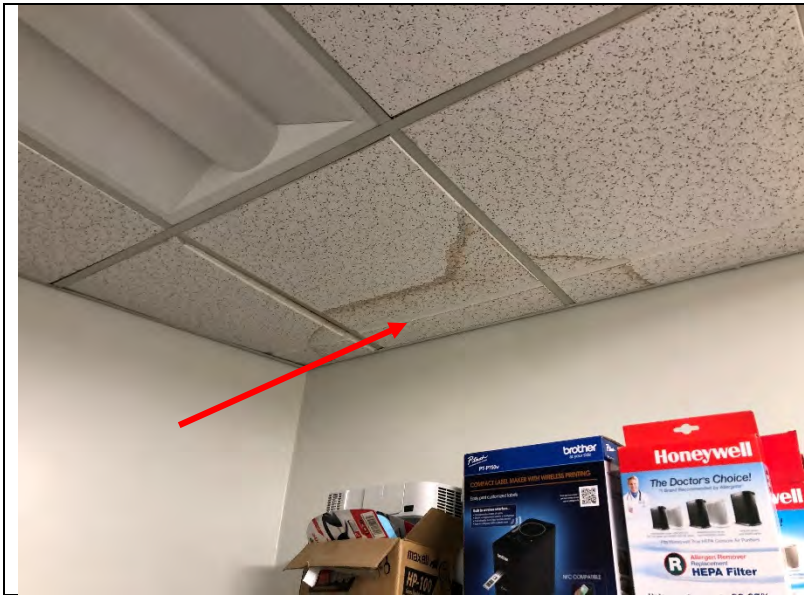
Photo 180:
Staining was visible on the ceiling tiles in room 210B Media Equipment

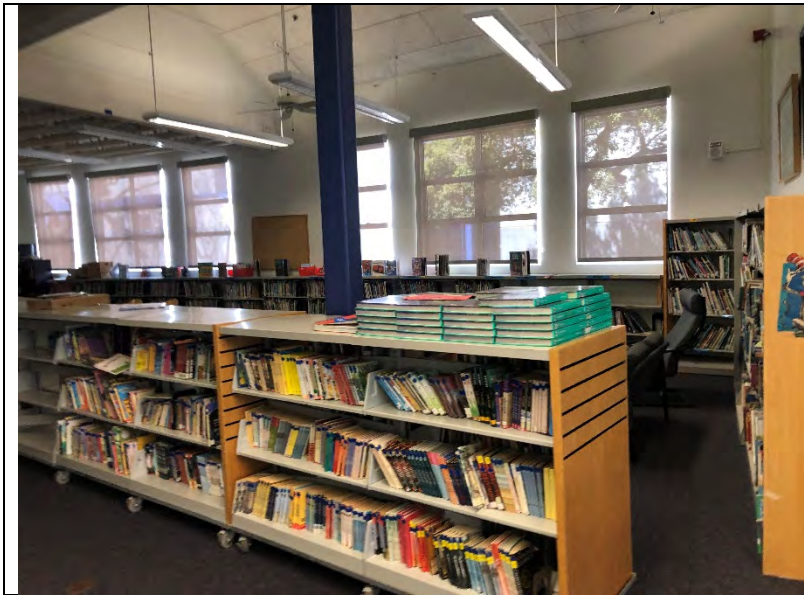
Photo 181:

School District staff informed DTR that several leaks had been observed in Room 200 Media Center/Library. Locations in the library had recently been repainted. Many of the reported leaks were at the wall-to-roof juncture of the patio deck above the center of the north side of the library. A leak was confirmed over the east entry to the Media Center/the Library. Some water marks were still visible. Two (2) HVAC wall vents are located on the exterior of the 2nd floor covered walkway, above the east entrance to the library. The perimeter of those vents was not flashed or sealed and exterior light could be seen at the seams from the interior of the building. Water marks were observed on the ceiling tiles of room 205 communications on the east side of building A. The water stains were along the north perimeter wall, at the junction of the building and the walking deck above (**Photos 181 – 184**).

DTR made observations in the library. Many reported leak locations had been obscured by new paint.
