**Santa Monica-Malibu
Unified School District**
John Muir - SMASH Elementary School

Findings Report
Building Envelope Investigation

April 05 – 06, 2022

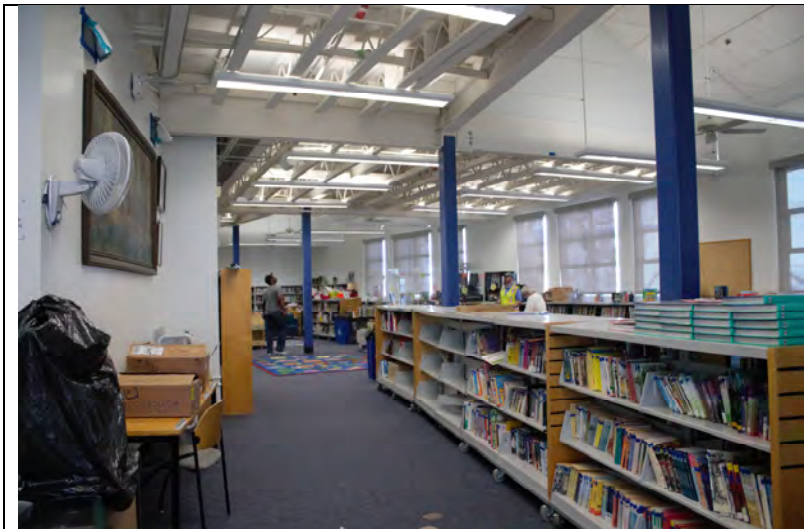
Photo 182:

School District staff informed DTR that several leaks had been observed in Room 200 Media Center/Library. Locations in the library had recently been repainted. Many of the reported leaks were at the wall-to-roof juncture of the patio deck above the center of the north side of the library. A leak was confirmed over the east entry to the Media Center/the Library. Some water marks were still visible. Two (2) HVAC wall vents are located on the exterior of the 2nd floor covered walkway, above the east entrance to the library. The perimeter of those vents was not flashed or sealed and exterior light could be seen at the seams from the interior of the building. Water marks were observed on the ceiling tiles of room 205 communications on the east side of building A. The water stains were along the north perimeter wall, at the junction of the building and the walking deck above (**Photos 181 – 184**).

DTR made observations in the library. Many reported leak locations had been obscured by new paint.

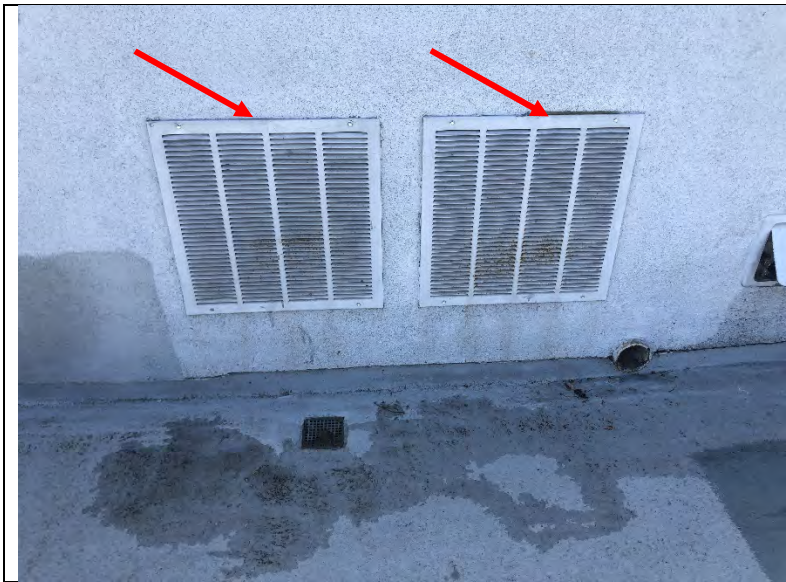
Photo 184:
Louvers at the elevated walkway over the east entrance to the library.

The louvers were not properly flashed and sealed.

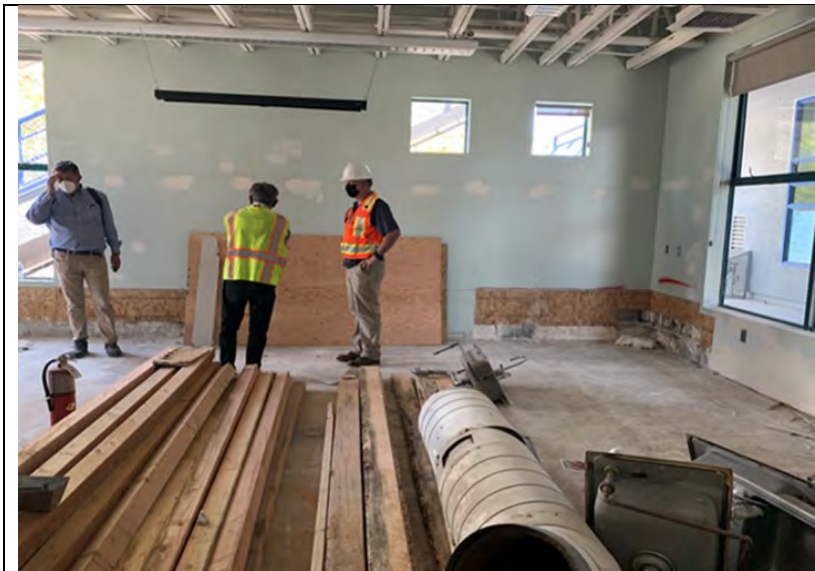
Photo 186:

Water marks, corrosion, and staining were visible at numerous interior locations of Building B. Classroom 415 was reported to have had water intrusion issues at numerous locations and at different times. During the previous mold remediation, the shelves and lower portion of the gypsum board had been removed along the east wall. According to the school district, leaks had continued at the location. The south wall of the classroom was not part of the previous mold remediation. The south wall is directly under the door of classroom 480 where standing water was observed in the expansion joint and the exterior sheathing was found to be damp to the touch. Water stains, peeling paint, and staining were visible on the south wall of the classroom. Towels had been left on the classroom floor in the event of a rain event during the school break. Staining was visible at electrical outlets and the school district stated that water had also percolated through a floor outlet in the center of the classroom during a previous rain event. Staining was observed on the ceiling as well, both adjacent to the south wall and at beams on the north side of the classroom (**Photos 185 – 190**).

Previous mold abatement at classroom 415.

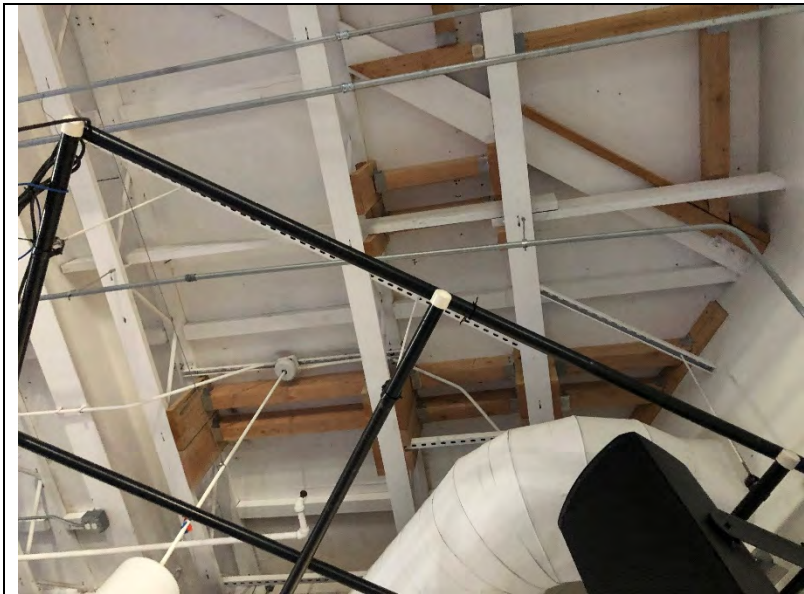
Photo 194:
New blocking was installed in the ceiling of the multipurpose room during the HVAC project.

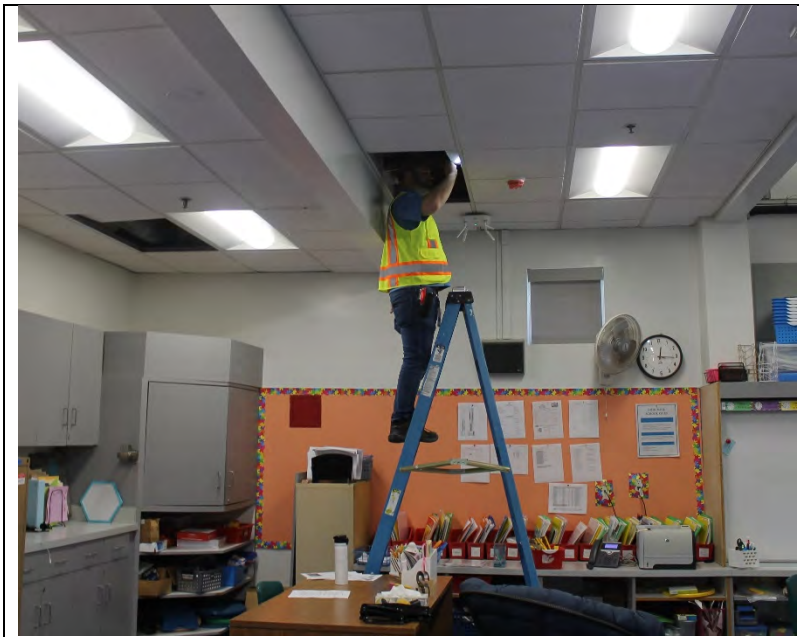
Water marks, corrosion, and staining were visible at numerous interior locations of Building C. During the flood testing deck drains, DTR was able to make observations of drain assemblies below the decks. While no leaks were observed at the drain assemblies during the testing, DTR was able to observe that multiple drain assemblies had been moved or replaced. While no active water was observed at those drains, evidence of previous leaks were visible in multiple locations. Water marks were found on plumbing pipes, on the top of storage bins, and on the tops of the shelves (**Photos 198 – 201**).

Photo 198:
DTR making observations above the ceiling panels in a classroom in building C

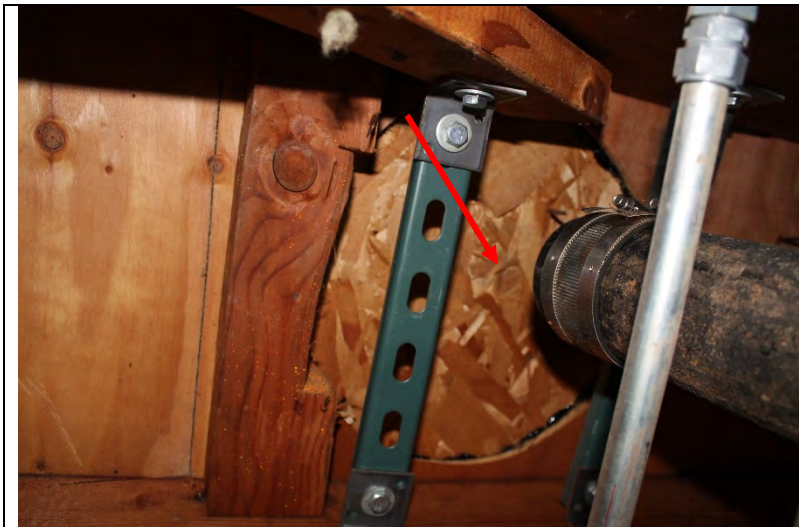
Photo 199:

A drain assembly had been relocated above the ceiling panels in a classroom in building C

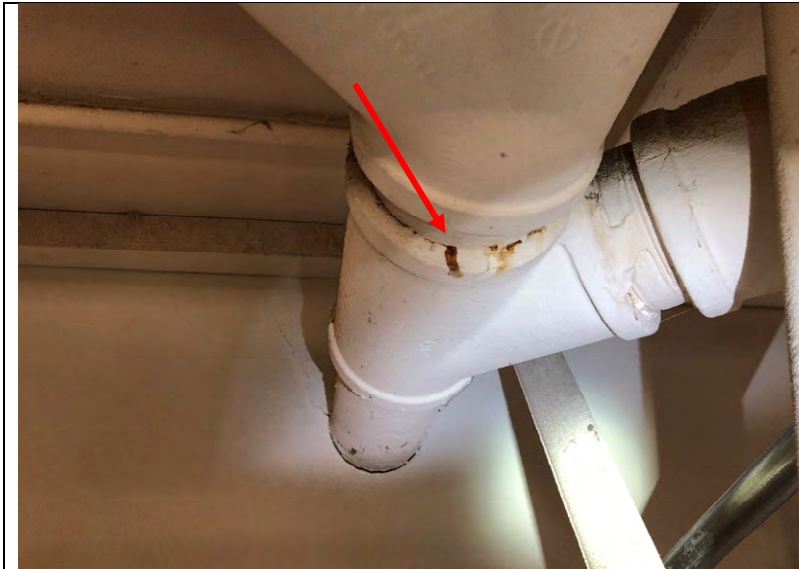
Photo 200:

Water stains at a drain pipe from a previous leak. No active water was observed at this location.

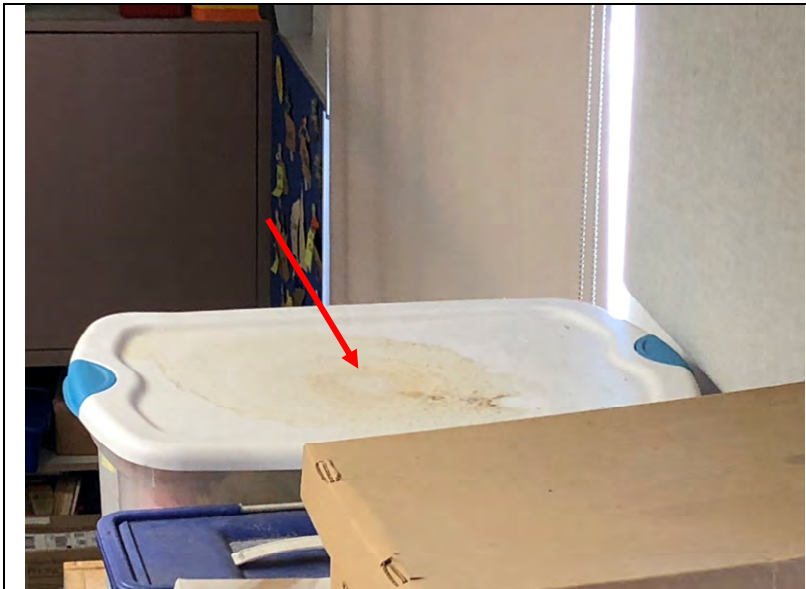
Photo 201:

Water staining on top of a storage bin in a classroom in building C.

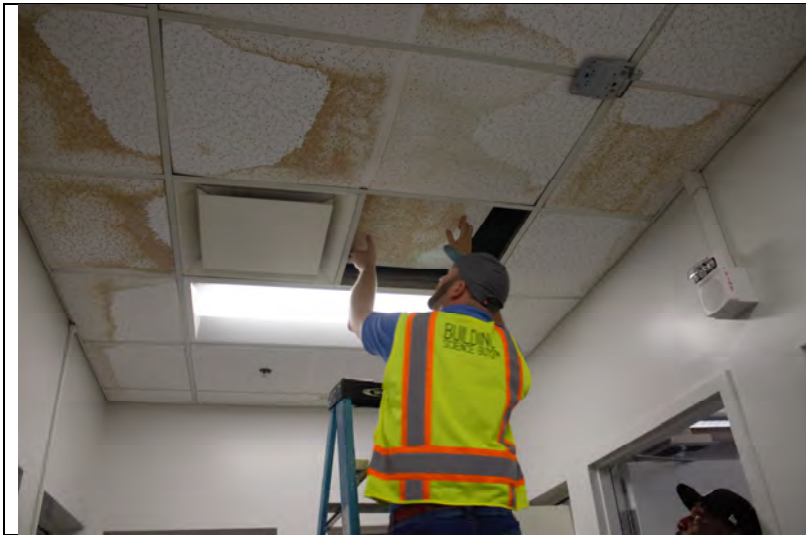
Photo 202:

with the corroded plumbing pipes and water stains observed above the ceiling panels in room 205 Teachers' Prep (**Photos 202 – 206**).

Stained ceiling tiles in room 205 Teacher's Prep.

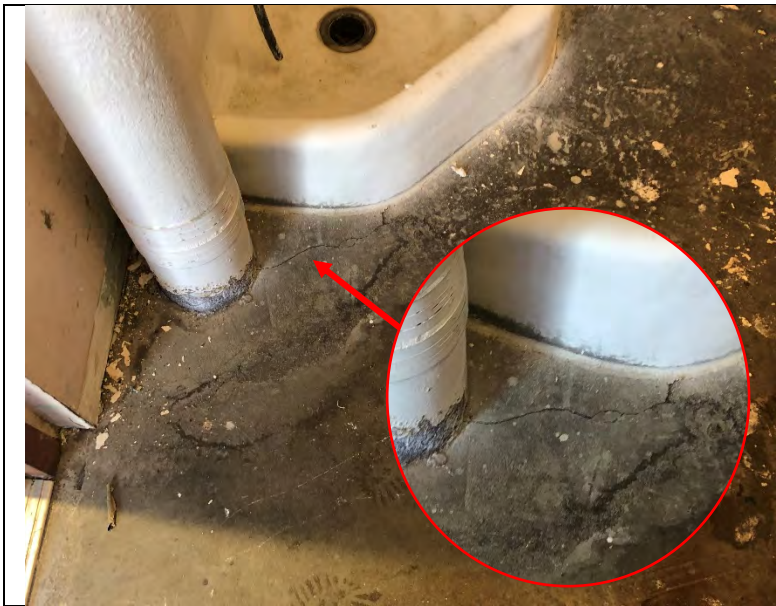
Photo 206:
A crack in the floor of the
janitorial room above room 205
Teacher's Prep.

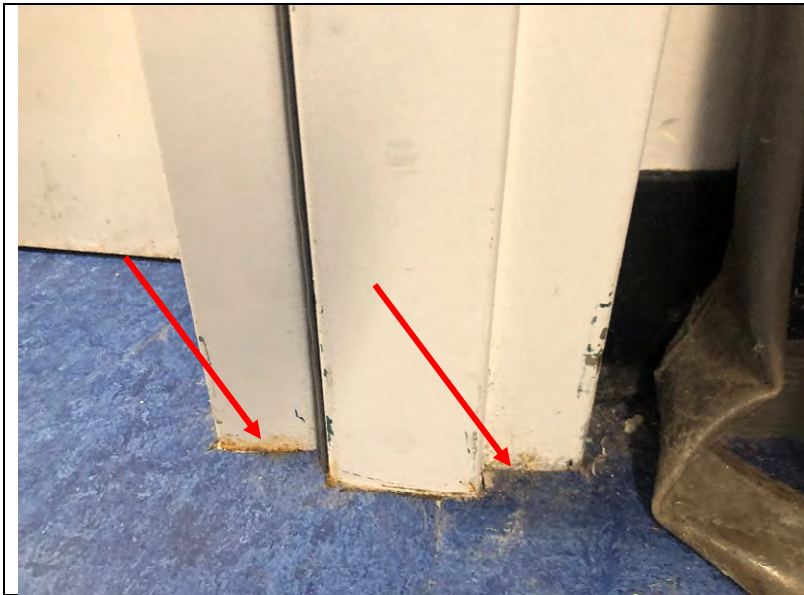
Photo 208:
Corrosion at the bottom of the door jamb at Room 403 Teachers' Prep.

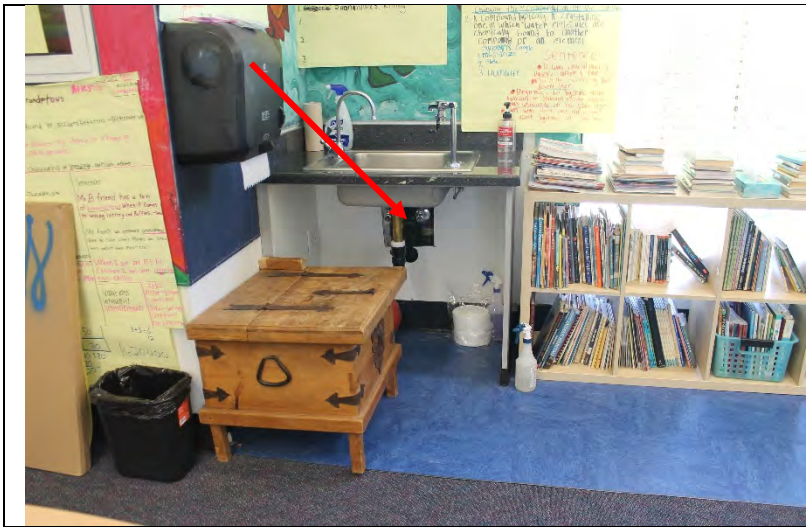
Photo 210:

On the northeast side of Building D in the room 515 classroom, finishes had been removed under and above a classroom sink. Cardboard had been placed over openings in the interior wallboard. School District staff stated that the finishes had been removed to allow for observations of leak conditions. The interior finishes at the sink in the classroom above Room 515 had also been removed in an attempt to find the leak. This location correlates to deficiencies observed in the roof above this location, including openings in the sheet metal valley, deteriorated shingles, and a corroded roof vent (**Photos 210 – 212**).

Interior finishes had been removed at two classrooms in building D prior to the DTR site assessment, in an effort to address a leak at this location.

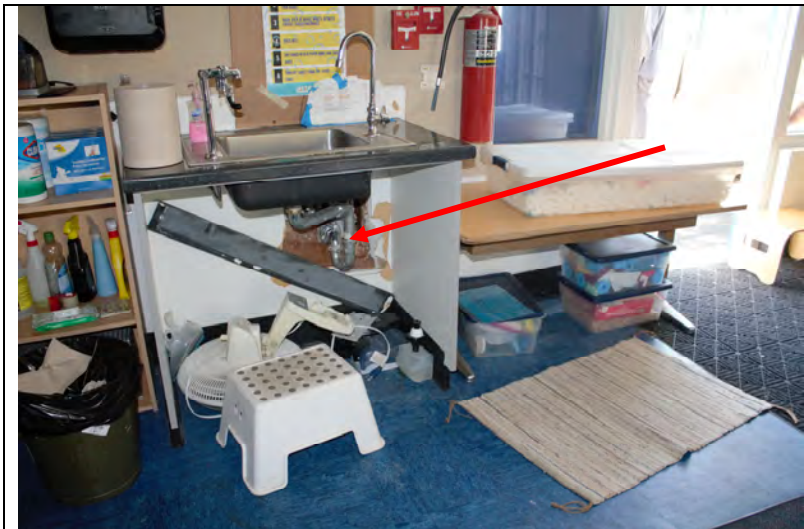
Photo 211:

Interior finishes had been removed at two classrooms in building D prior to the DTR site assessment, in an effort to address a leak at this location.

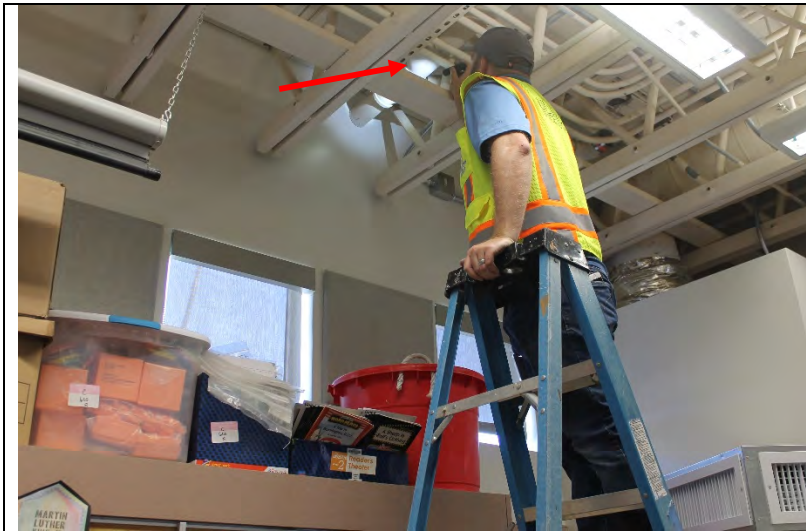
Photo 213:

DTR making observations of drain assemblies during a flood test.

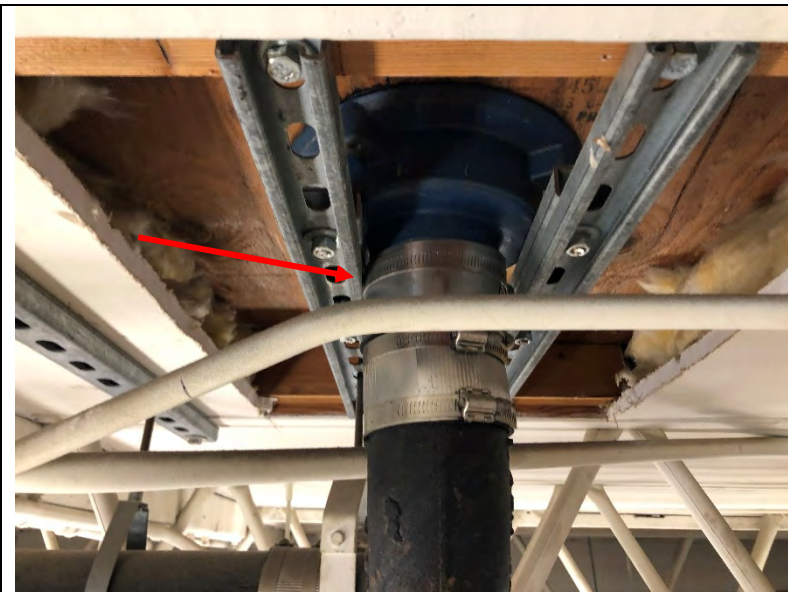
Photo 215:

Drain bowls were compressed to the underside of the deck with uni-strut and wood blocking.

No anchor bolts were holding the drain bowl to the deck.

This is a nonstandard mounting system for drains

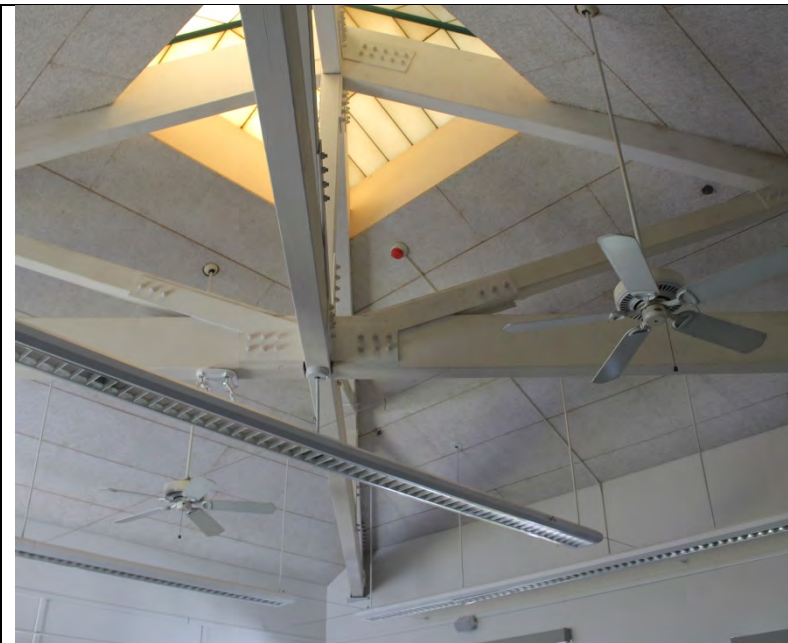
Photo 216:

Many of the classrooms had acoustical panels on the ceiling. The panels partially obscured water stains that may have been present. School District staff stated that the ceilings had been painted also. New paint will have further obscured evidence of water stains. Discolored areas were still visible on the acoustical panels. In one location, recessed can lighting had also come loose from the ceiling (**Photos 216 – 219**).

Acoustical panels on the ceiling of the pyramid roofed classroom in building D.

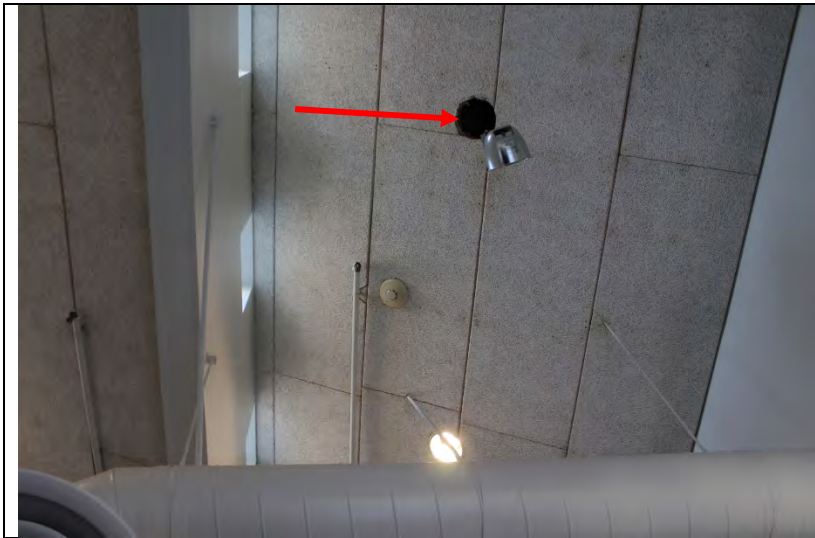
Photo 217:
A loose light fixture in the
acoustical panels on the ceiling
of the classrooms in building D.

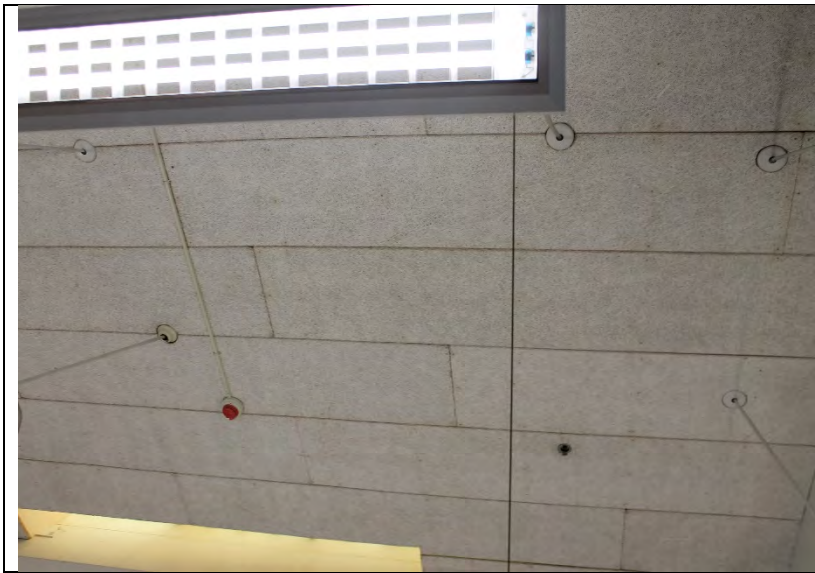
Photo 218:
Acoustical panels on the ceiling
of the classrooms in building D.

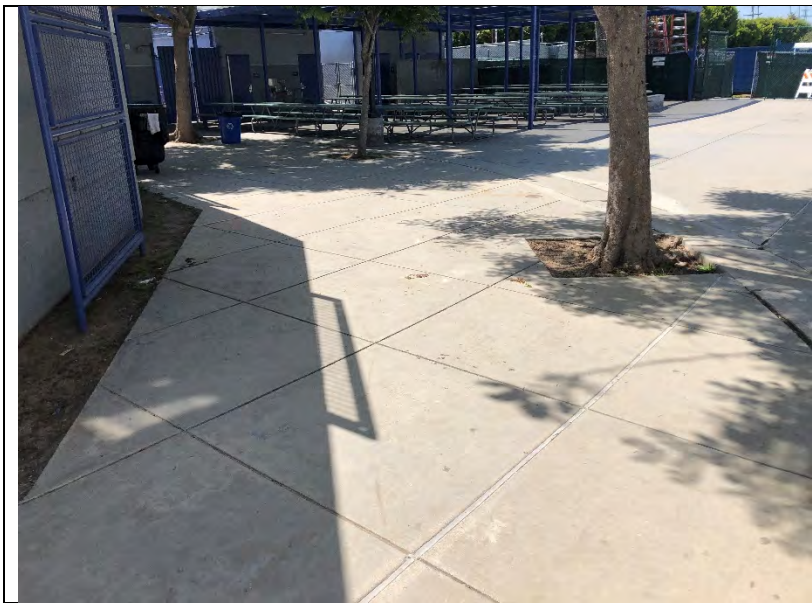
Much of the at-grade ground surface on campus is covered in hardscape materials. Surface drains through the campus are widely spaced and in a variety of sizes. Some of the landscaping drains are partially covered by landscaping limiting their effectiveness. The hardscape is often uneven and does not promote positive drainage (**Photos 220 – 226**).

Photo 220:
The campus is extensively hardscaped.

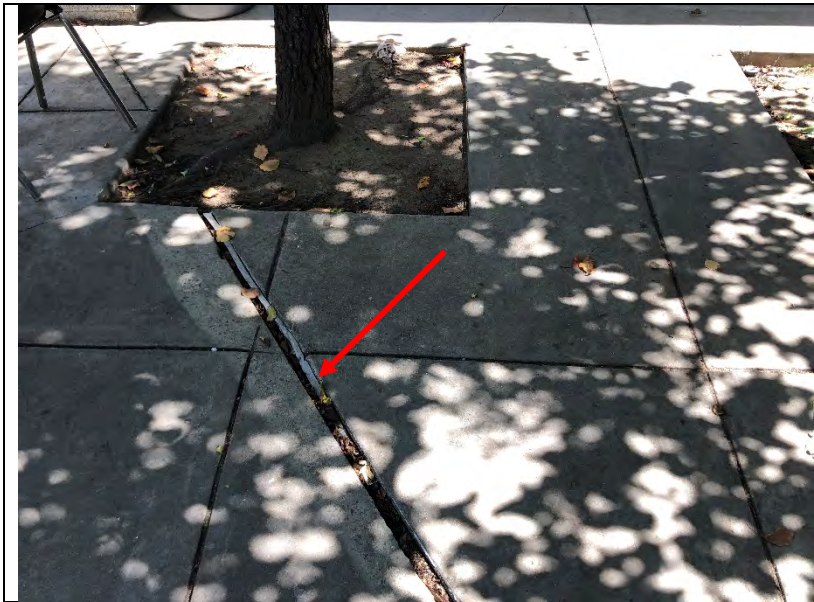
Photo 221:

The campus is extensively hardscaped.

Hardscape has shifted in many locations.

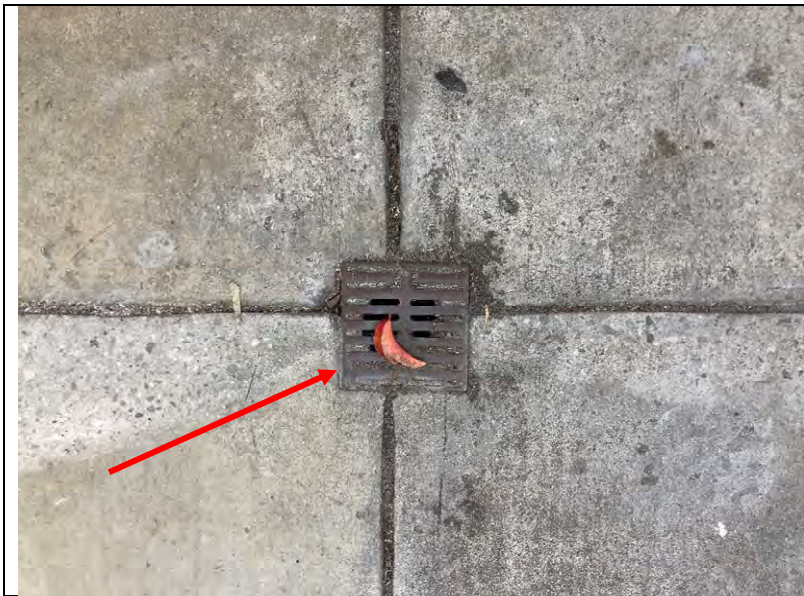
Photo 222:

Surface drains in the hardscape vary in size.

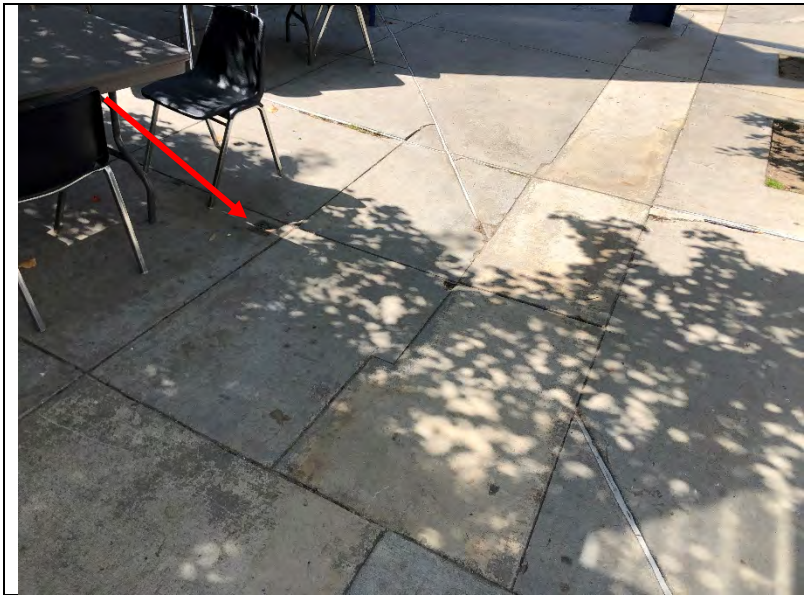
Photo 225:
Drains in the hardscape were often not at the lowest points.

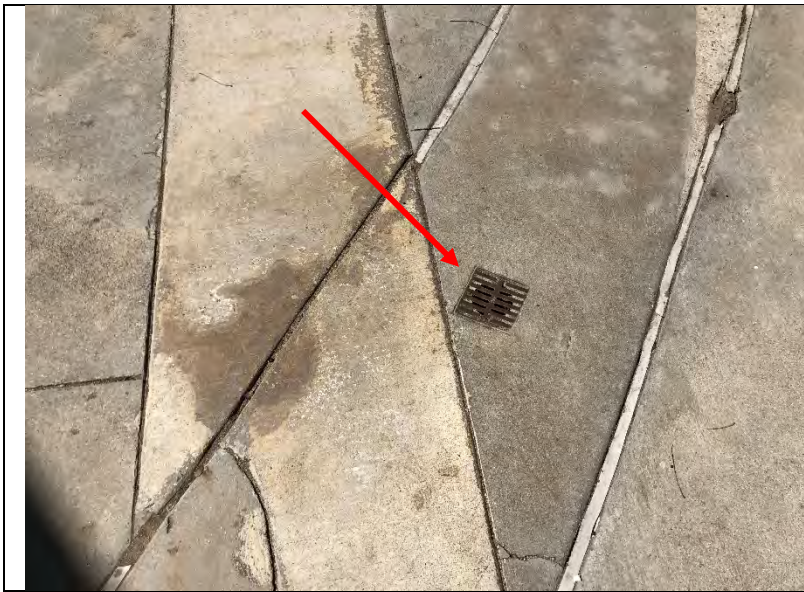
Photo 226:
Drains in the hardscape were often not at the lowest points.
